City of Phoenix

ANNUAL REPORT

Municipal Separate Storm Sewer System

September 27, 2019

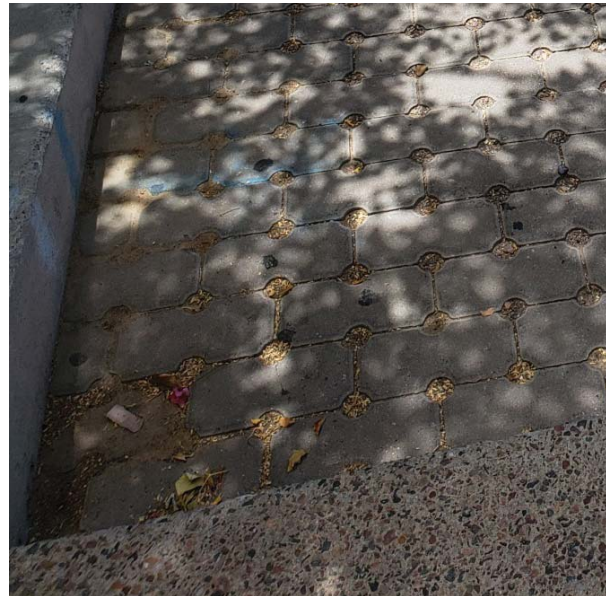
Debris on Pavers

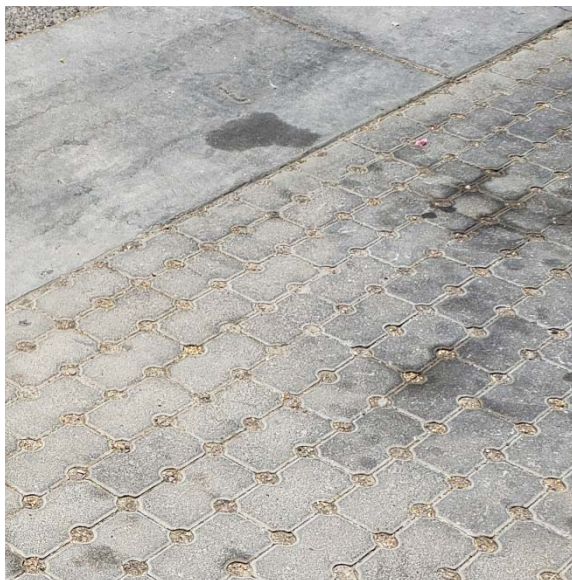
Oil on pavers

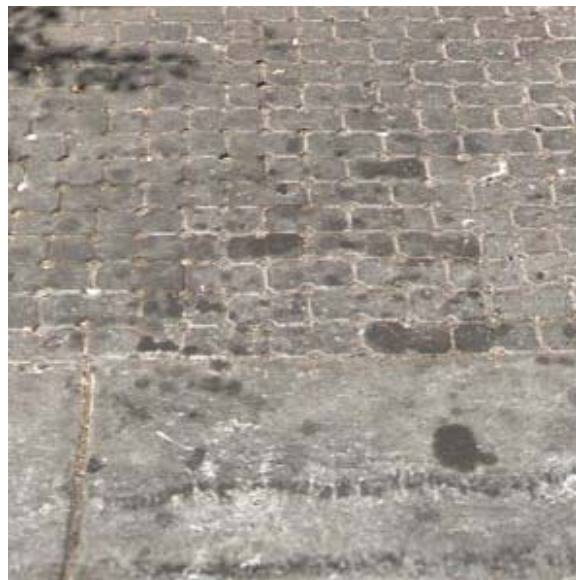
Oil on pavers

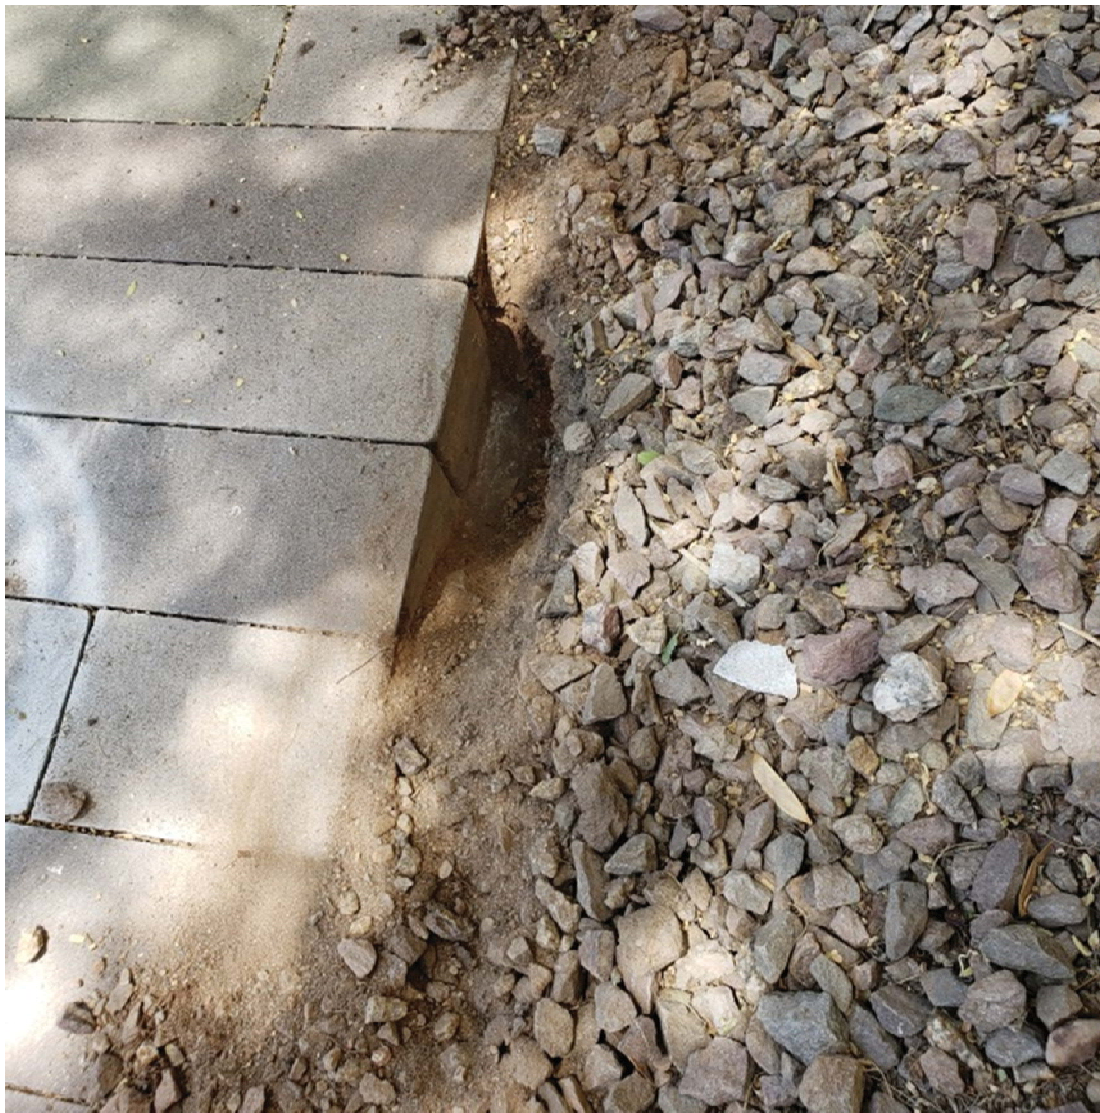
- One of the two site tested indicated no infiltration
- Permeable pavers could not be removed for subgrade testing due to narrow joints, or grouting of pavers near the perimeter (see picture below)

Grouted pavers around edge (header)

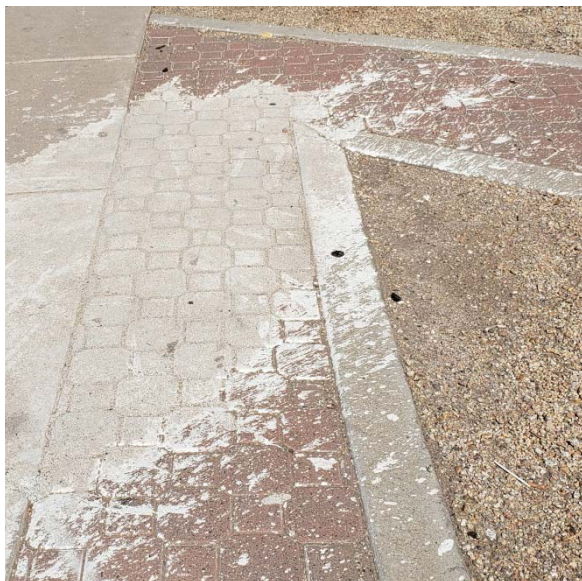
Paint spill over pavers

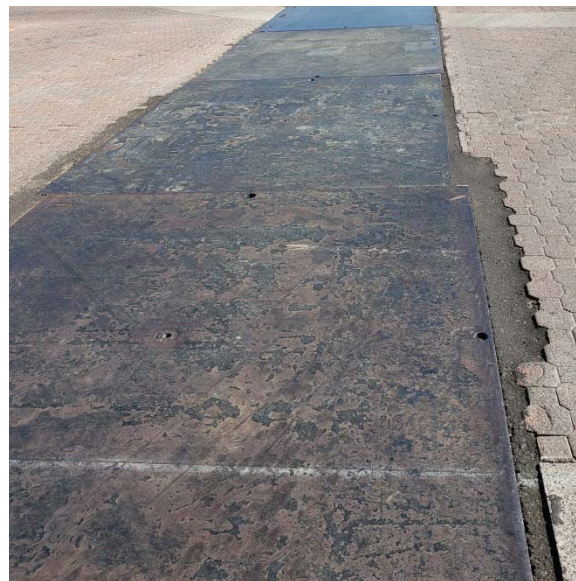
Trenching at intersection

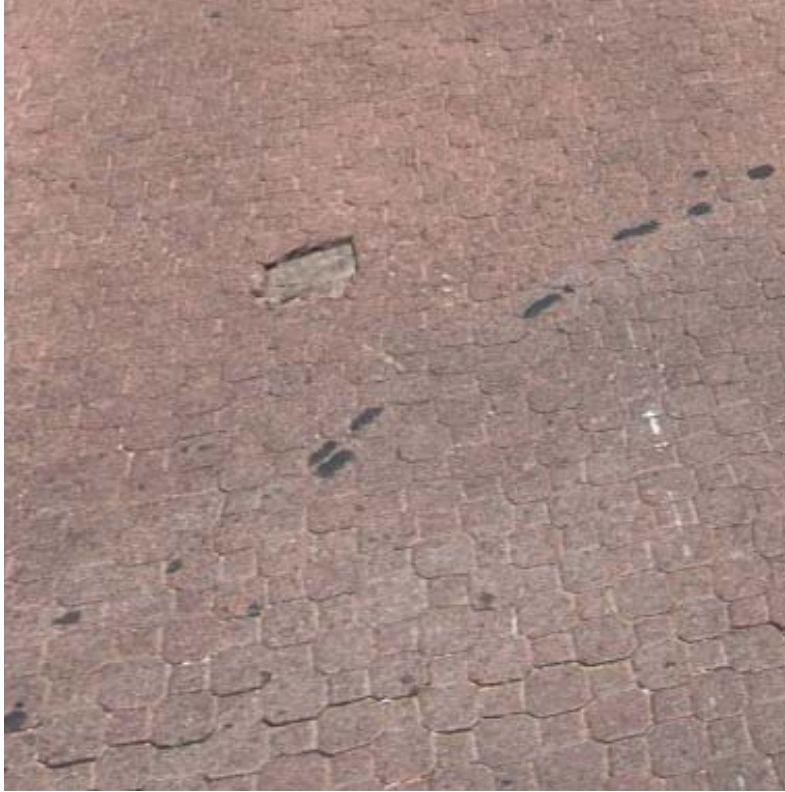
Intersection pavers missing and stained with oil and grease

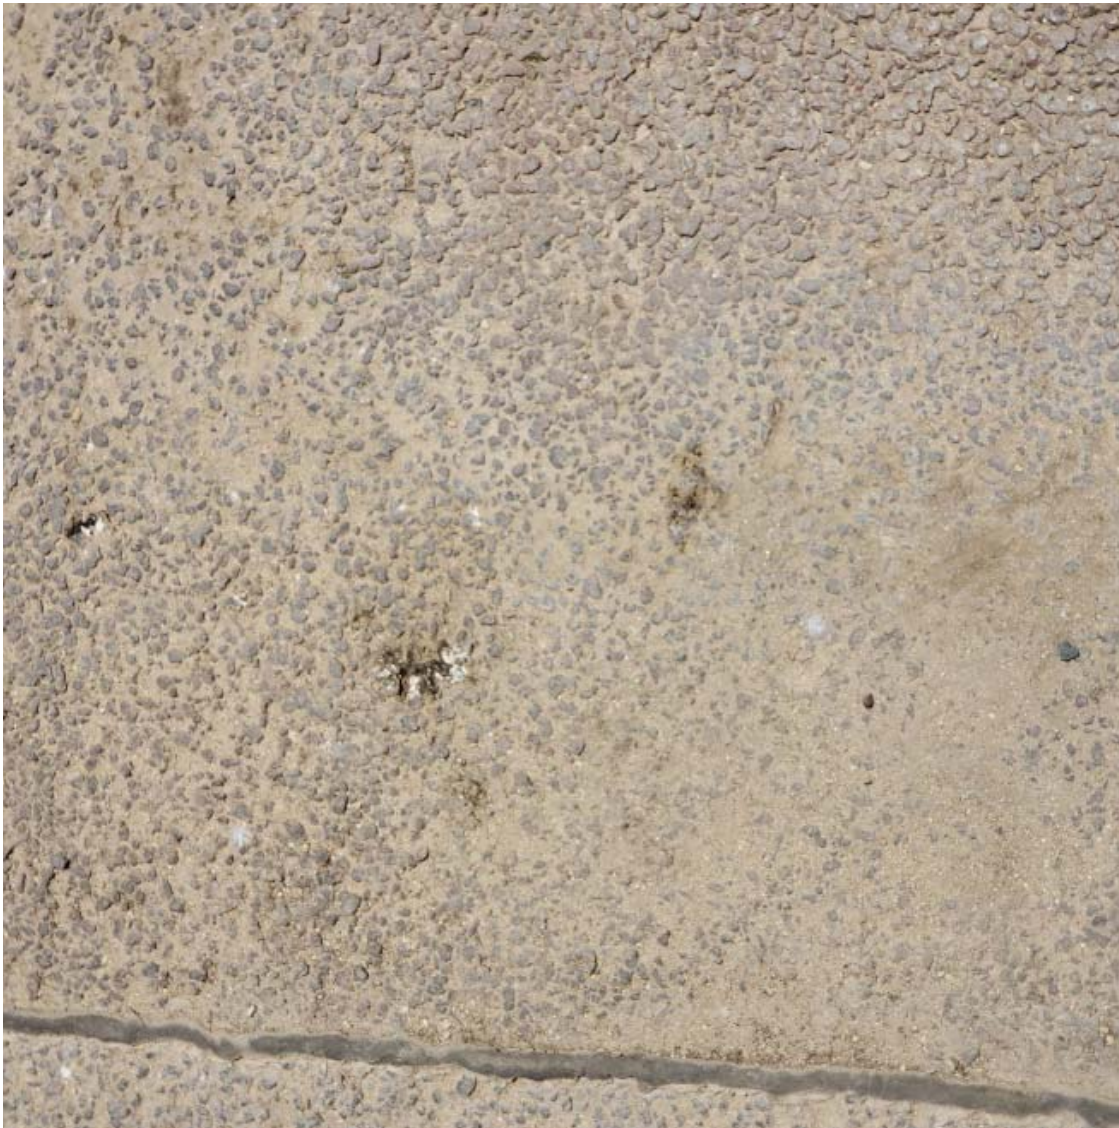
- Sediment build-up on pervious concrete throughout the park (see picture on following page)

Pervious concrete full of sediment

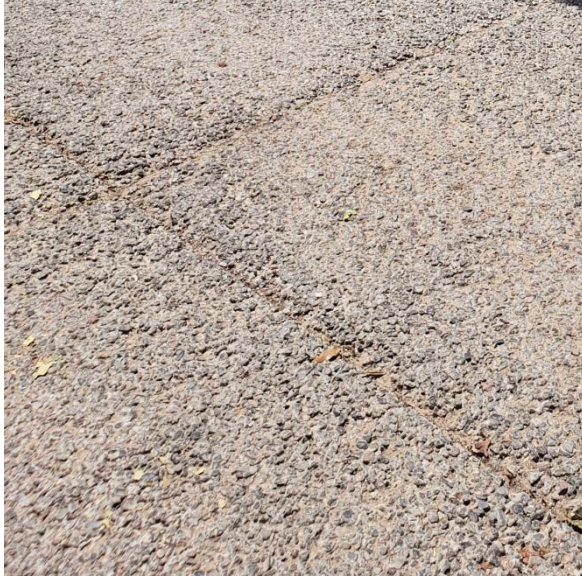
Sediment filling surface voids

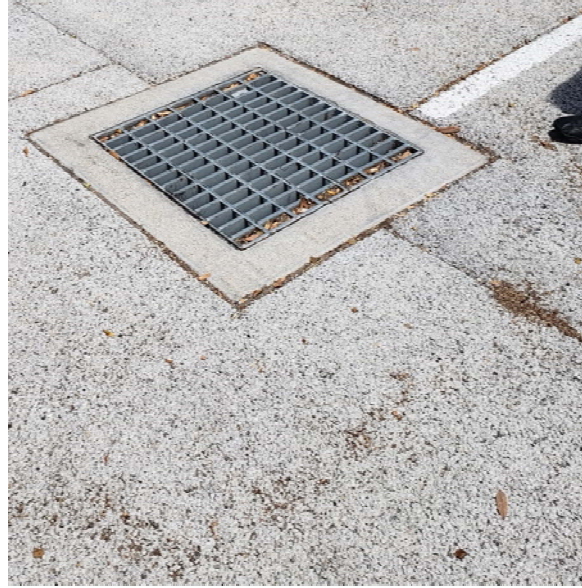
Loose leaf debris in pervious concrete

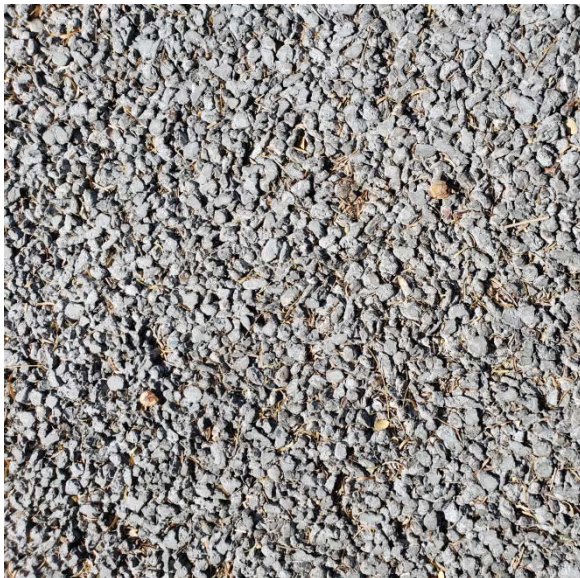
Pervious conc. partially clogged with debris

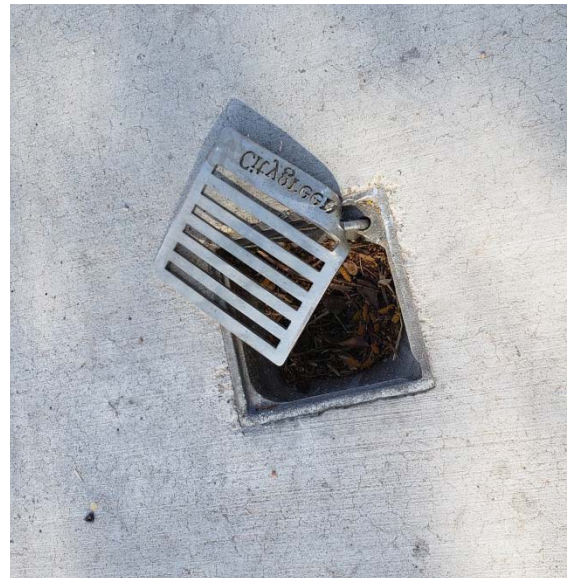
Clogged drain inlet

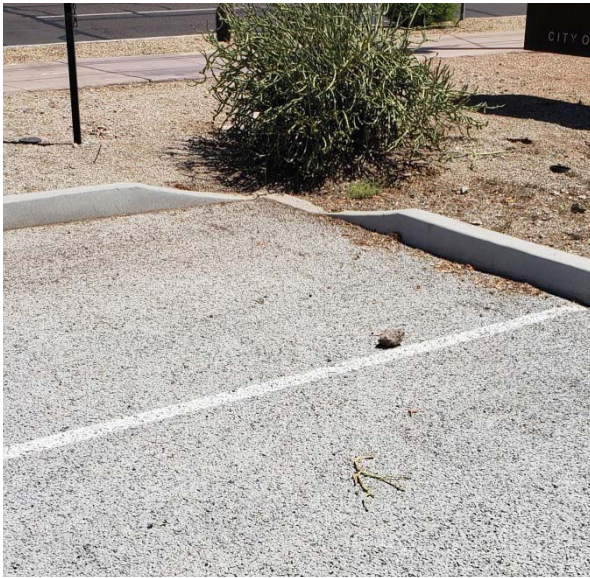
Debris buildup at sump locations

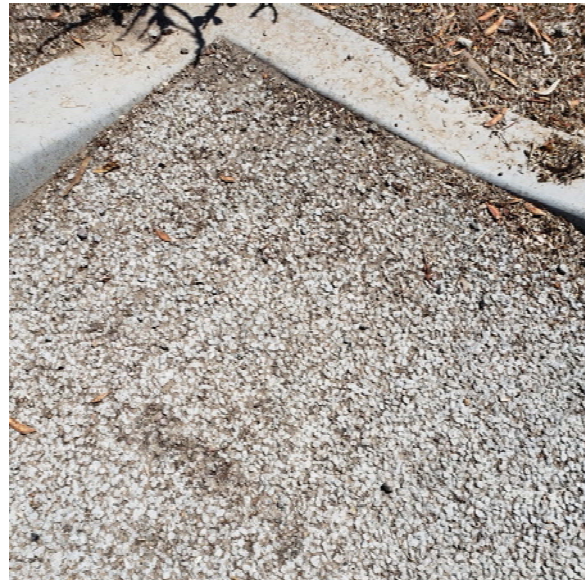
Sediment buildup at sump locations

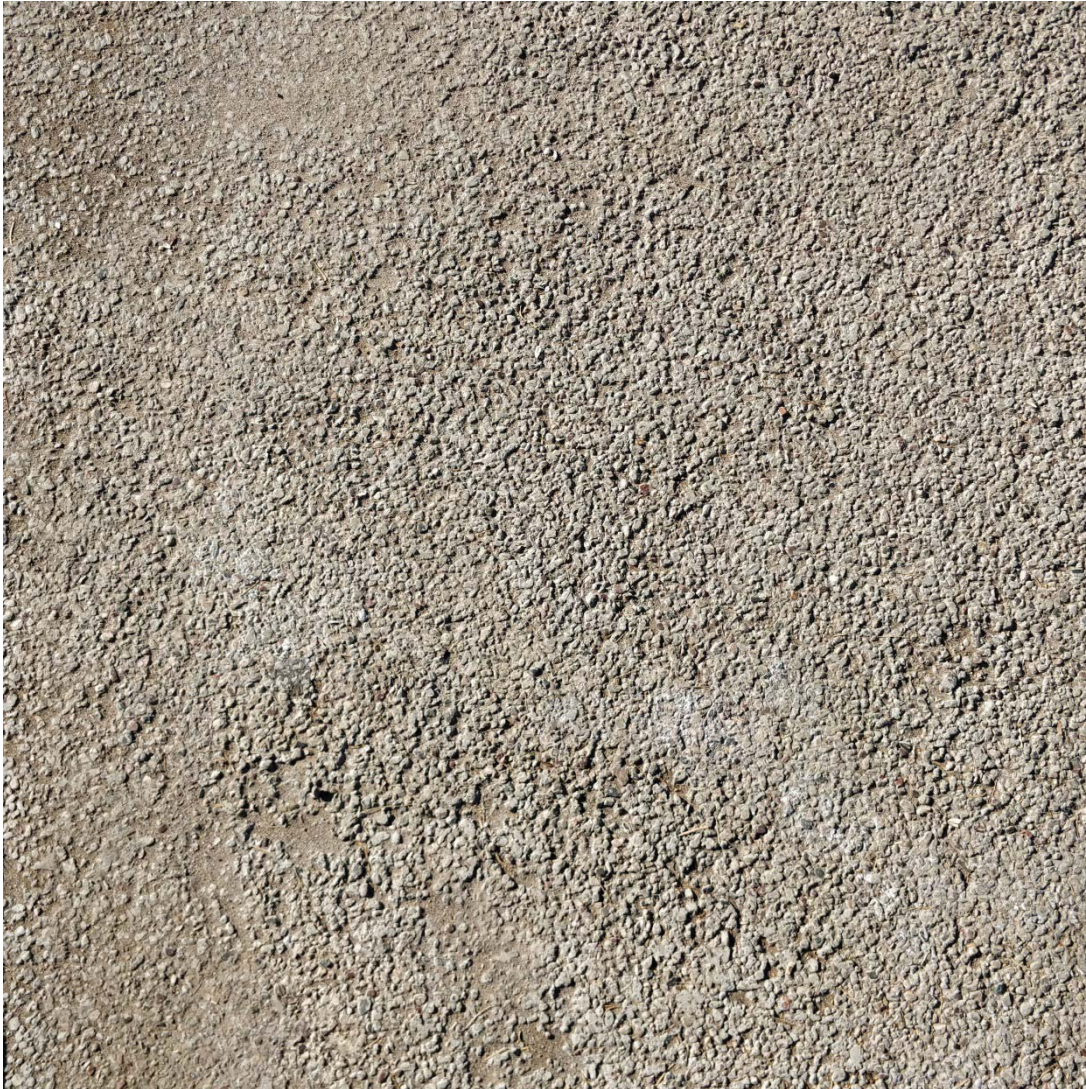
- Sediment build-up on pervious concrete throughout the pavement (see picture on following page)

Sediment filling surface voids

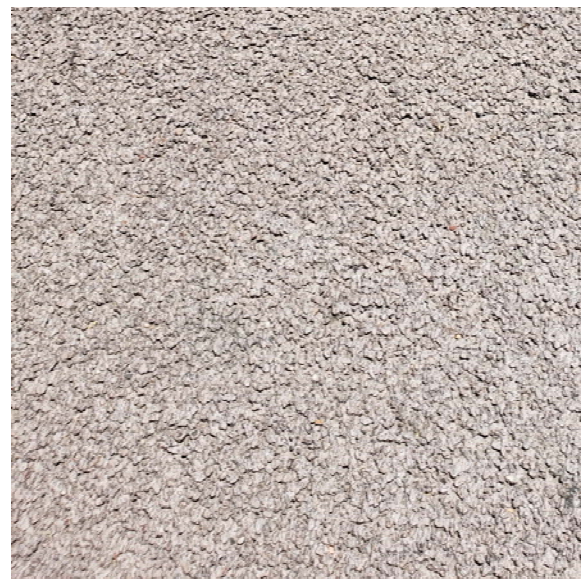
Pervious concrete at Central Station

- According to the Geotechnical Data Report provided by Ninyo & Moore and observations during testing, it is suspected that the mix design may have contained too much water, which, after hardening, would have sealed it and prohibit it from infiltrating and storing water (see picture). As a result, the pervious concrete performs like traditional concrete and
