Current Conditions Report

Mobility Area 5: Kuban Park

City of Phoenix

August 2018

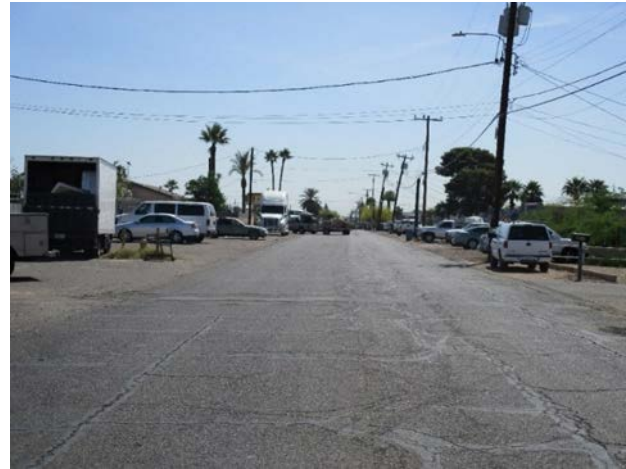
Figure 5-1: No sidewalks and vehicles on ROW

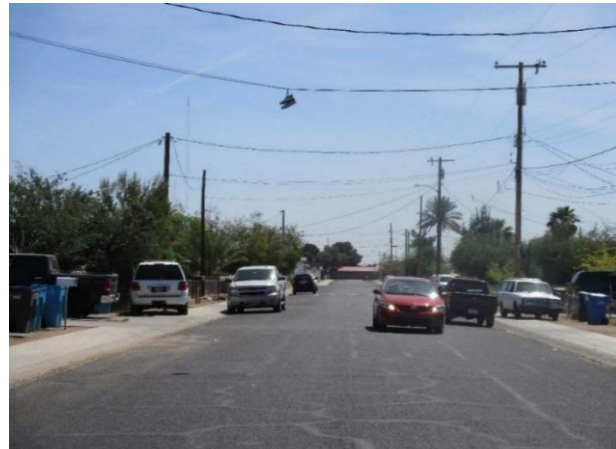
Figure 5-2: Vehicles on sidewalks on a local street in the study area

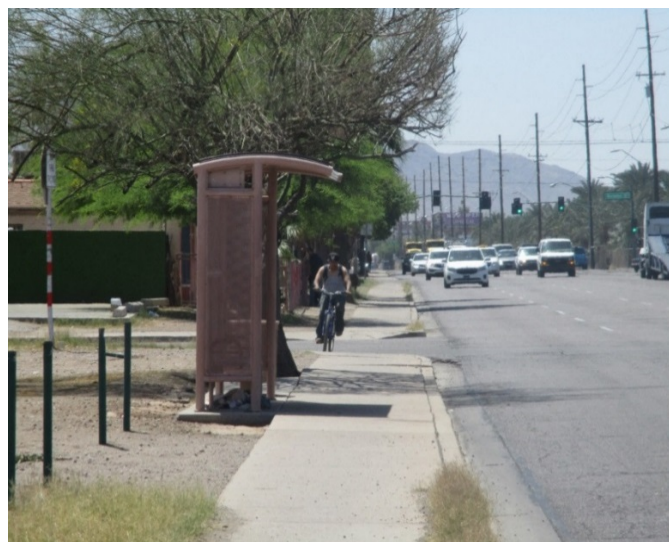
Figure 5-6: Bus stop along 35th Avenue -no bus pullout (major arterial)

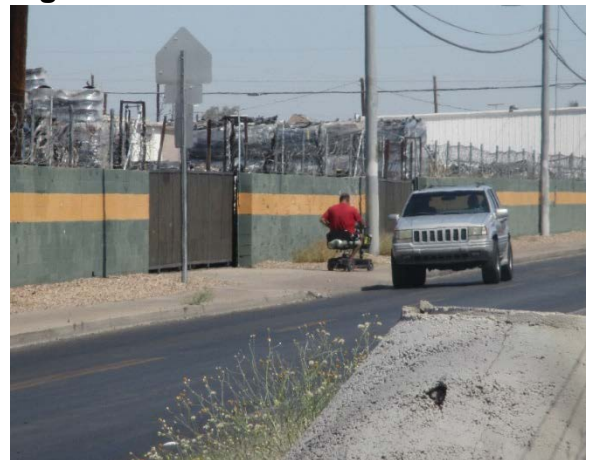
Figure 5-8: Narrow sidewalks

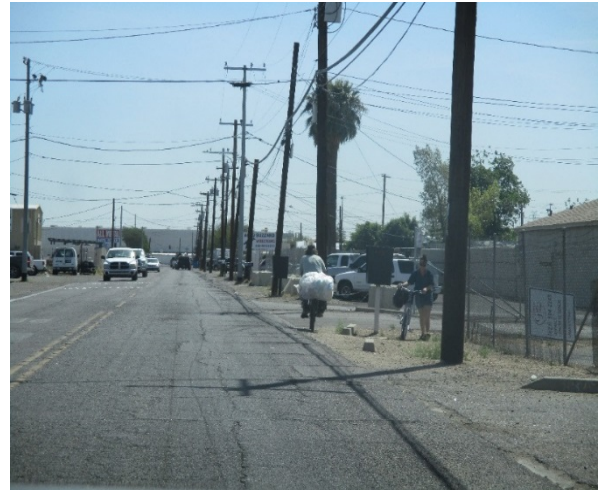
Figure 5-9: Missing sidewalk on Lincoln Street

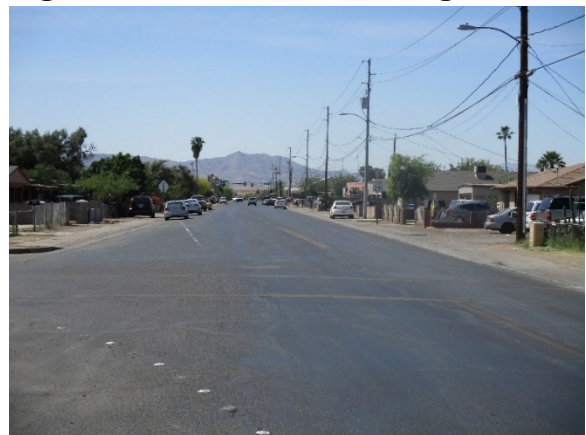
Figure 5-11: Limited street lights

- Lighting infrastructure is concentrated along major/minor arterials like Buckeye Road and 35th Avenue. Yuma Street and Pima Street, where the neighborhood is more residential, have less lighting infrastructure. There are also large gaps in lighting infrastructure on Pima Street between 31st Avenue and 30th Avenue where there are no light poles except at the cross-streets.

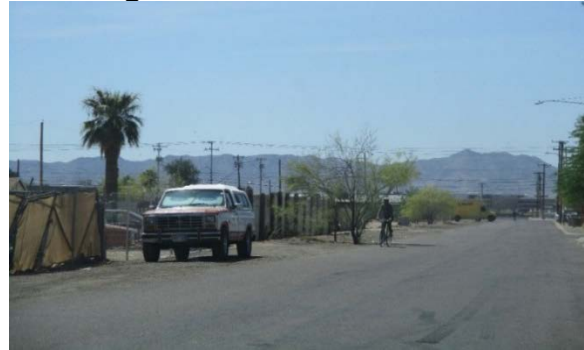
- Trees and tree pits are located at Kuban Park and in some areas along Buckeye Road, and 35th Avenue.
- Most of the Kuban Park study area is void of shade coverage.
- Trees that are located within the study area are shade trees and do provide shade to pedestrian and bicycle facilities, however, trees are spaced far apart and are generally inconsistent.

Figure 5-13: Lack of proper shade covering

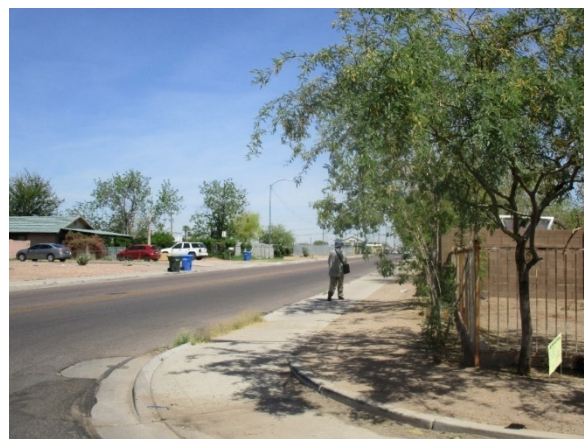
Figure 5-14: Shade in some areas and not others
