CITY OF PHOENIX

Submitted by:
Project Engineering Consultants
2310 Mission Lane Suite 4
Phoenix, AZ 85021
602.906.1901

February 25, 2016

ACCESS AND ADAPTIVE MANAGEMENT PLAN

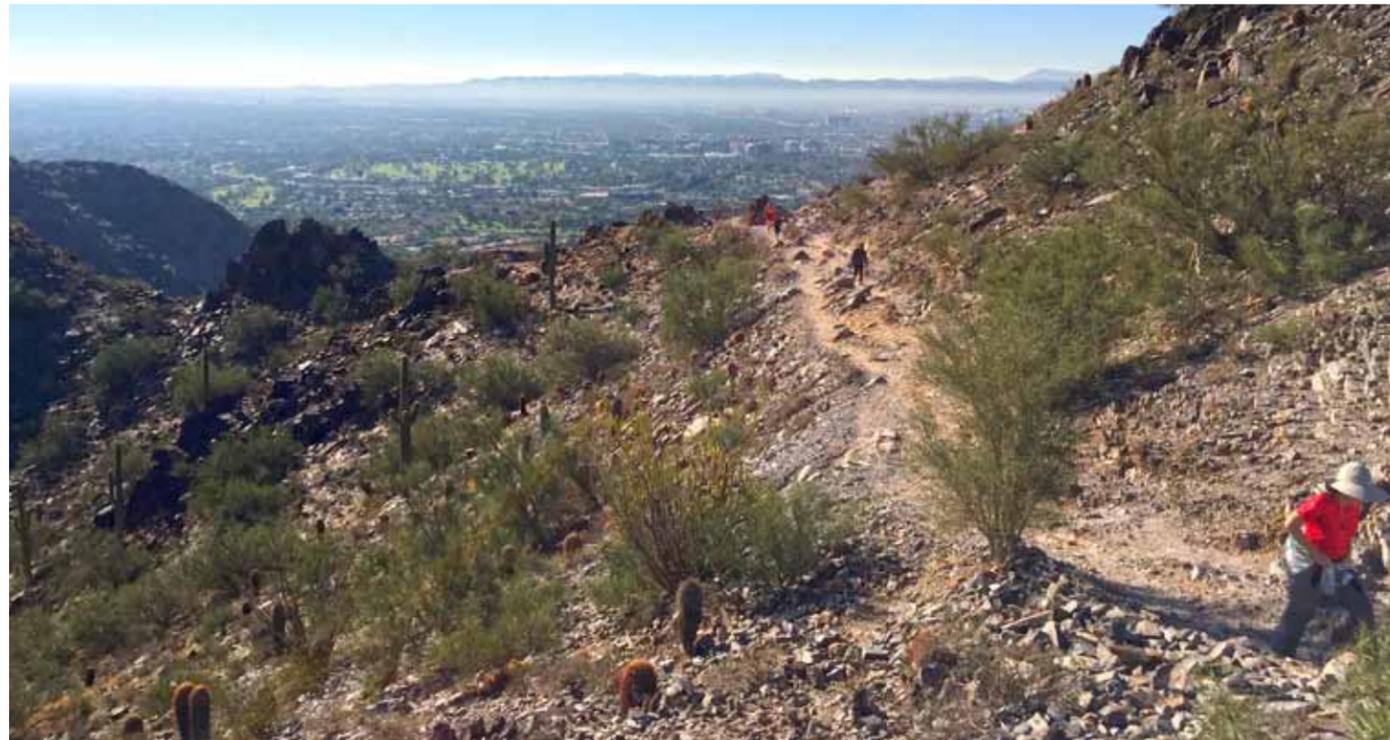
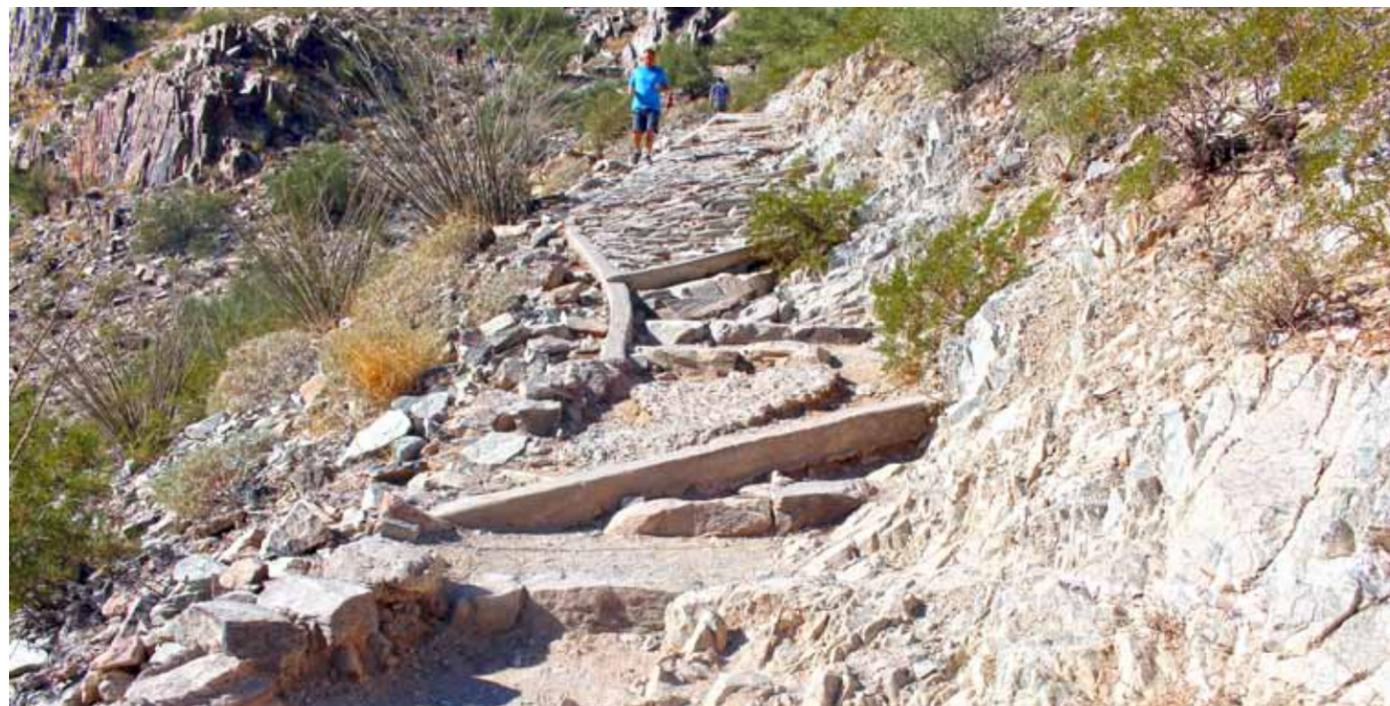
Figures 3.6 and 3.7: Accessibility of the preserve has caused numerous safety concerns. New trails will connect with existing trails. Some trails will be designated as one-way access to avoid future conflicts.

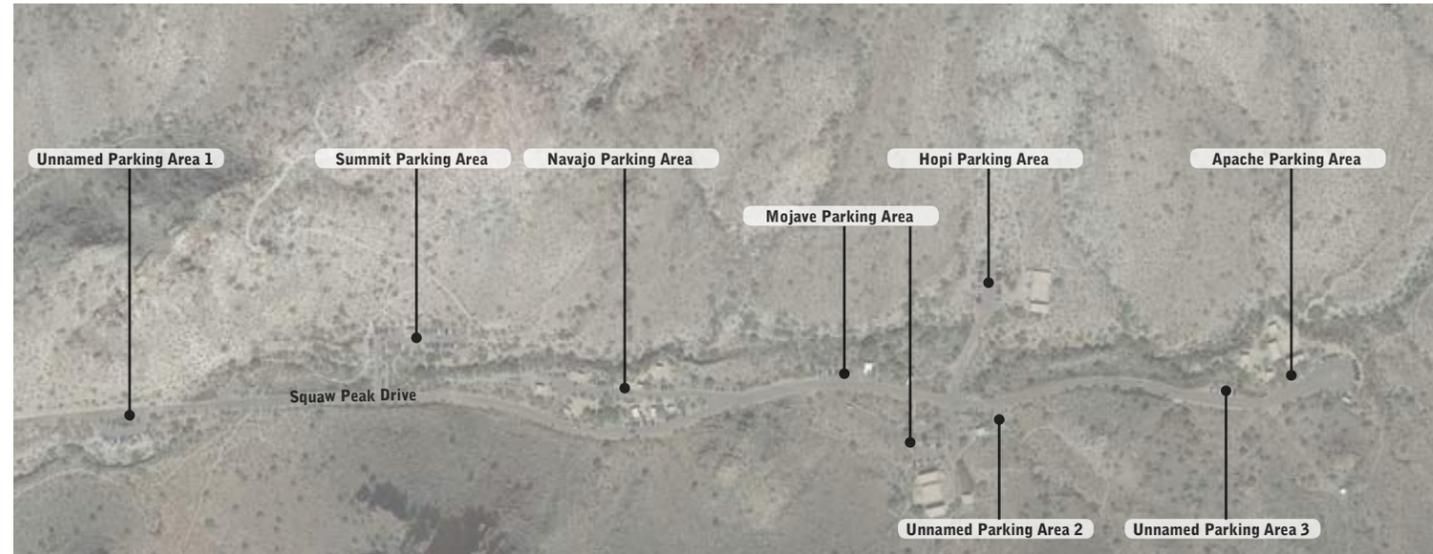
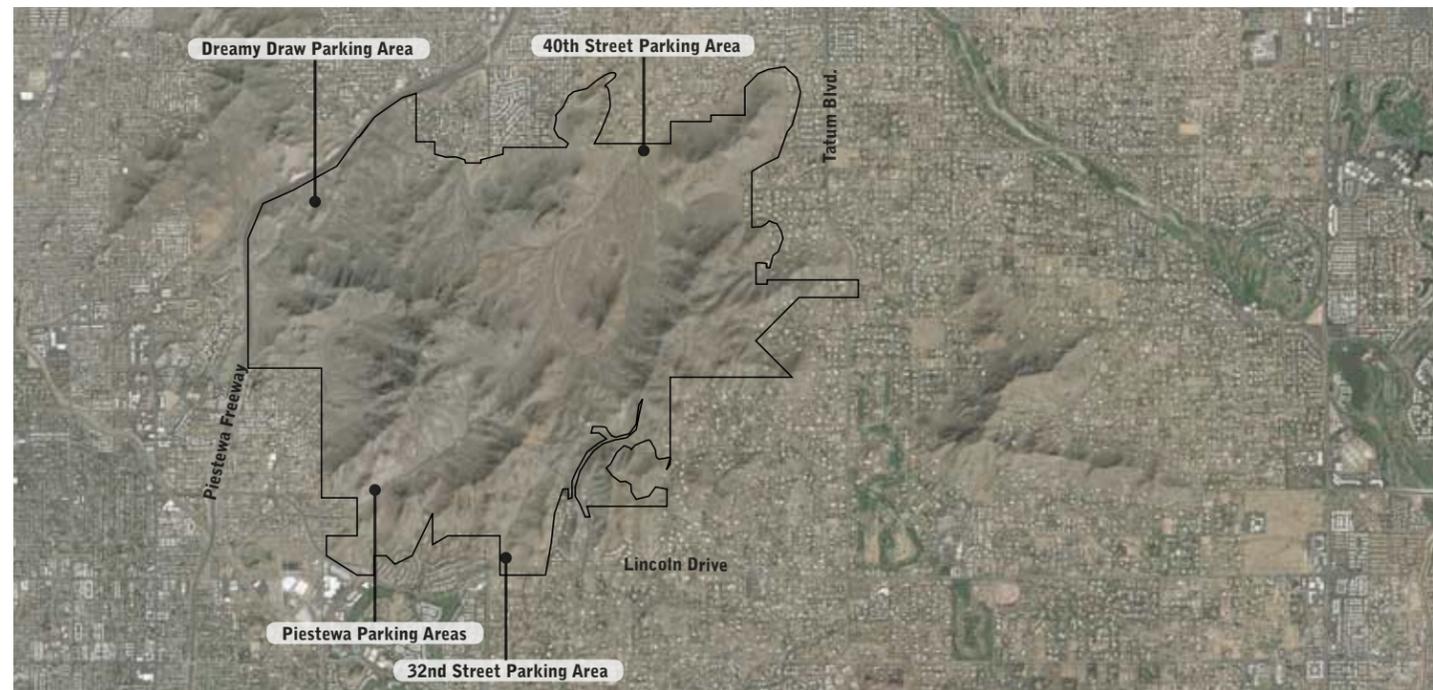
Figures 3.8 and 3.9: Trailhead location maps.

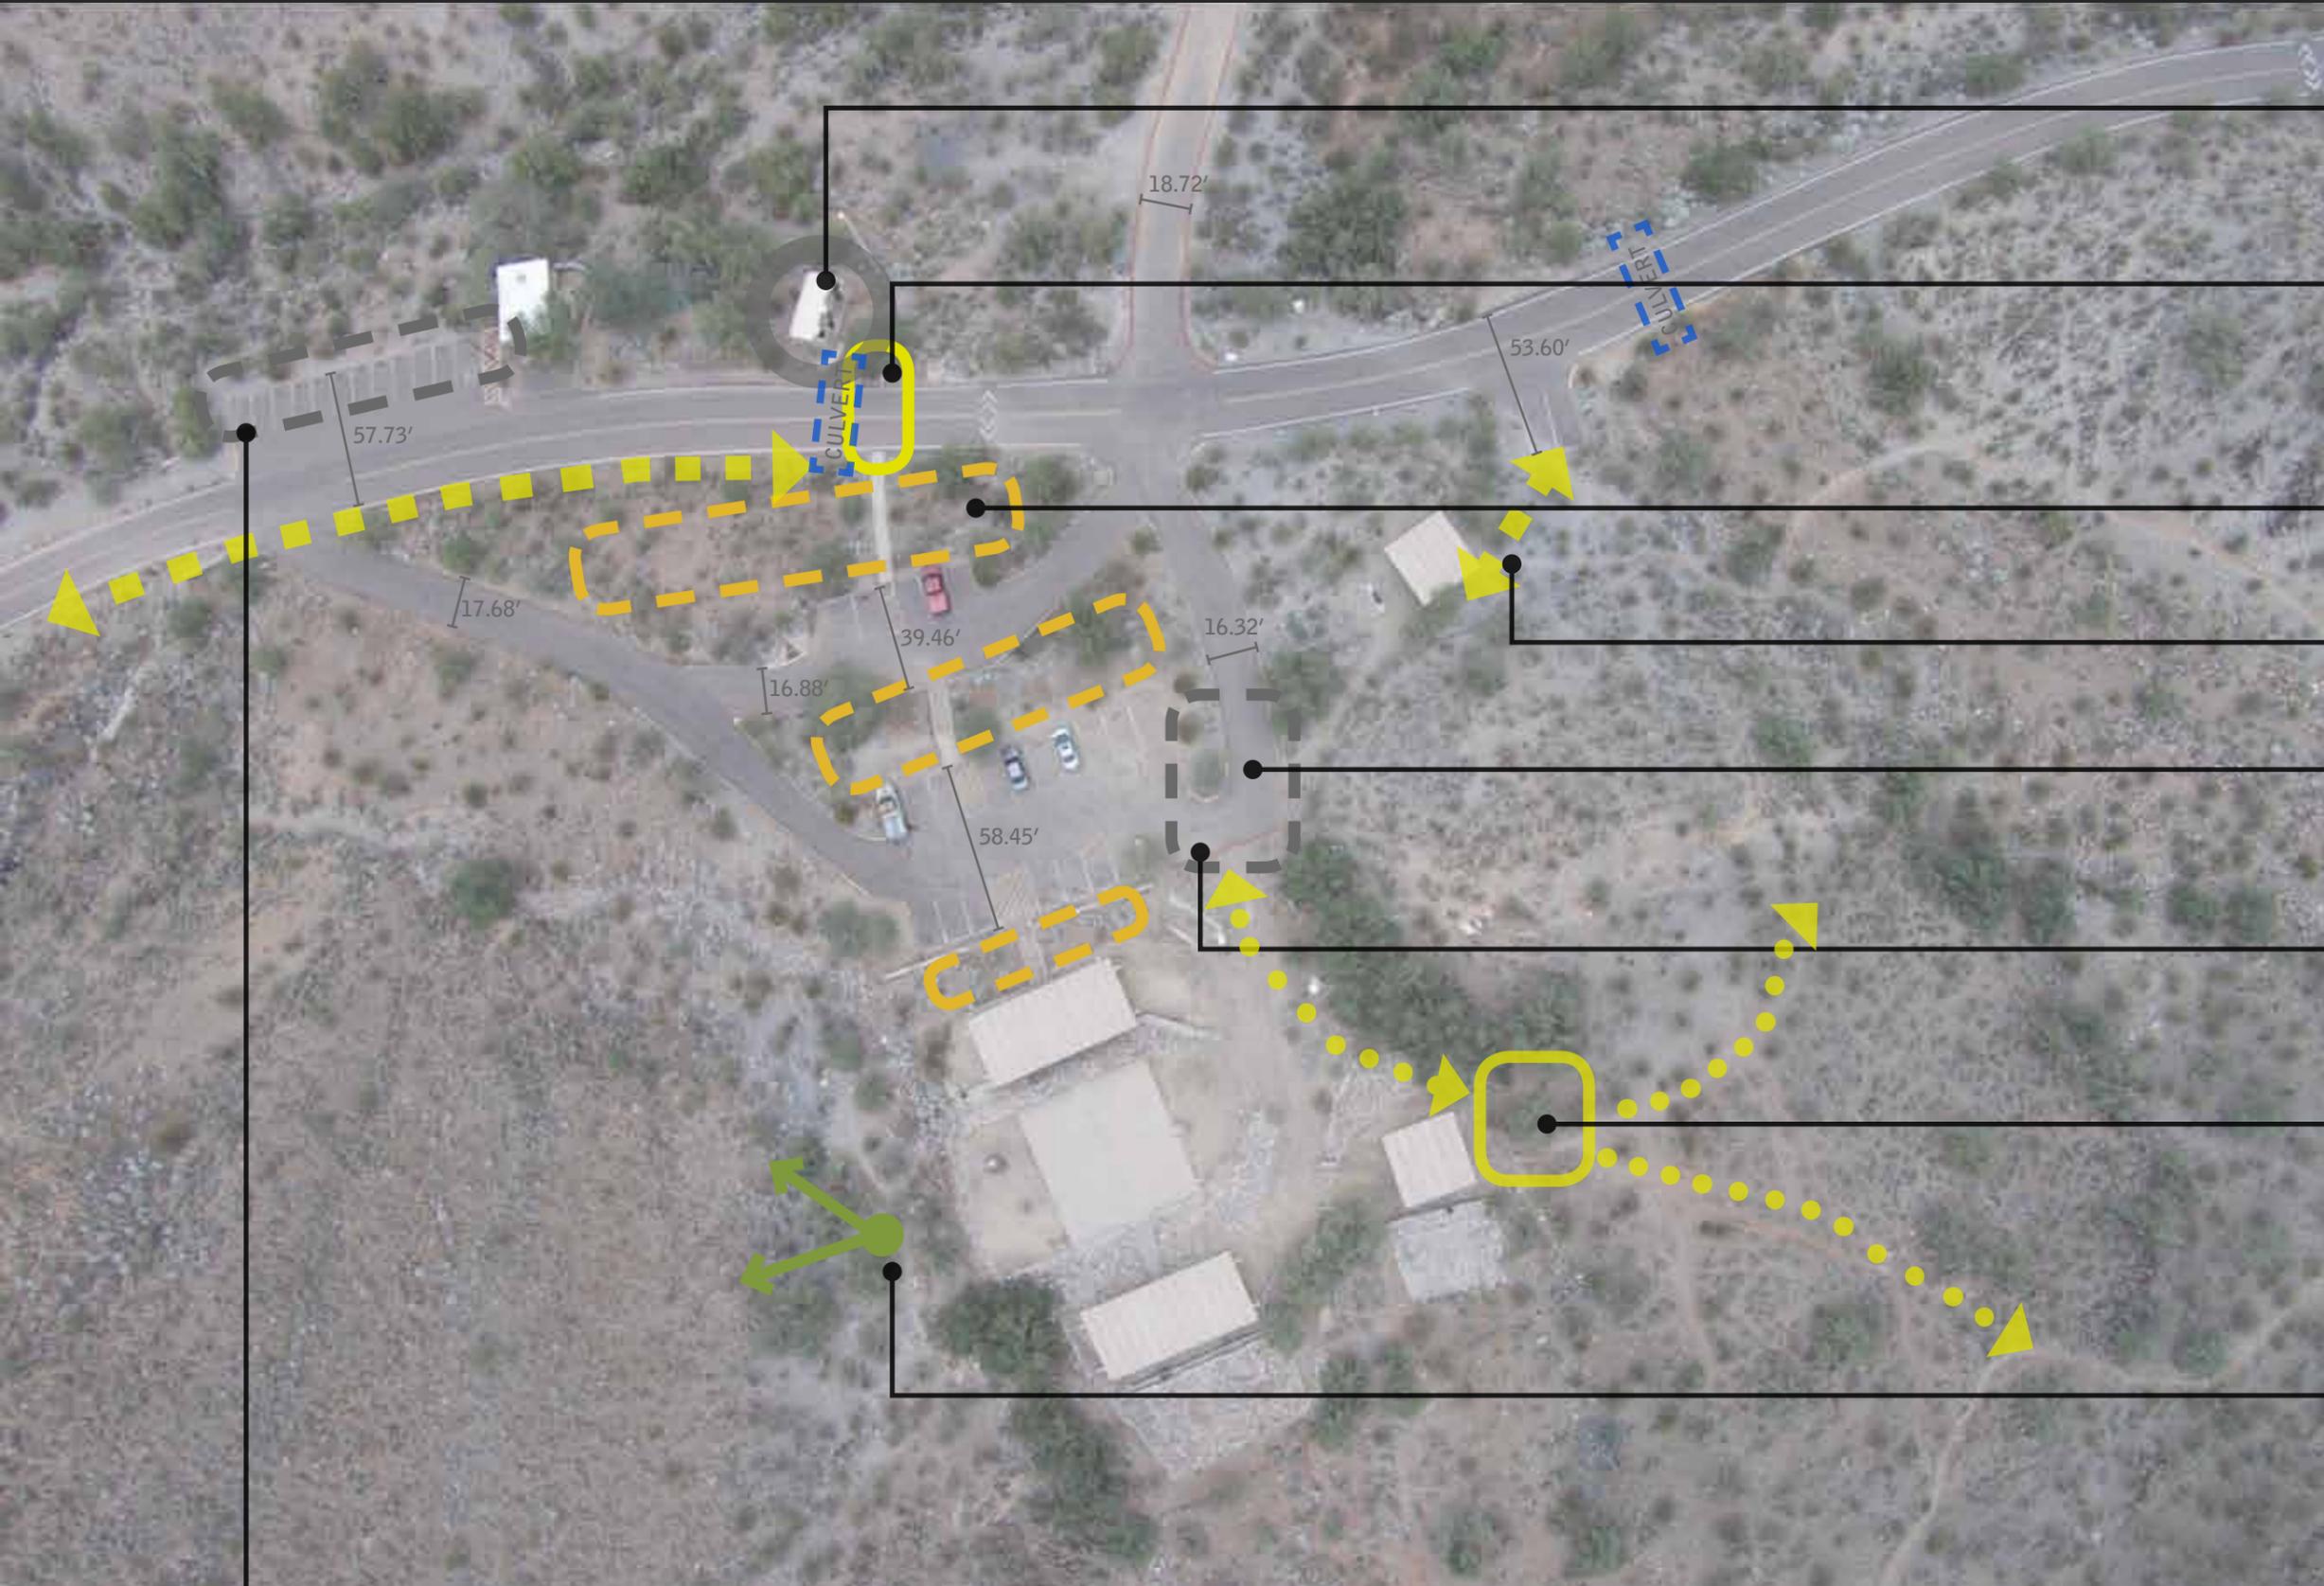
A designated crosswalk could benefit this area by providing increased safety, as well as better connectivity to ramadas and parking.

This restroom is distant from other amenities, which can be overcome by clearly designated paths and directional signage.

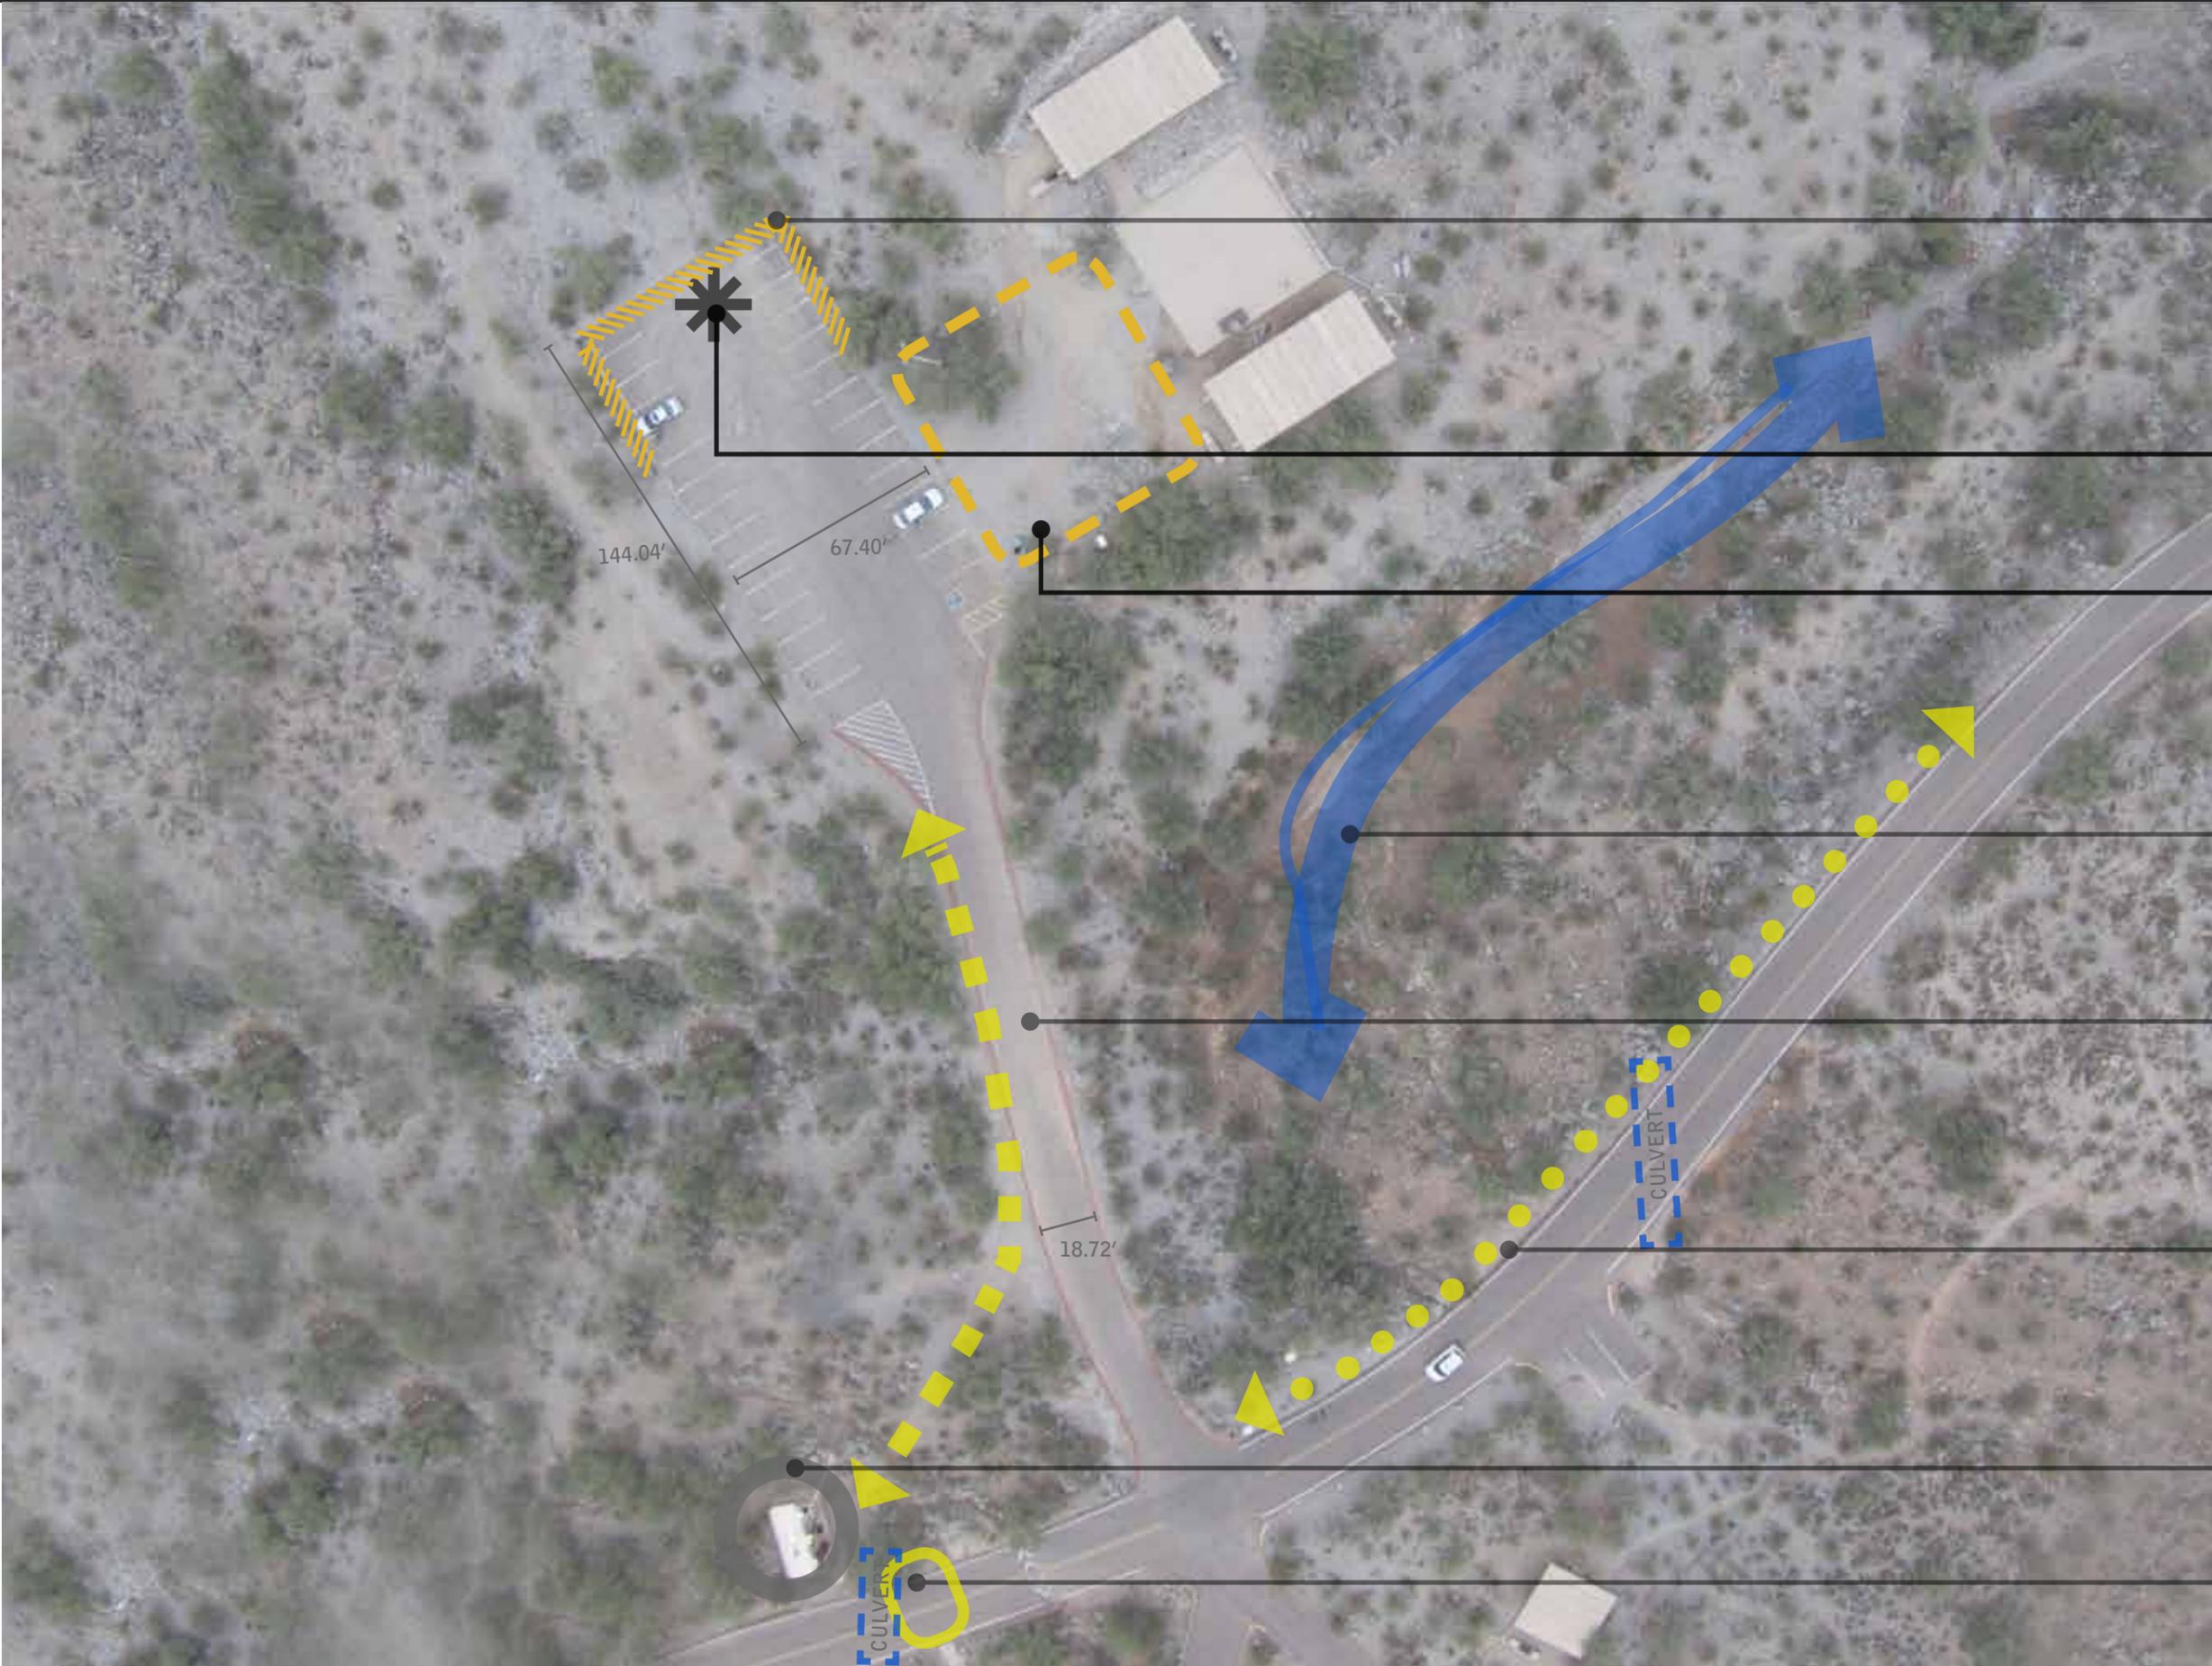
HOPI PARKING AREA

The narrow corridor between the parking area and retaining wall limits pedestrian circulation around vehicles. This also forces pedestrians to walk through the parking isle to access trails.

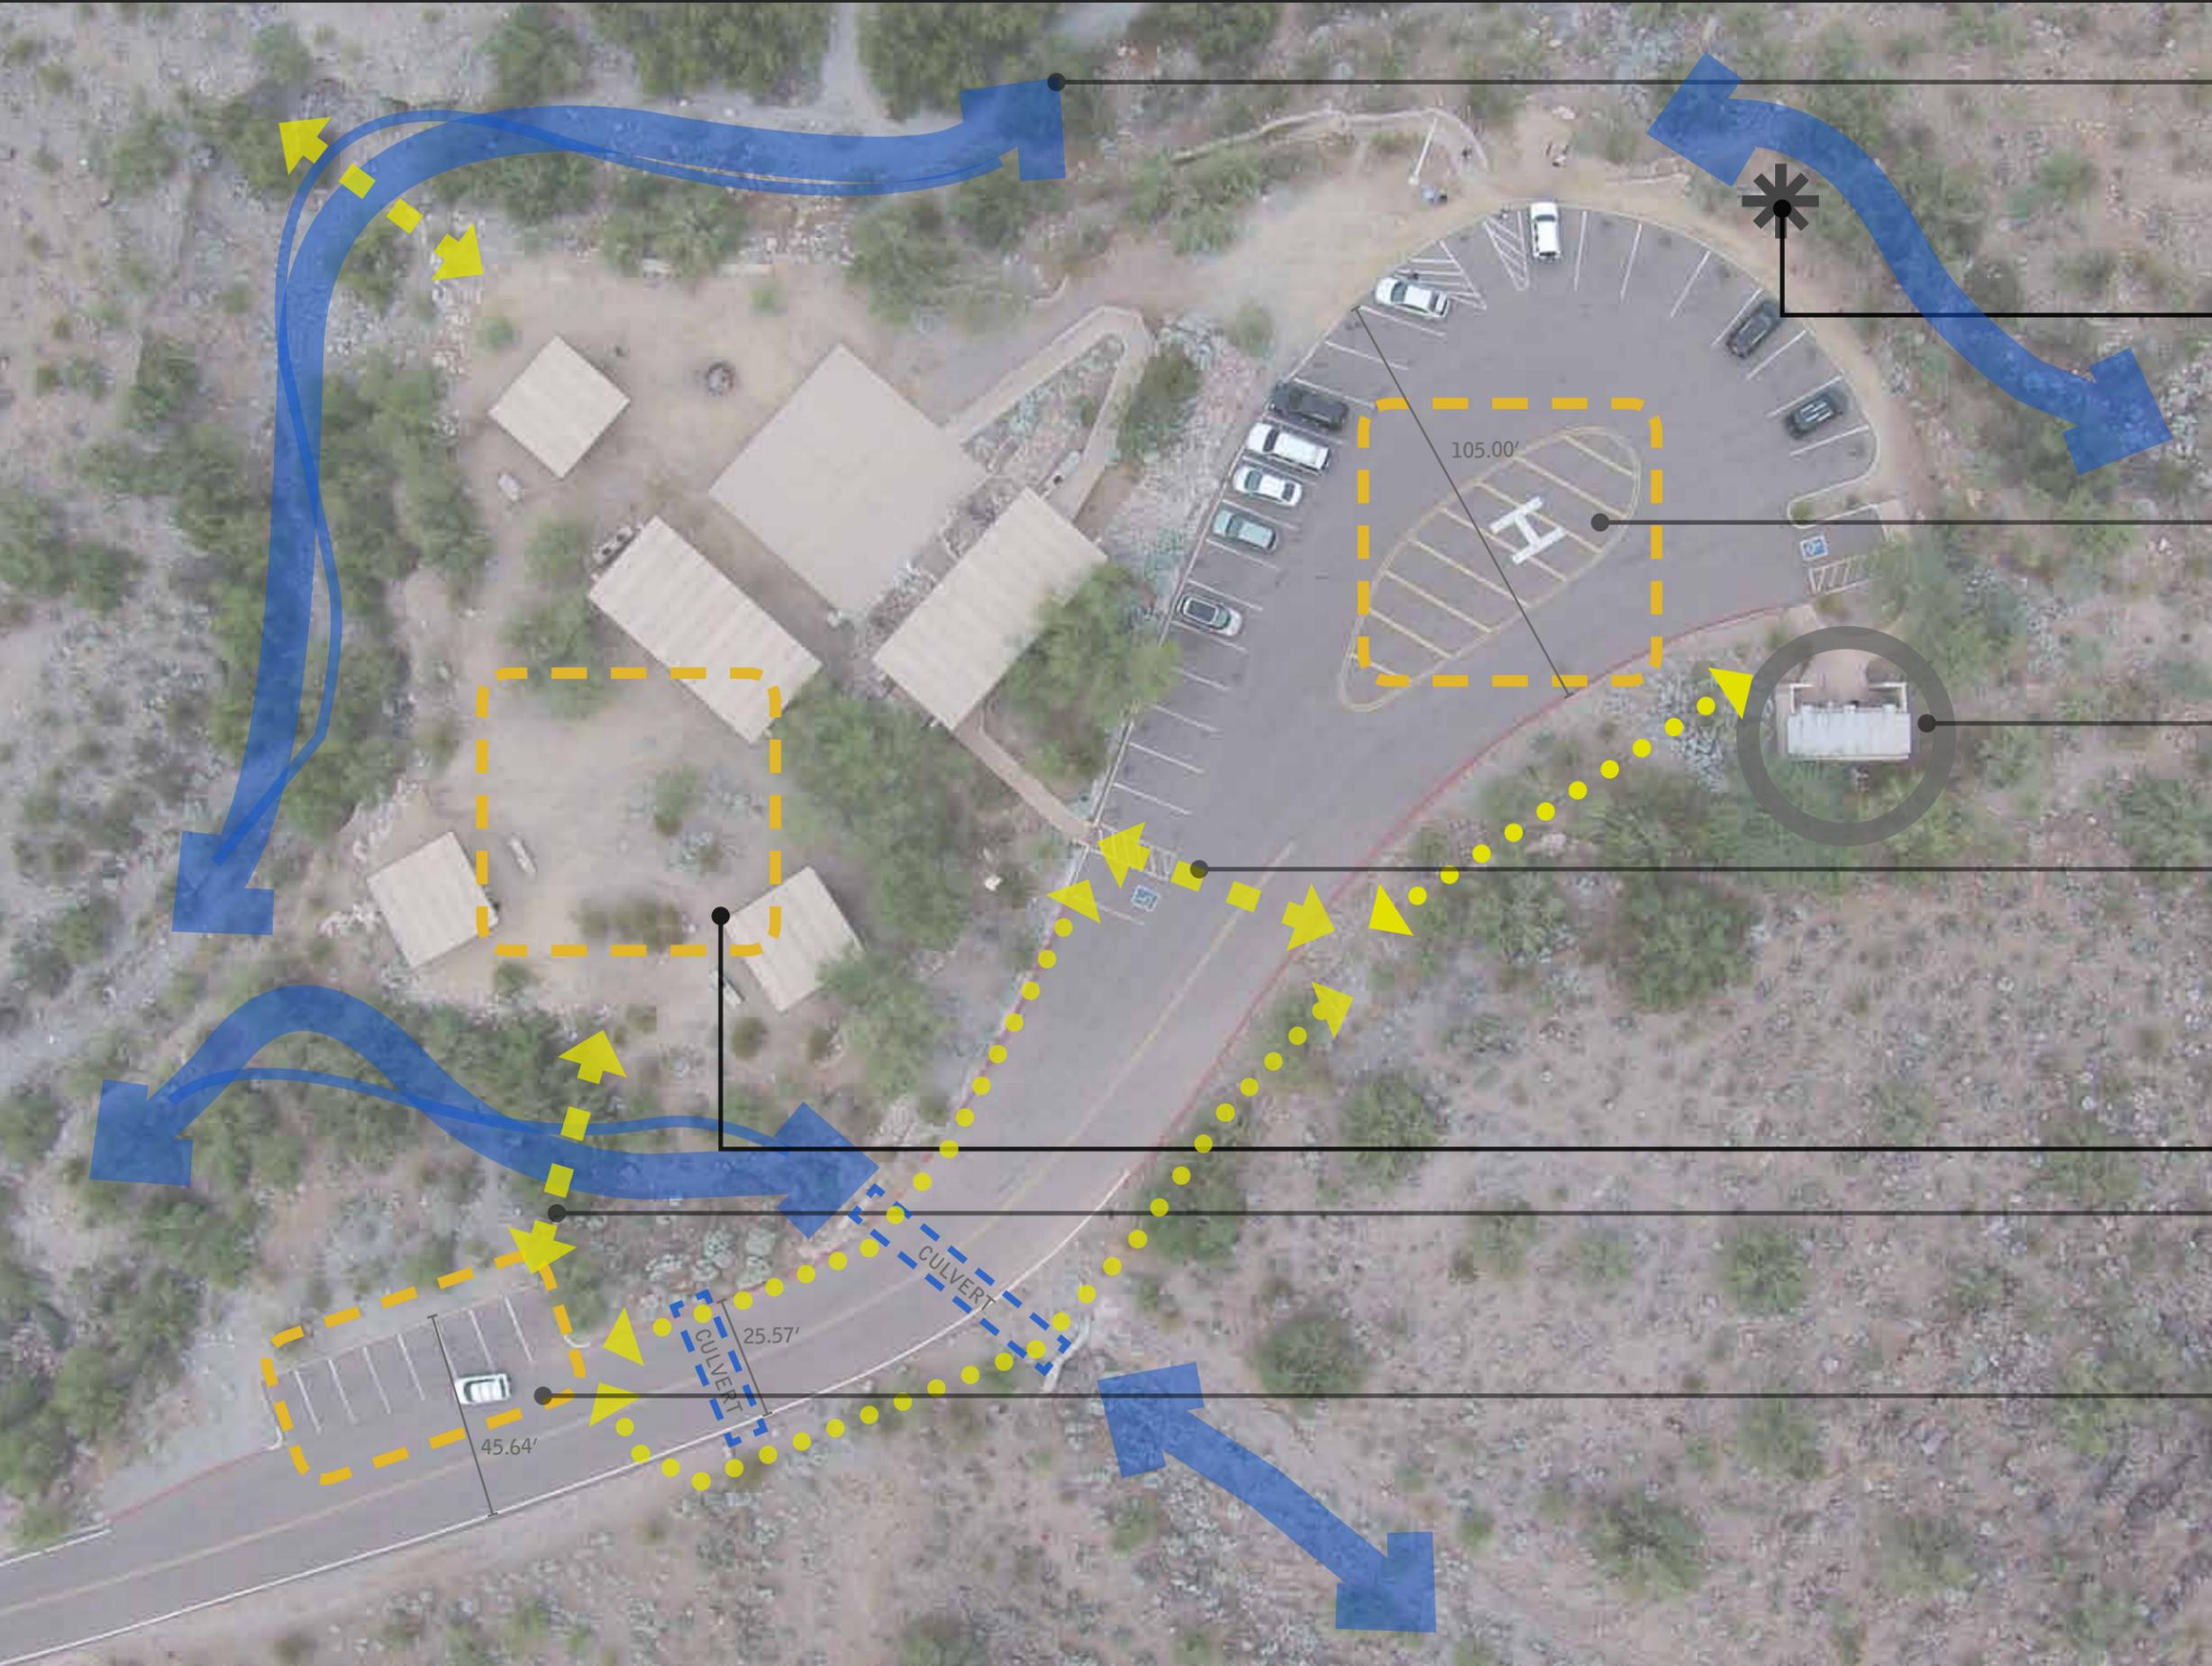
APACHE PARKING AREA AND UNNAMED PARKING AREA 3

Various intermittent washes and drainages surround the trailhead and picnic area, limiting the connectivity of this area to surrounding trails and parking areas. Designated crossings with appropriate signage would be beneficial.

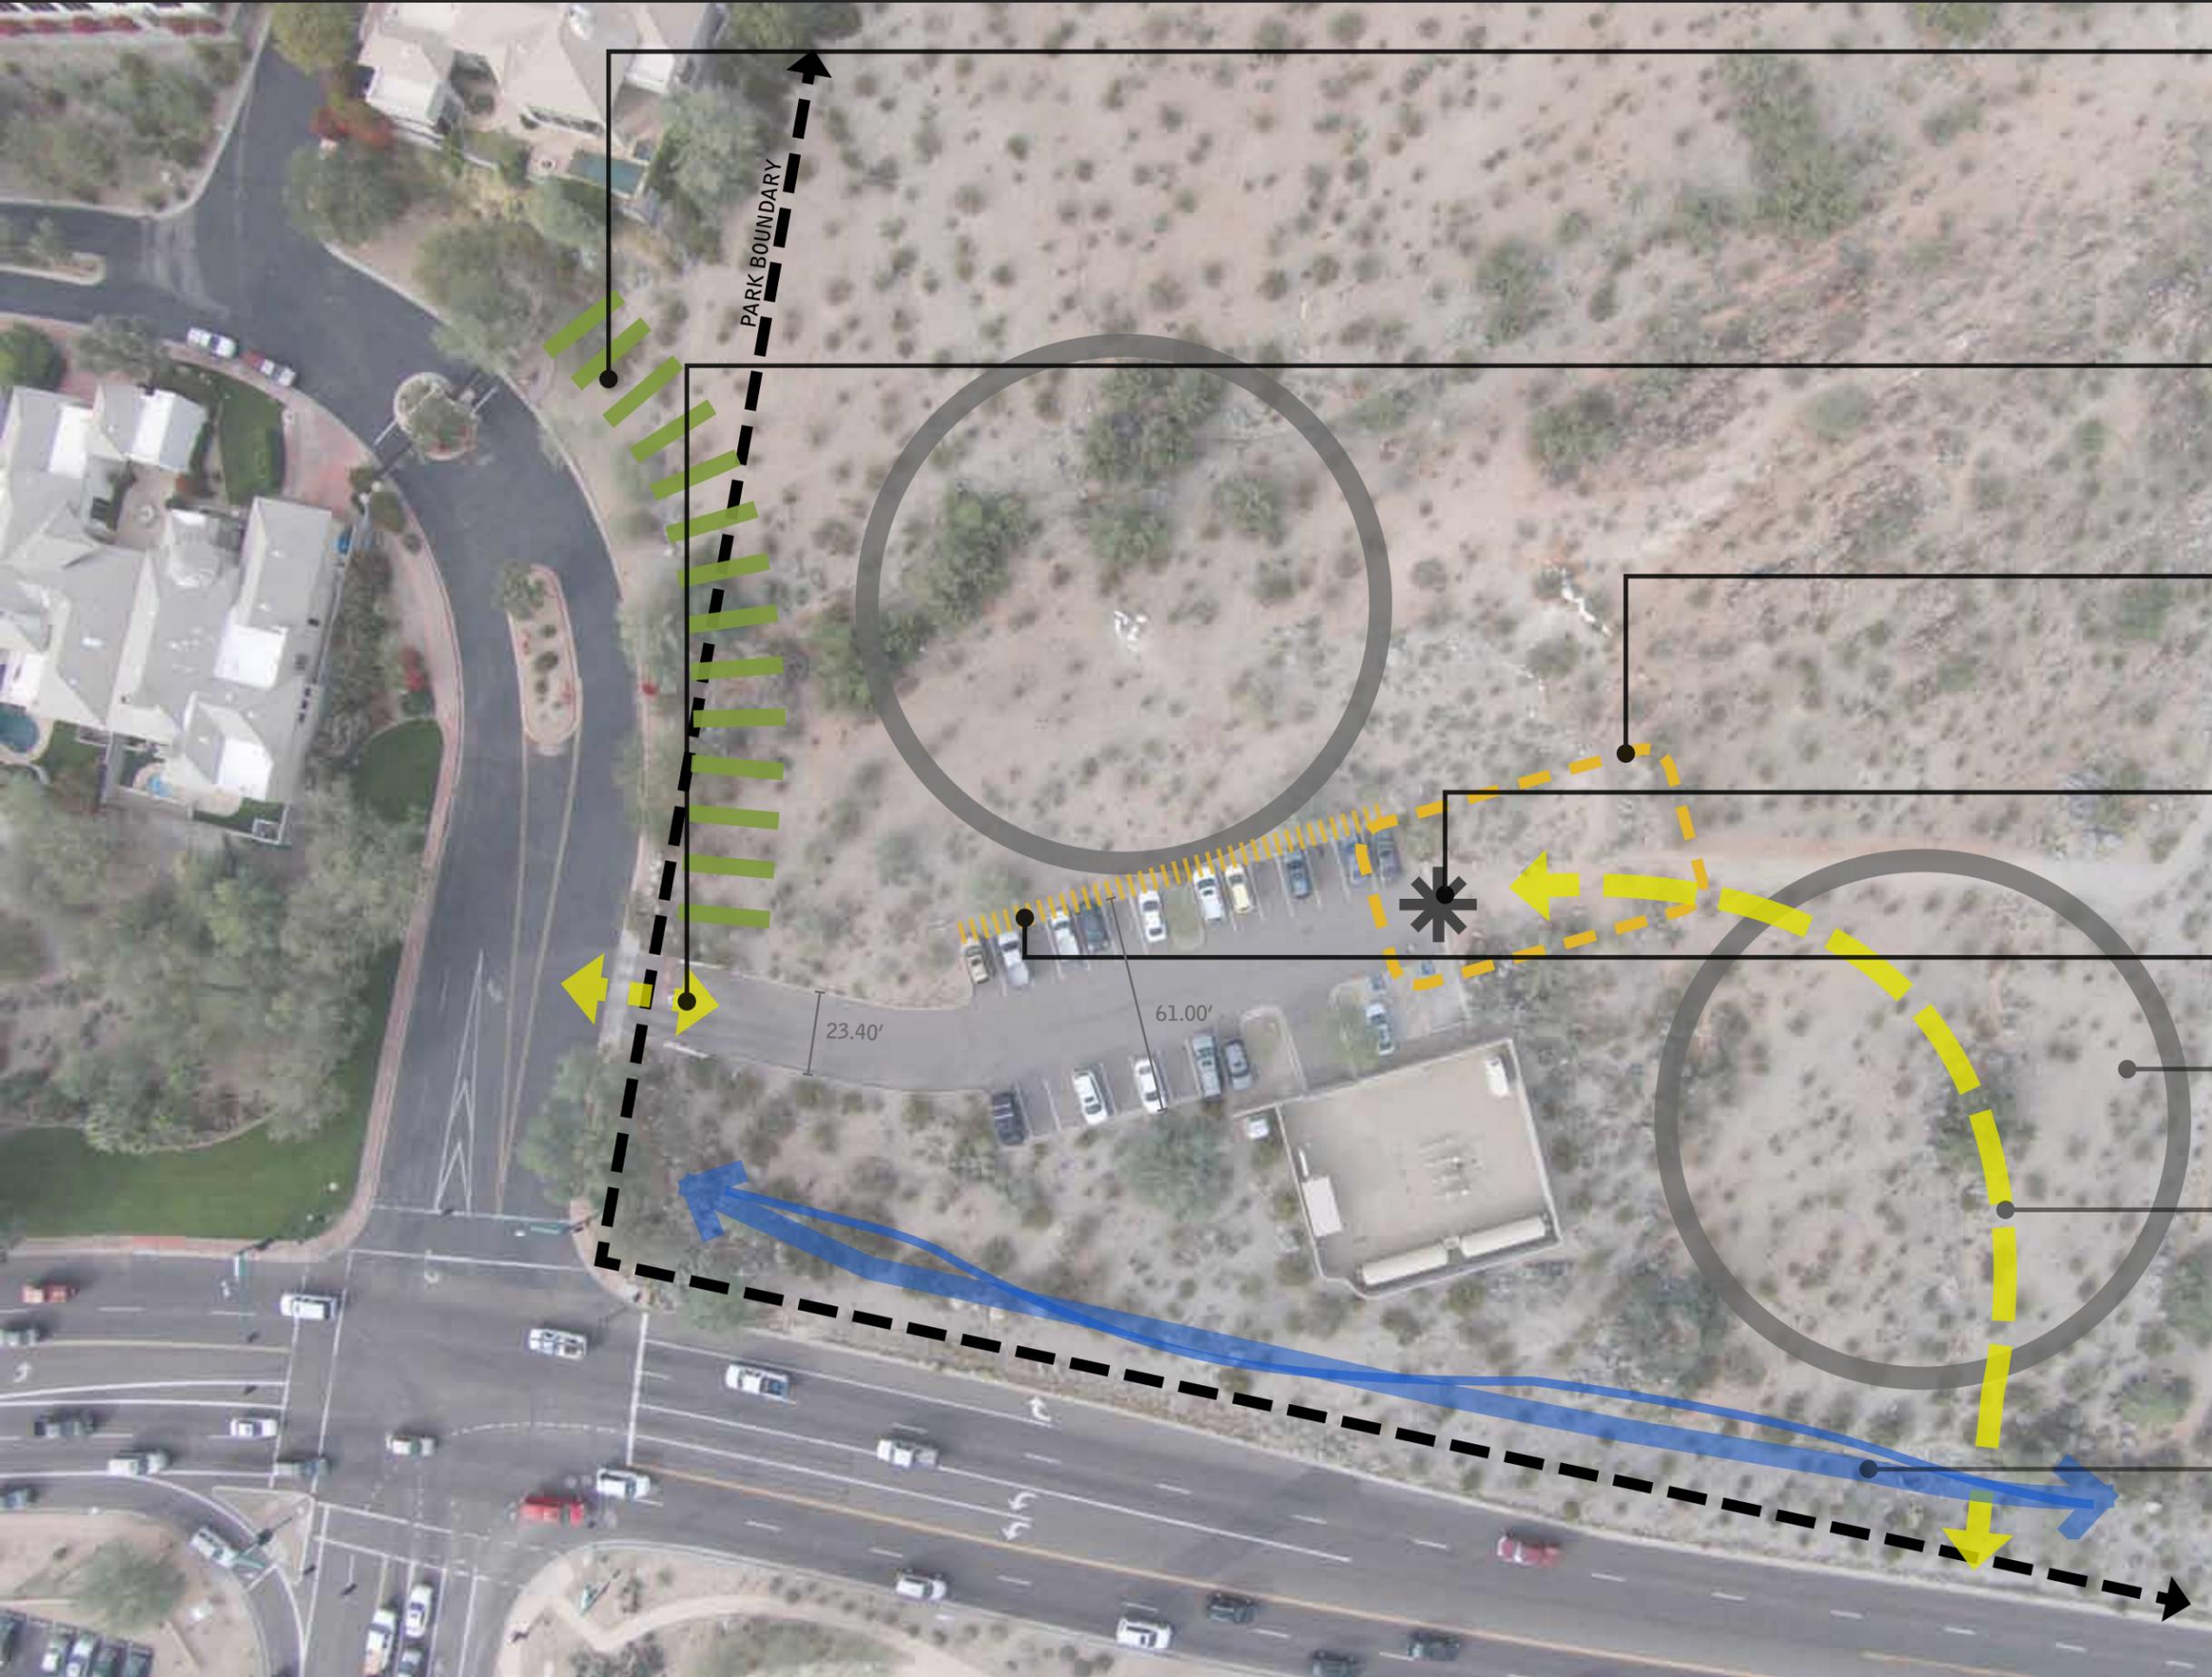
32ND STREET PARKING AREA

A vegetative or landform buffer in this location could improve site aesthetics and help to separate the nearby neighborhoods from traffic and activities at the trailhead.

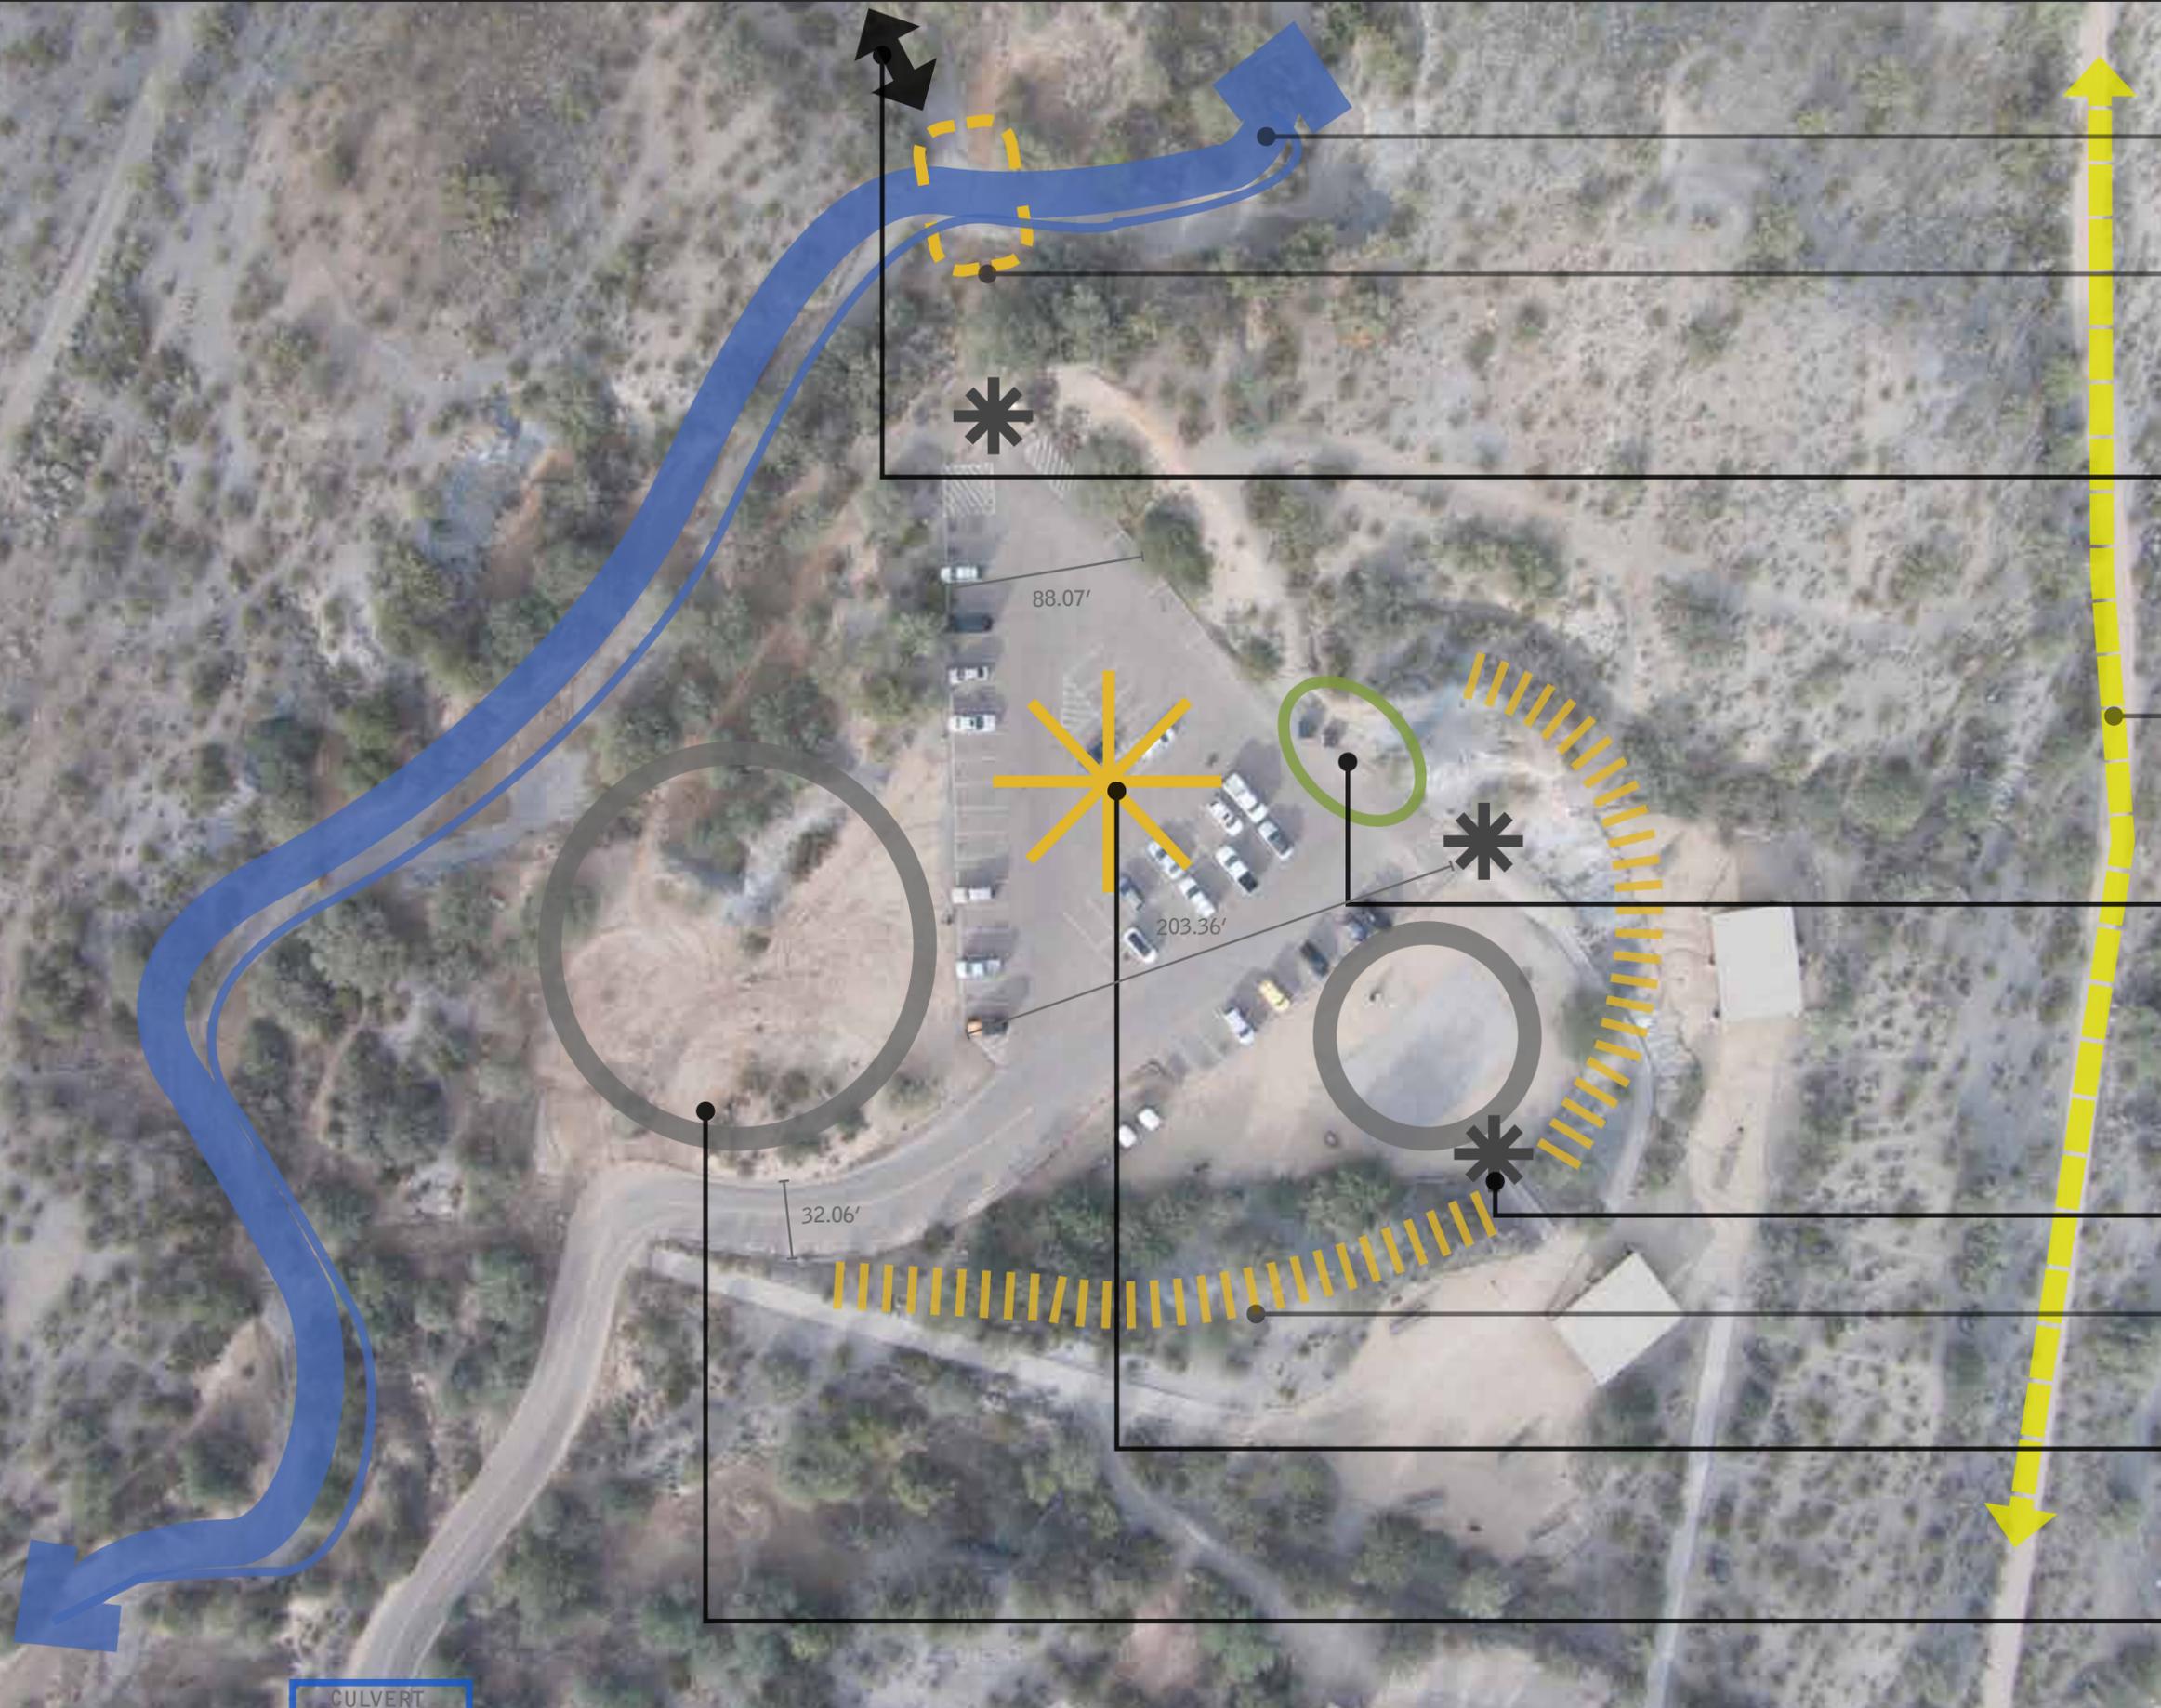
DREAMY DRAW PARKING AREA

A significant wash is found on the border of the trailhead parking area. This limits potential expansion to the west and north. Preservation of the wash is essential to future improvements.
