CITY OF PHOENIX

Submitted by:
Project Engineering Consultants
2310 Mission Lane Suite 4
Phoenix, AZ 85021
602.906.1901

February 25, 2016

ACCESS AND ADAPTIVE MANAGEMENT PLAN

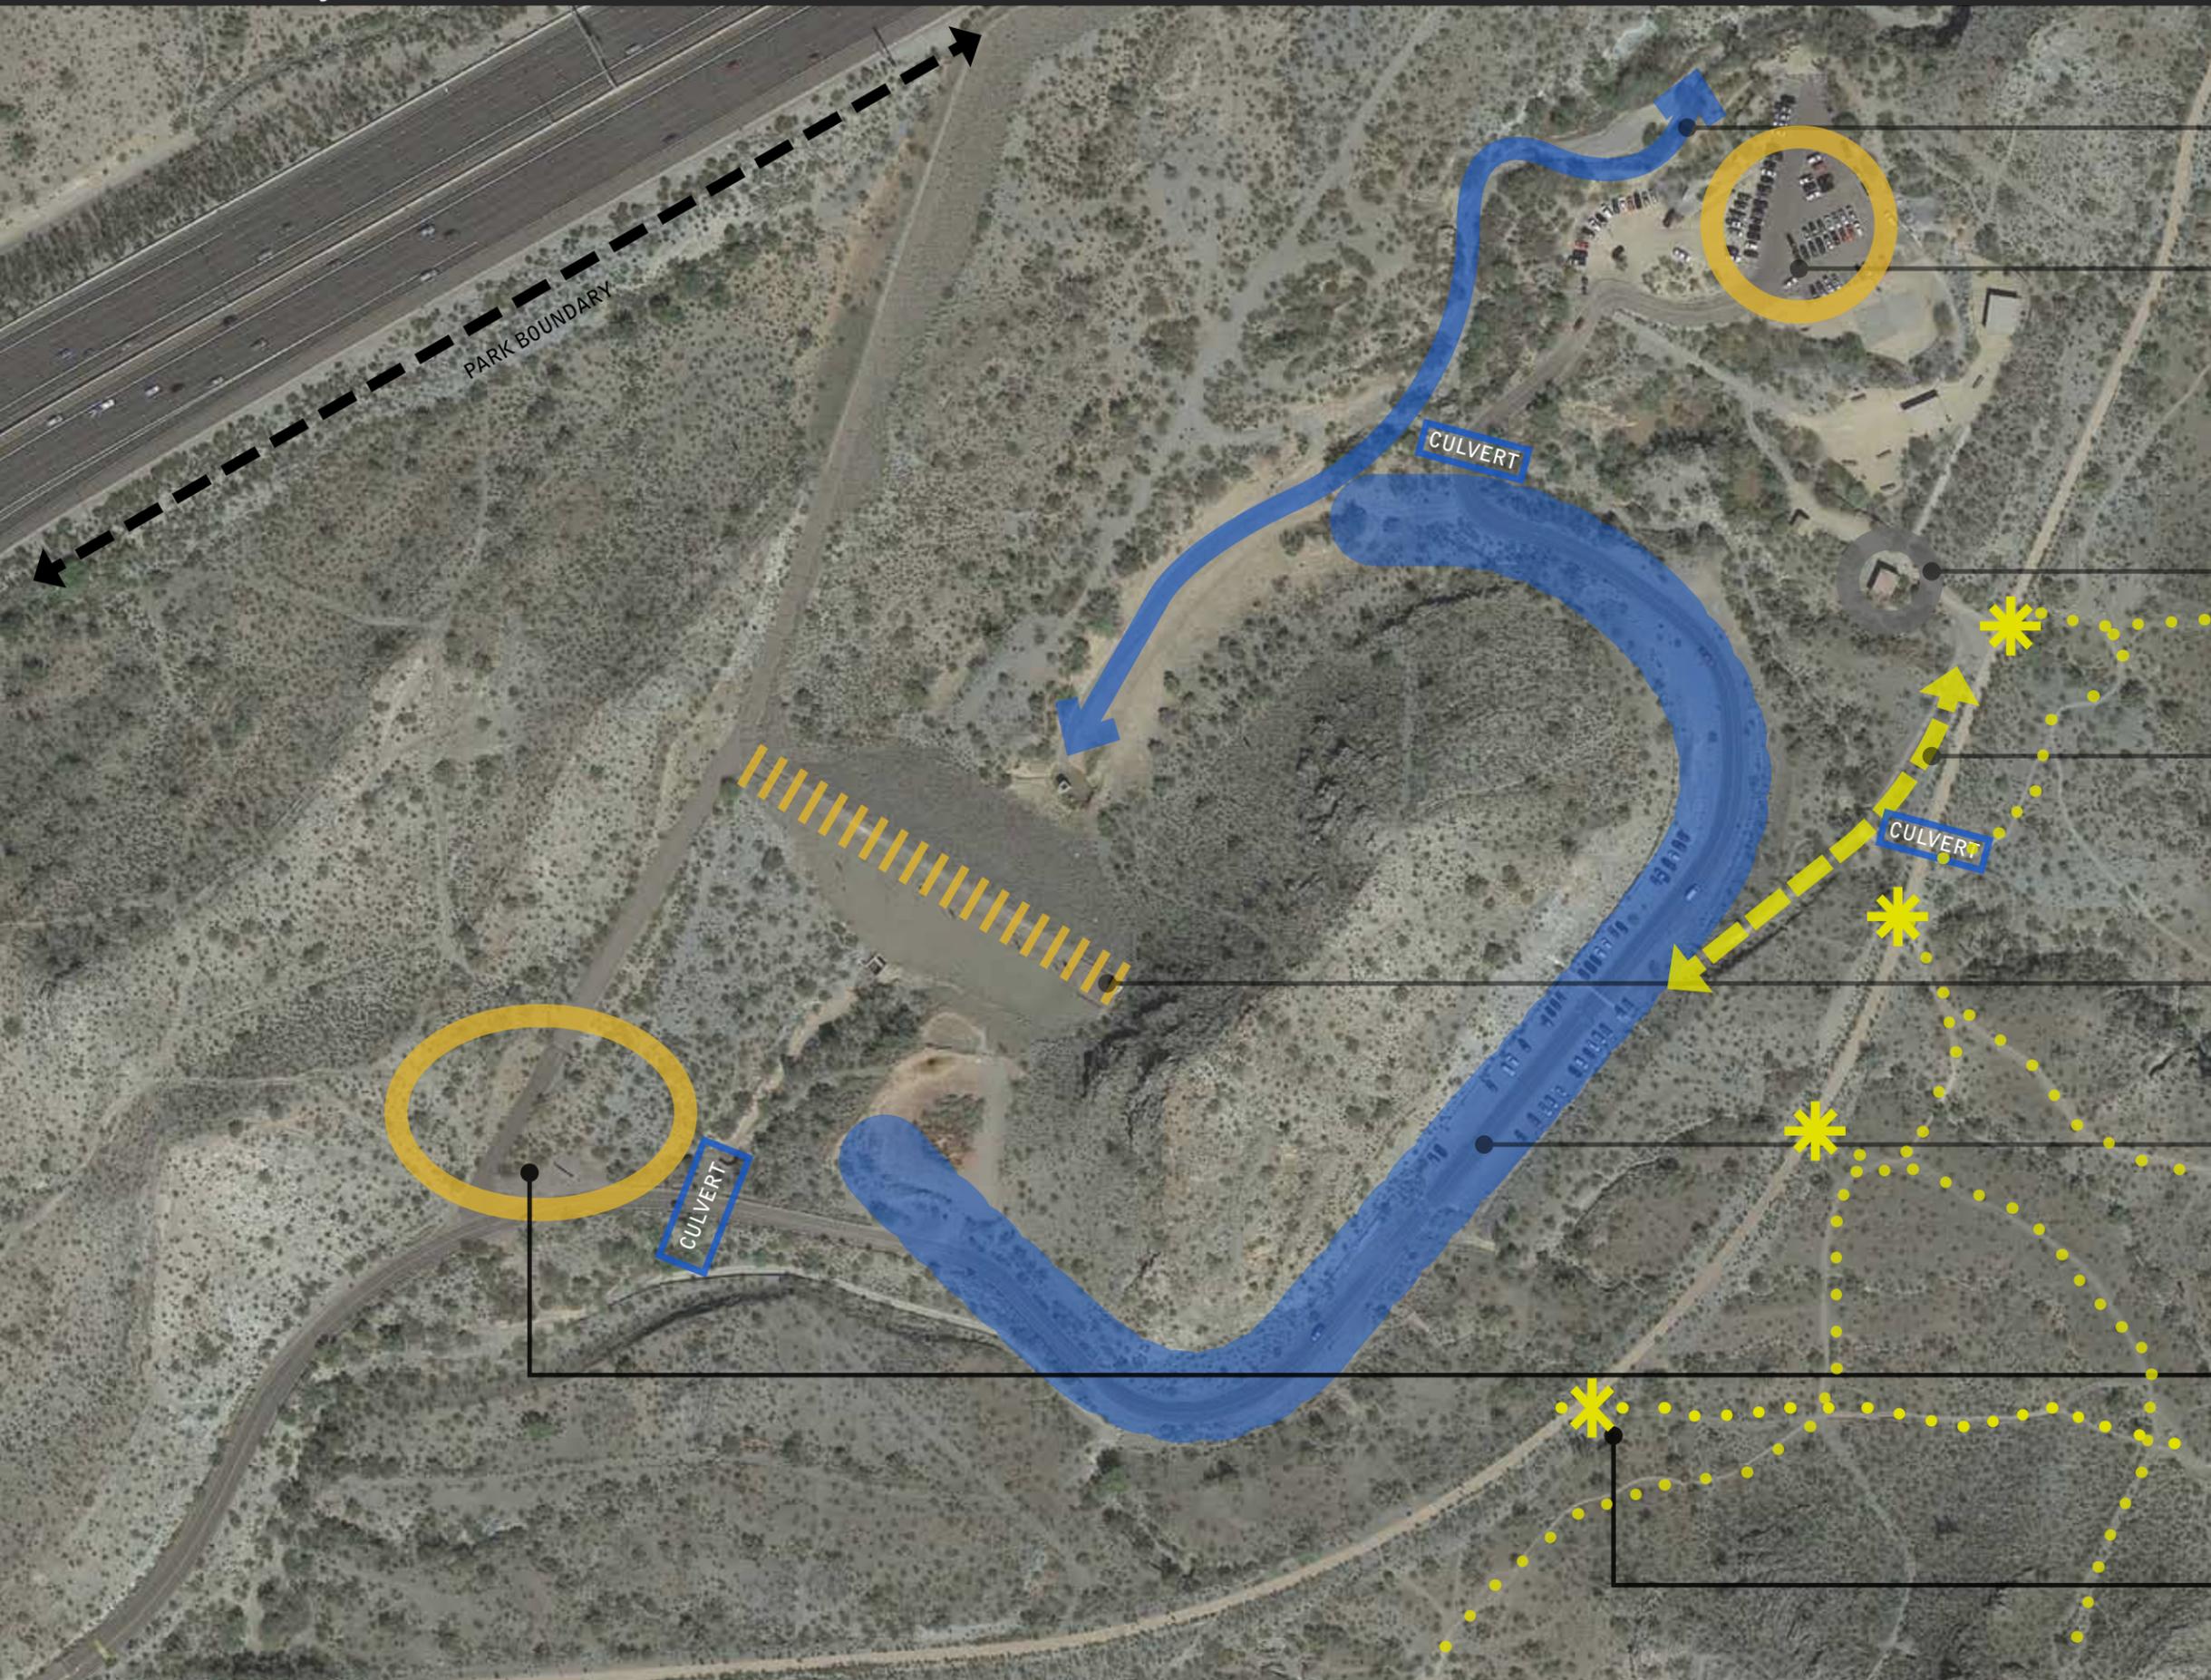
DREAMY DRAW PARKING AREA

A significant wash is found on the border of the trailhead parking area. This limits potential expansion to the west and north. Preservation of the wash is essential to future improvements.

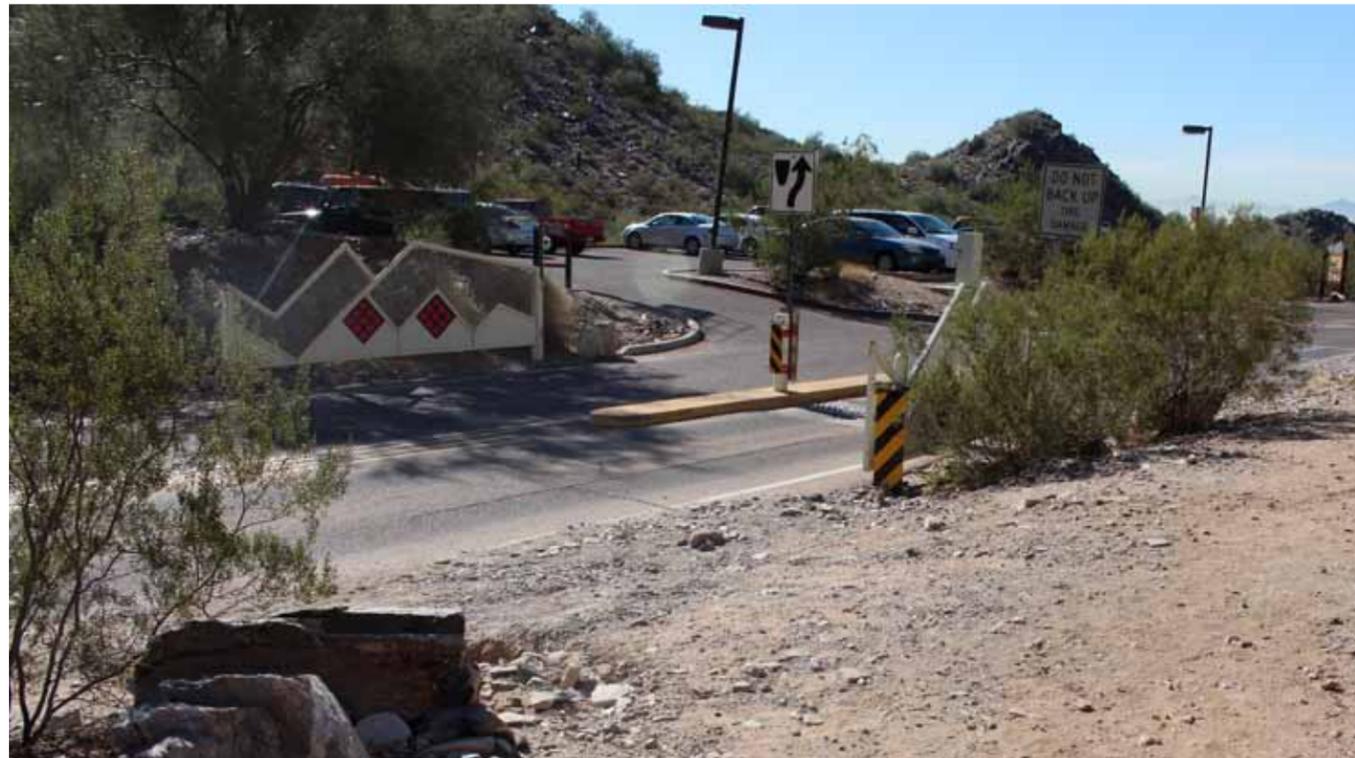
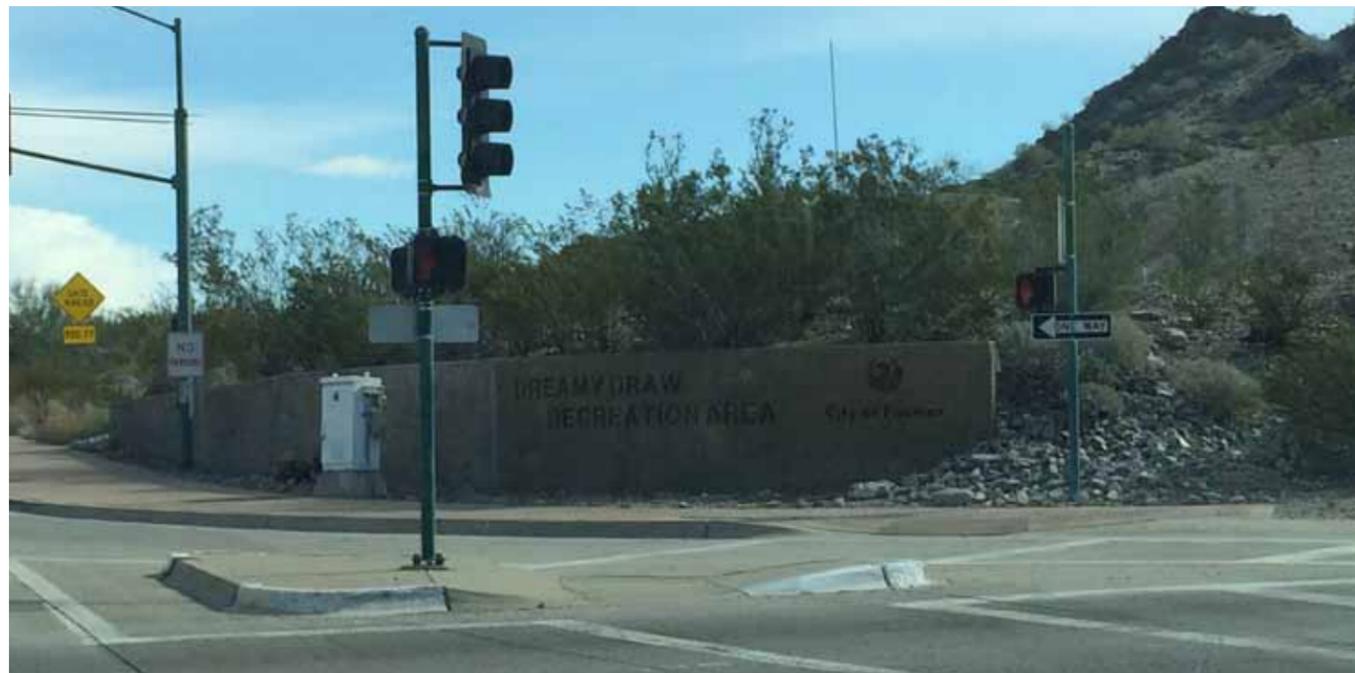
Figures 3.20 and 3.21 Examples of entrances to the preserve where traffic counts were taken.

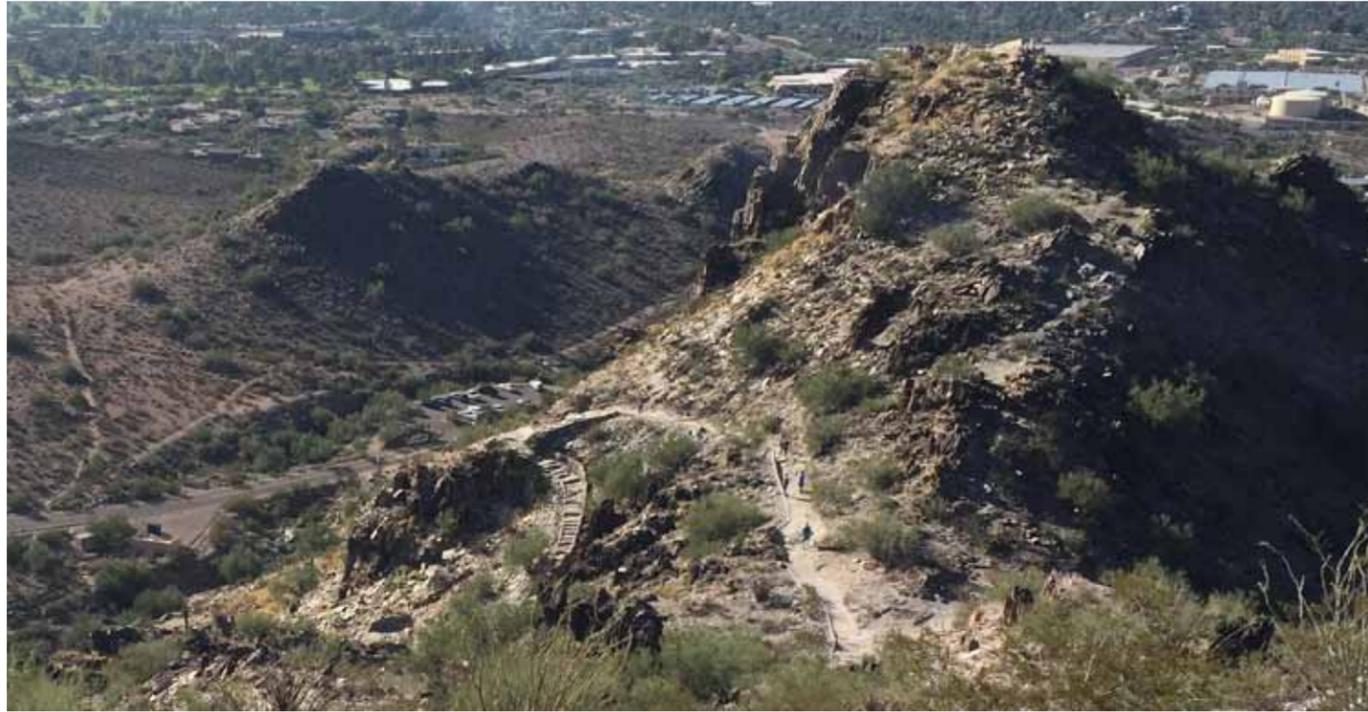
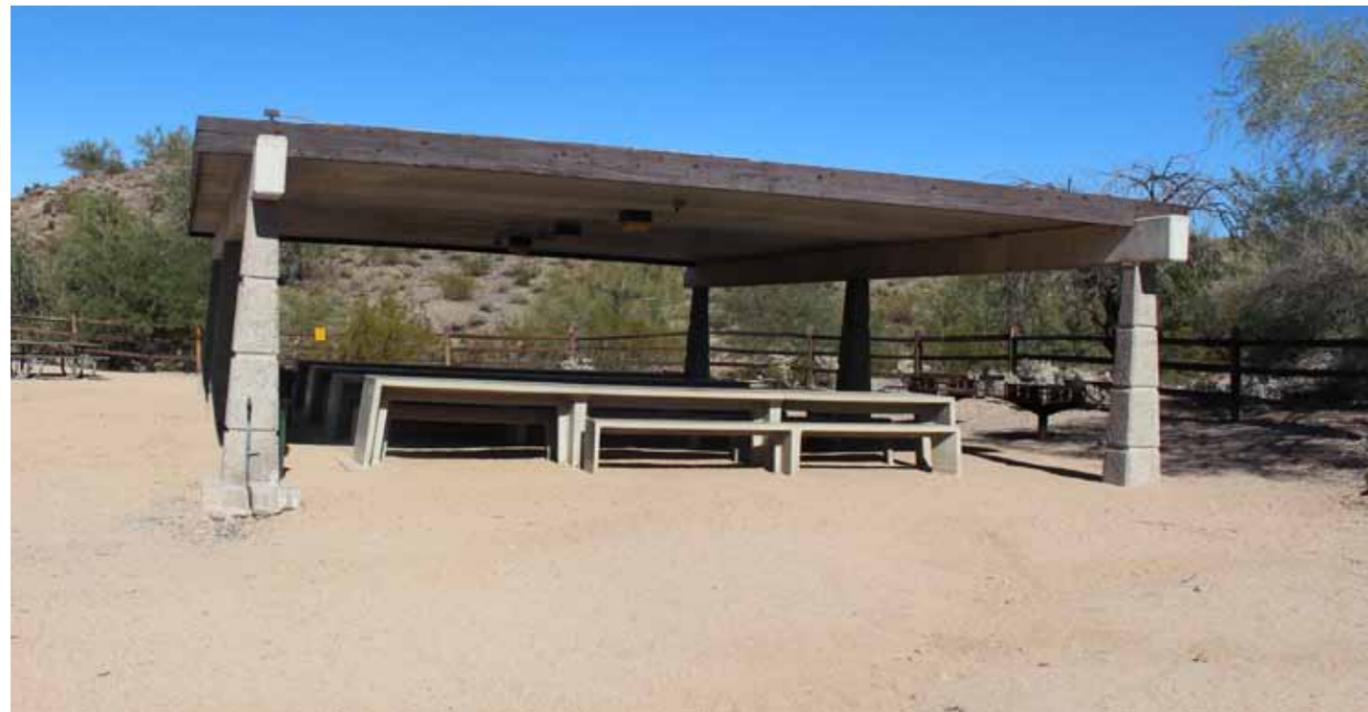
Figure 4.5 and 4.6 Figures of features evaluated for cultural resources.

None of the known cultural resources, such as the historic Piestewa Trail (see **Figure 4.5**), historic Rico Mine, and historic mining features associated with the Mercury Group claims, are within the areas where potential improvements will occur. As such, these cultural resources would not be affected by the proposed project as it is currently scoped. The access and adaptive management plan recommends that these features be preserved and that any potential improvements be directed away from these features.

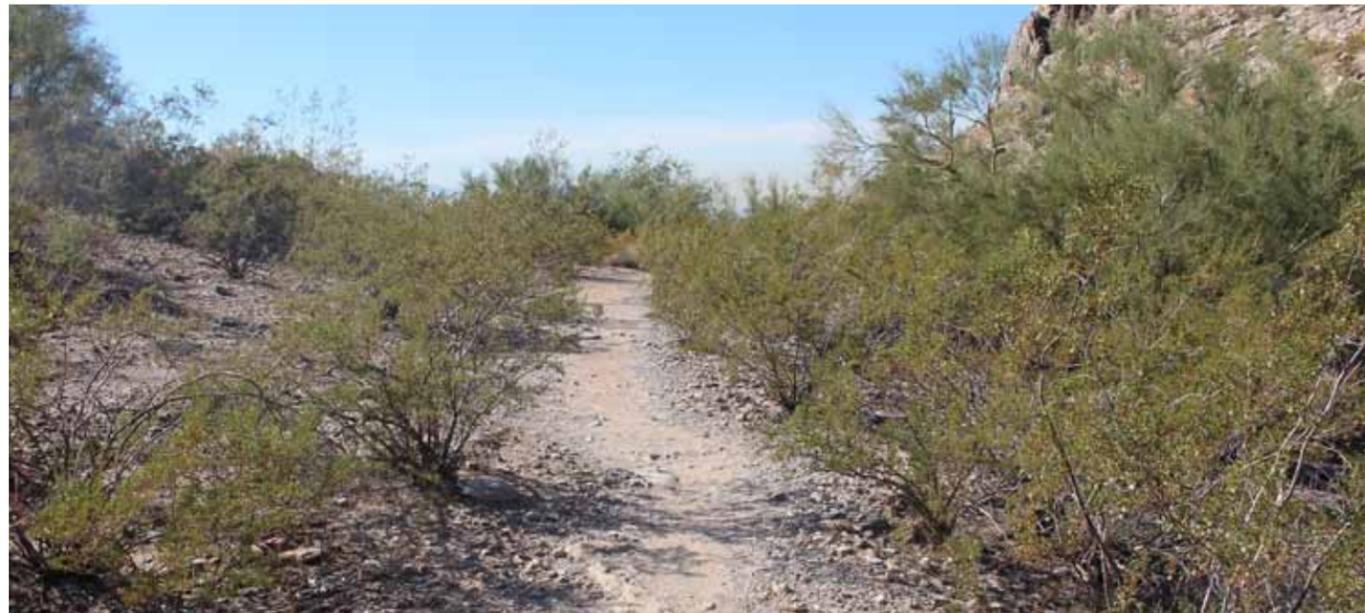
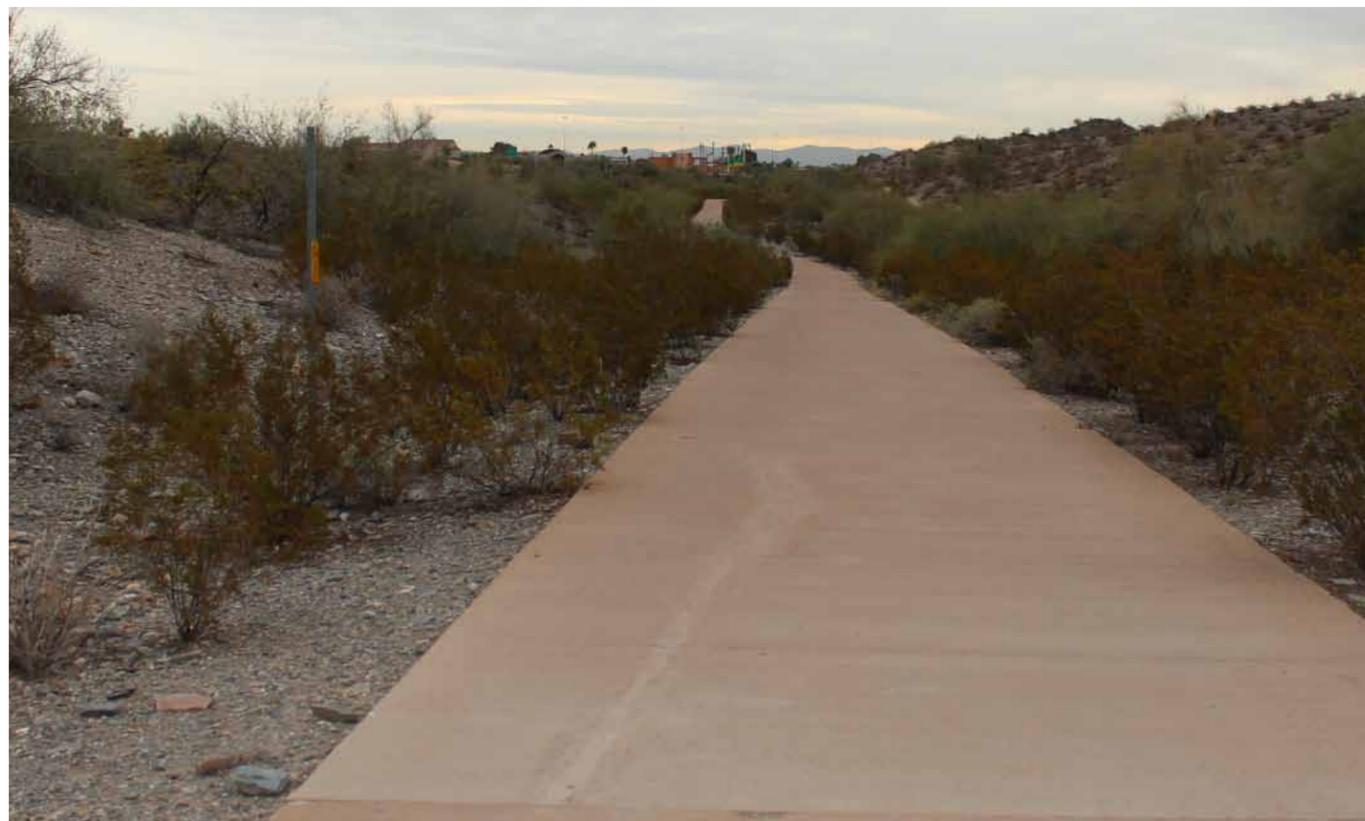
Figure 4.11 and 4.12 Additional examples of trails in the preserve.
