An Historic Resource Survey of the
Phoenix Miracle Mile
East McDowell Road
Phoenix, Arizona

The City of Phoenix Historic Preservation Office
Planning and Development Department
200 W. Washington St., 3rd Floor
Phoenix, AZ 85003

Design Group, LLC
Architecture - Historic Preservation - Planning - Landscape Design

Project 19-022

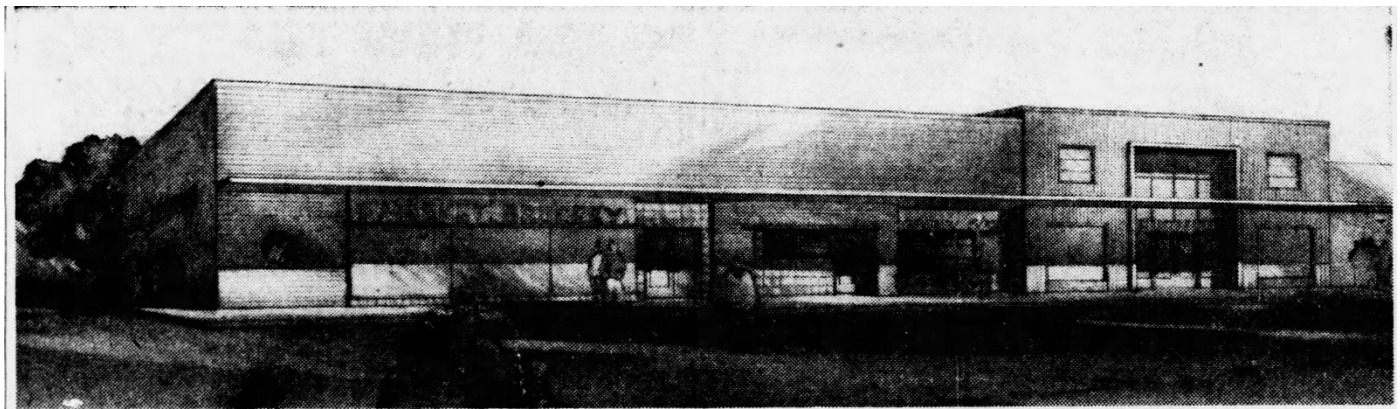
NEW BUILDING RISES: Above is the sketch of Kemper Goodwin, Tempe architect, of the new business block for Nick Klim, which is being erected at 1640 East McDowell road by the J. W. Lillywhite Construction Company at a cost of \$60,000. Facing south, it will have masonry walls, a canopy over the sidewalk and an exterior

trim of glass blocks, structural glass and stucco. The two-story section at the east will be occupied by a furniture store, the other sections include a grocery, beauty parlor and possibly a branch bank. When it is completed the block between 16th and 17th streets on McDowell road will be solid with business buildings.

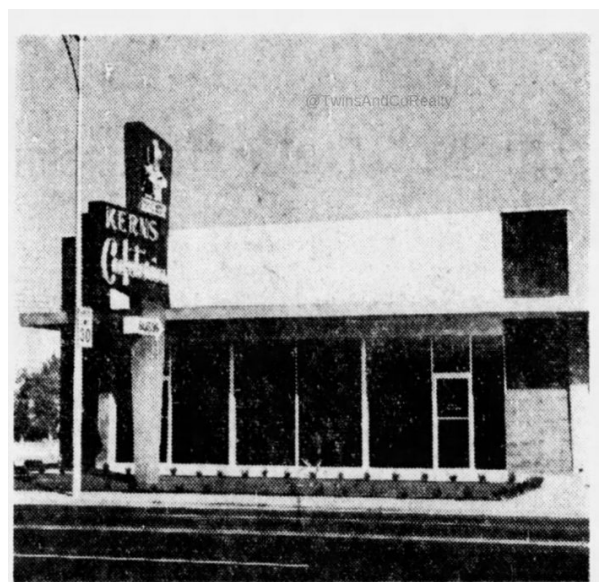
Kerns Cafeteria (Survey Site 20)

EAST McDOWELL—The cafeteria building at 1730 E. McDowell was completed last week by Rod Evans, contractor, from plans drawn by John Sing Tang, architect, for Edward Kerns, who will operate it. Kerns formerly operated the lunch-room in the Sahara Hotel.—(Republic Photo)

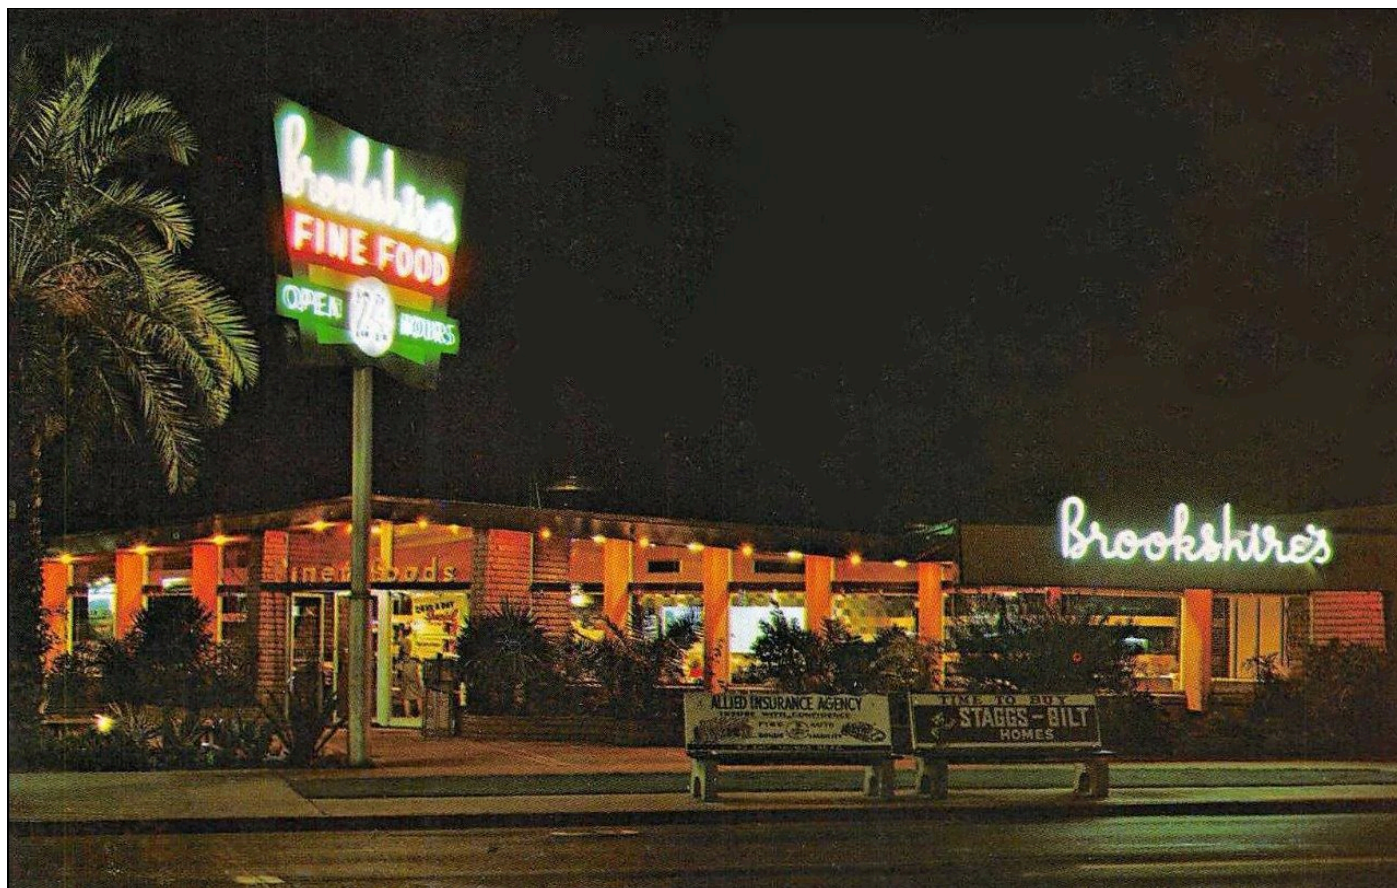
Brookshire's Coffee Shop (Survey Site No. 12), from a postcard

These buildings were a major influence on the use of concrete block in Phoenix (another postwar trend), using patterned screen block and exposed block in stacked patterns. In the Miracle Mile, the use of façade materials such as stacked block and ashlar stone veneer and battered columns harken to some of Wright's design work.

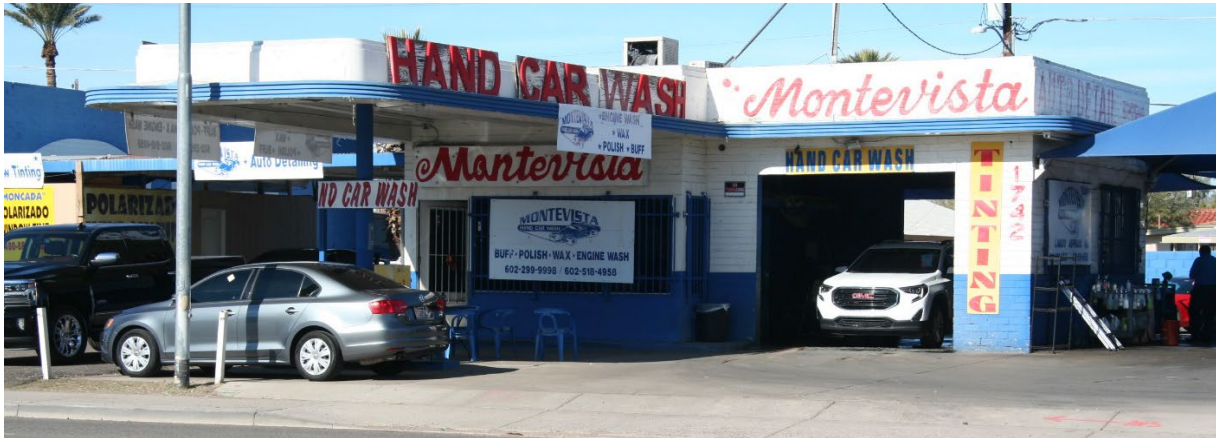
- a. **Union Service Station, c. 1951 (Survey Site no. 22).** This is a rare, intact example of a gas station of this type and design left in the Miracle Mile area and within the city.

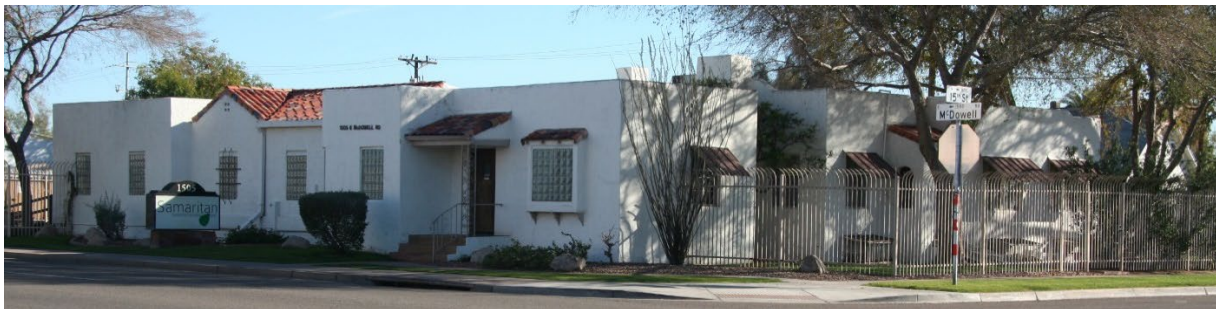
- b. **Dr. Edward Hoehn Offices/Residence, 1932-56 (Survey Site No. 42).** This property is significant for its historical associations to Miracle Mile and Commerce in Phoenix as well as being a good quality residential-commercial hybrid building with a coherent architectural statement and sense of place.

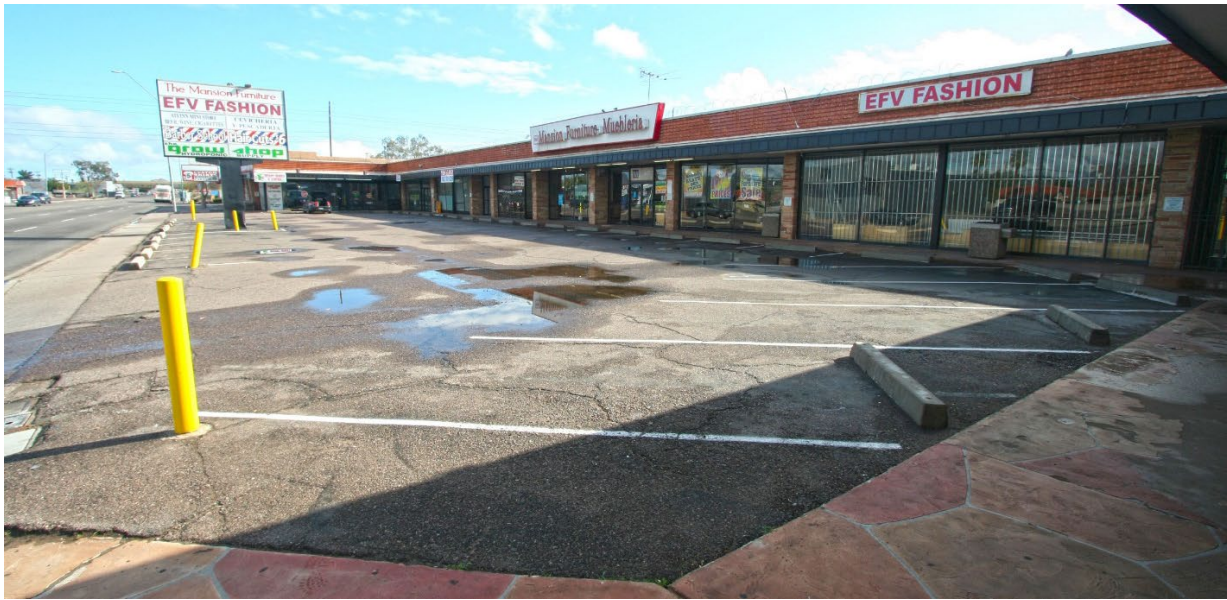
- c. **Miracle Mile Mart Building, 1954 (Survey Site No. 56).** This property is an excellent early example of commercial architecture directly leading to the development of the Strip Shopping Center building type; it is a focal point on the south side of the district and unique in the streetscape.

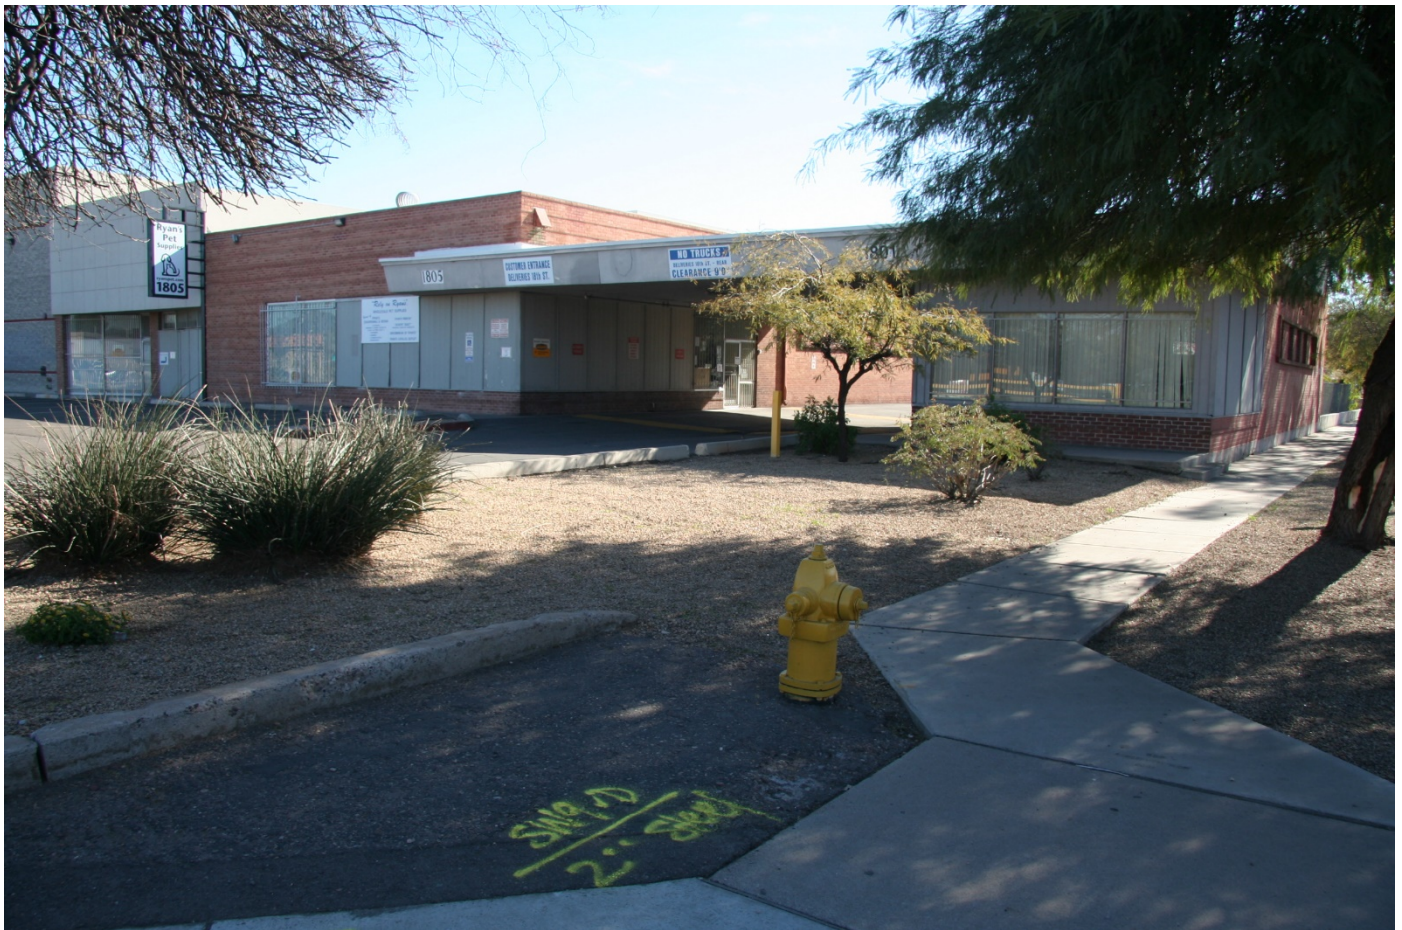
d. **Sparkle Dry Cleaners and Laundry, 1955 (Survey Site No. 58).** This property is an excellent example of the International Style reflected in the design of a drive-through laundry. Its well-integrated three-part façade composition provides a strong focal point within the Miracle Mile district. It retains a high degree of architectural integrity.

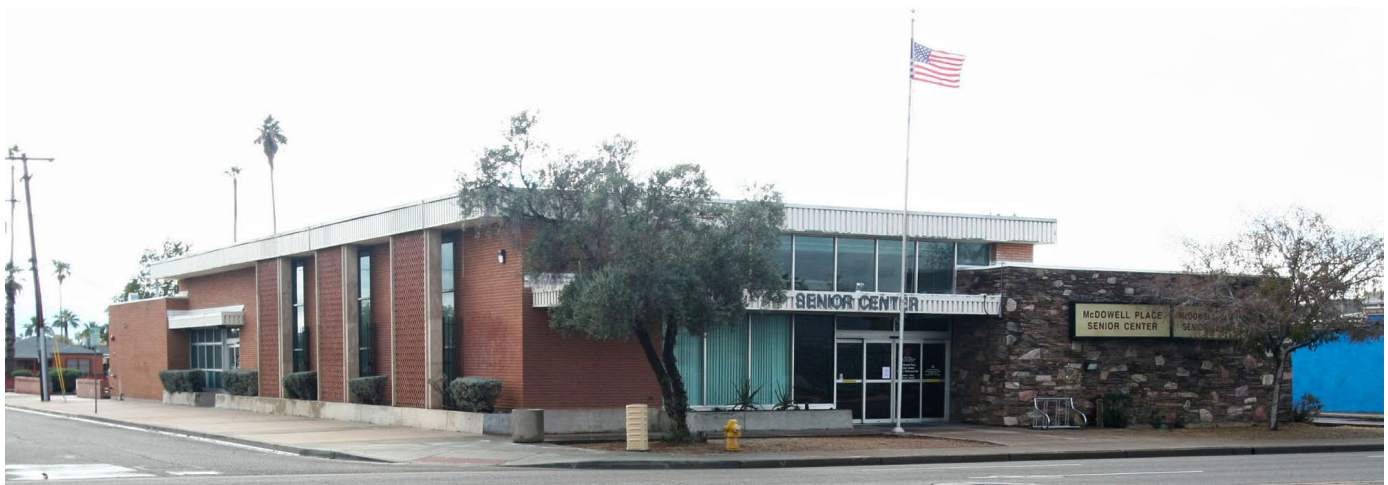
e. **Valley National Bank Branch No. 10 (Survey Site 62).** This property appears to be individually eligible under Criterion C for its architectural qualities as a modern movement design applied to a commercial bank. It retains a high degree of architectural integrity. *This is the only recommended property that occurs outside of the proposed historic district.* It is owned by the city of Phoenix and is currently used as a Senior Center.

- e. **Valley National Bank Branch No. 10 (Survey Site 62).** This property appears to be individually eligible under Criterion C for its architectural qualities as a modern movement design applied to a commercial bank. It retains a high degree of architectural integrity. *This is the only recommended property that occurs outside of the proposed historic district.* It is owned by the city of Phoenix and is currently used as a Senior Center.

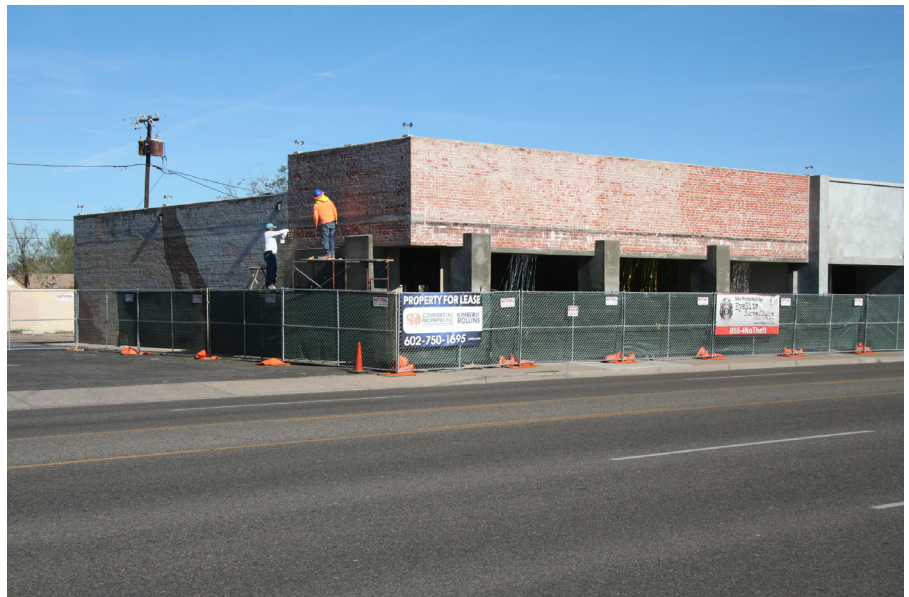
Site No. 1 Survey Area Miracle Mile

Windows/Doors: Missing - removed during 2019-2020 renovation. Probably originally aluminum or wood storefront.

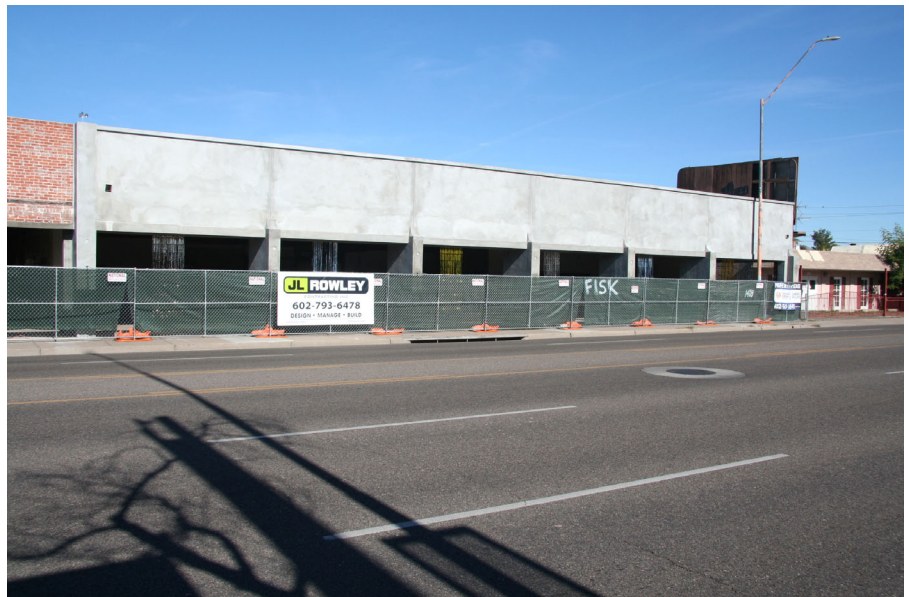
Site No. 2 Survey Area Miracle Mile

Windows/Doors: Missing - removed during 2019-2020 renovation. Probably originally aluminum or wood storefront.

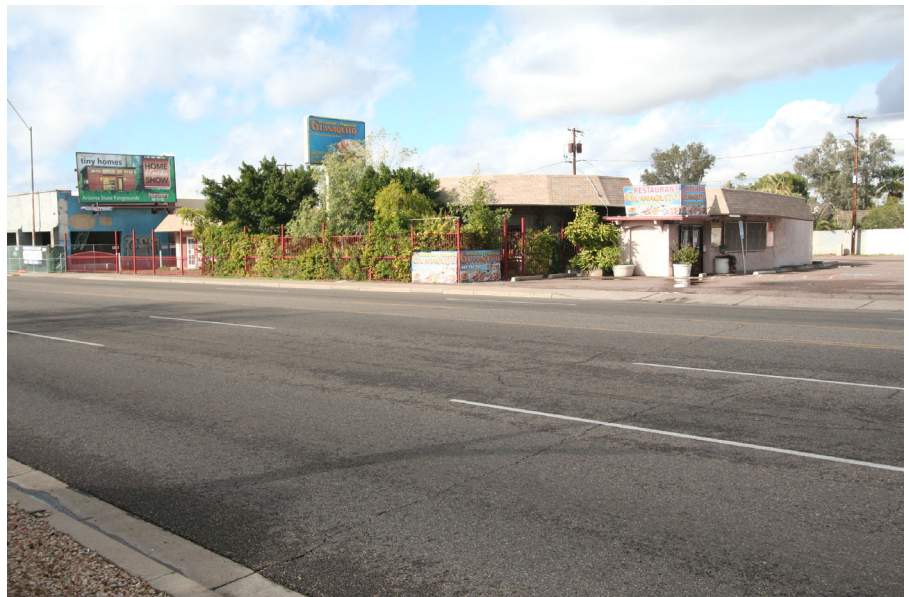
Site No. 4 Survey Area Miracle Mile

Windows/Doors: Modern aluminum replacement windows, non-original wood doors on west building at front façade.

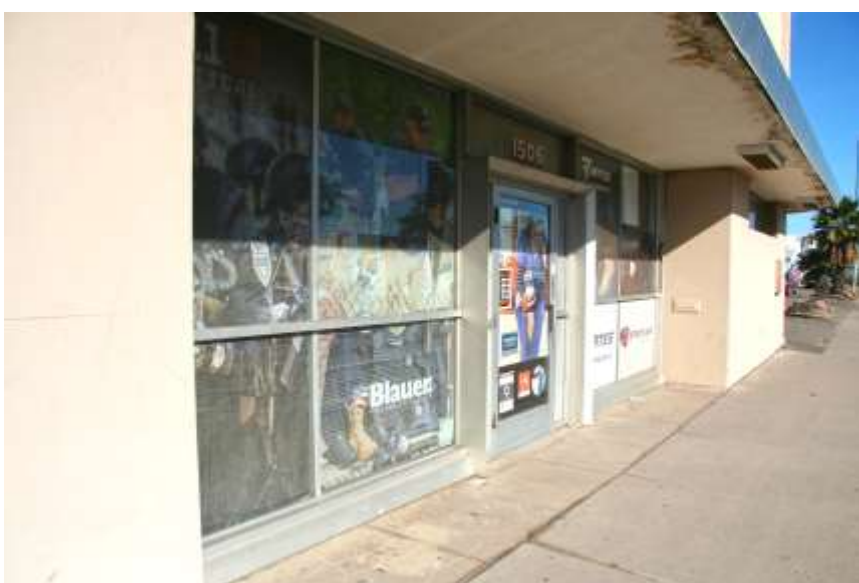
- GOOD (well maintained; no serious problems apparent)
- FAIR (some problems apparent) Some finish issues and deteriorating wood
- POOR (major prob.; imminent threat):
- RUIN / Uninhabitable / DEMOLISHED

Modern signage added, entry door replaced, alterations to entry area including removal of storefront west of entry door, awning facia replaced, stuccoed cornice added, early rear masonry addition

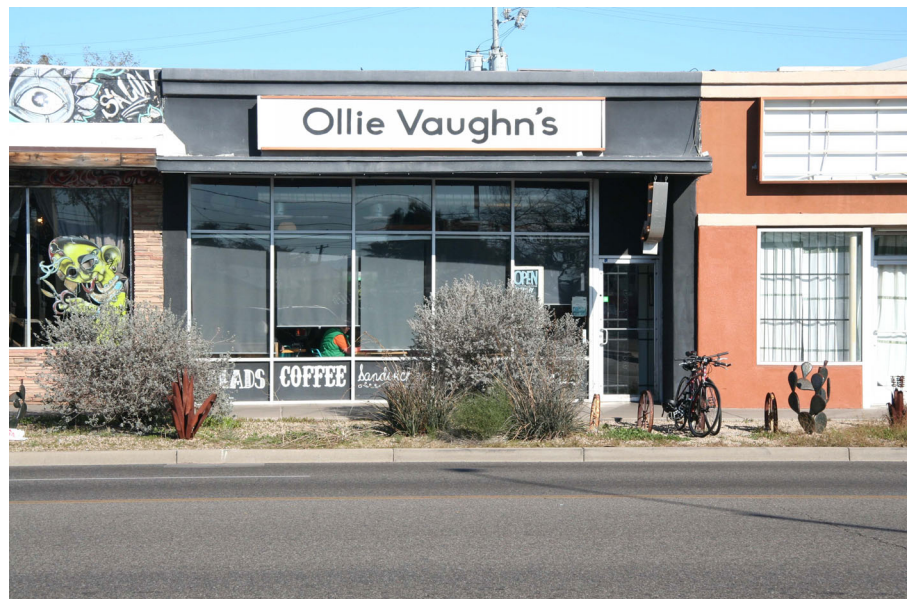
Site No. 7 Survey Area Miracle Mile

Permits: fire damage repairs (1976); tenant improvements (2013) (for Ollie Vaughn's)

Windows/Doors: Aluminum storefront, aluminum storefront entry door, replacement hardware

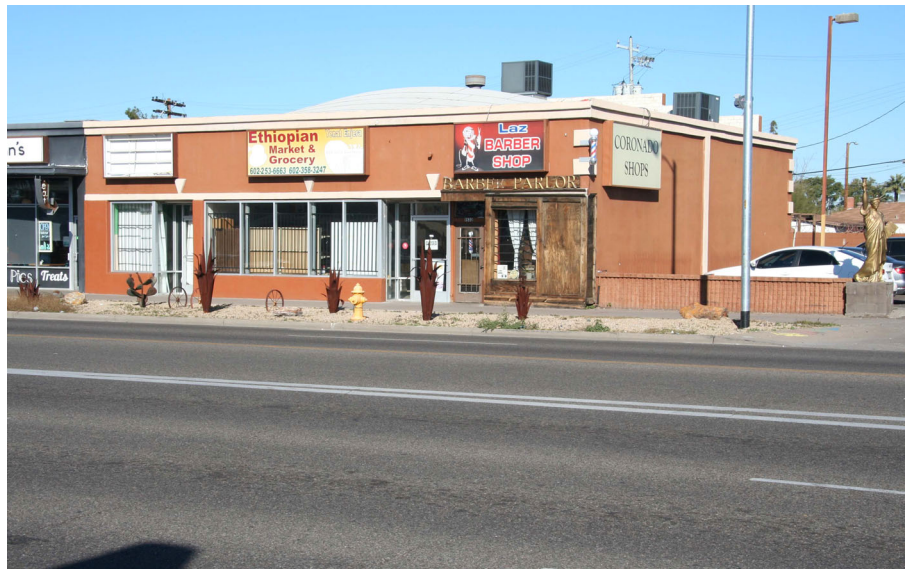
Site No. 8 Survey Area Miracle Mile

Re-stuccoed façade, storefronts replaced, remnants of original aluminum storefront remain on east suite, wood facing added over storefront window on east, awning removed, stuccoed cornice added

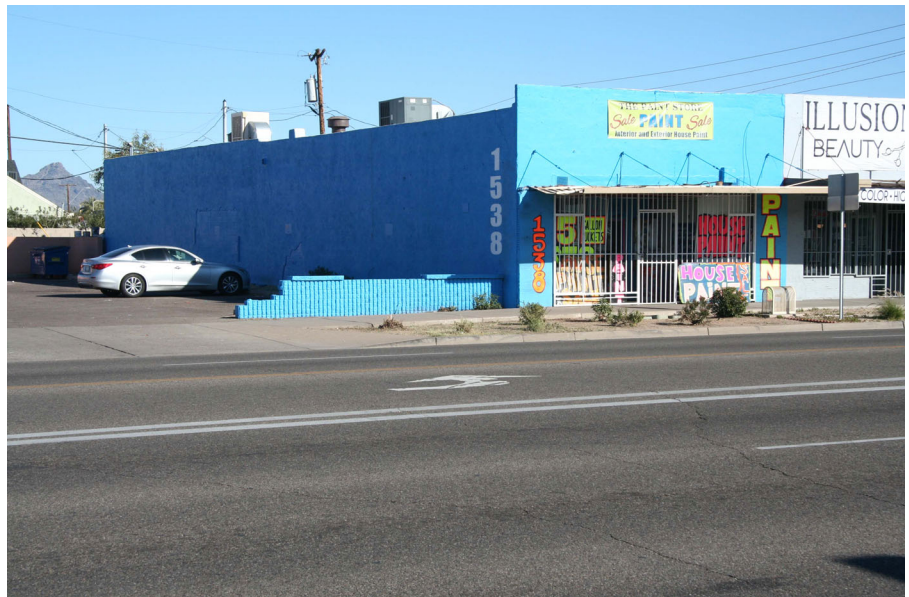
Site No. 9 Survey Area Miracle Mile

Storefront altered/replaced, re-stuccoed, security bars added over storefront, rear addition

Permits: Masonry addition (1944). Change store front (1951). Concrete block addition to store building for storage (1953). Interior remodeling to existing stores. A section of the masonry wall was removed and replaced with a steel beam and pipe

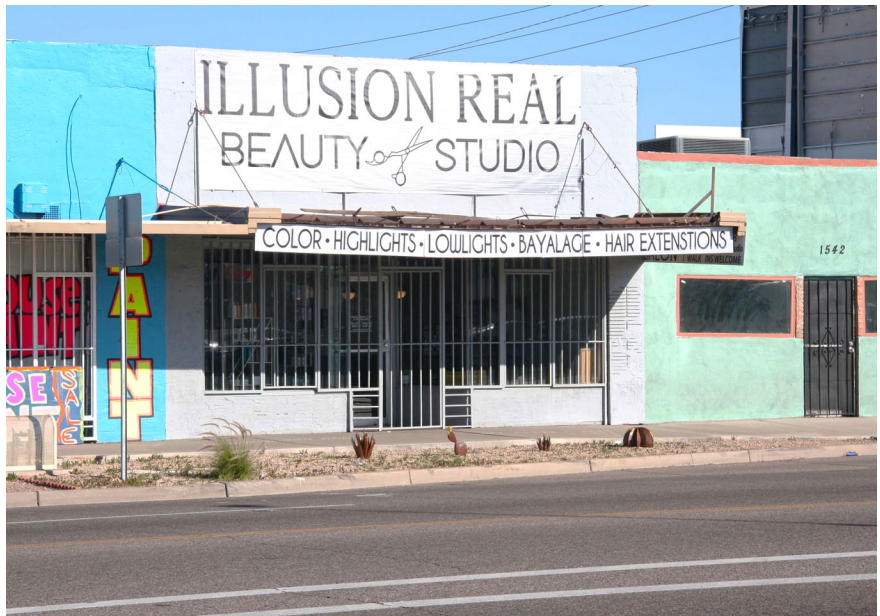
Site No. 10 Survey Area Miracle Mile

Storefront replaced/altered, re-stuccoes, brick painted, security bars added over storefront, signage added to awning

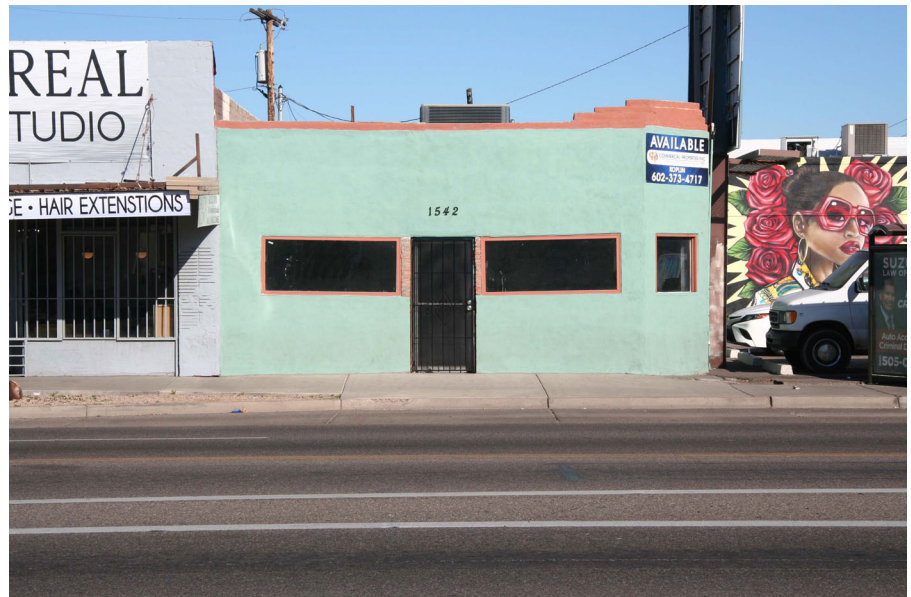
Site No. 11 Survey Area Miracle Mile

Storefronts largely infilled with concrete block, wood replacement windows, entry relocated from corner, original exposed brick has been stuccoed

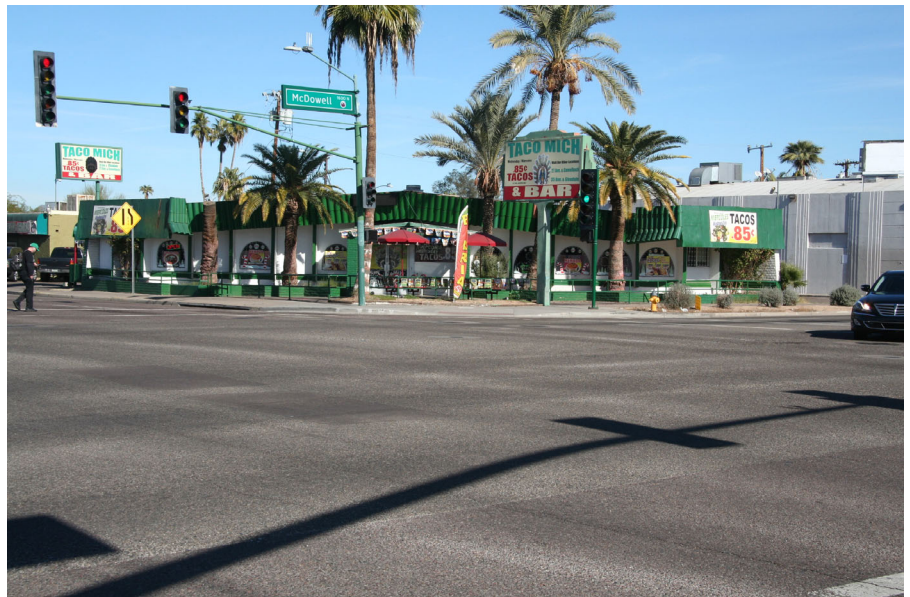
Site No. 12 Survey Area Miracle Mile

Stuccoed arches added, windows replaced, fascia added, sign replaced or altered. The location and footprint of the building are the only identifying exterior features remaining.

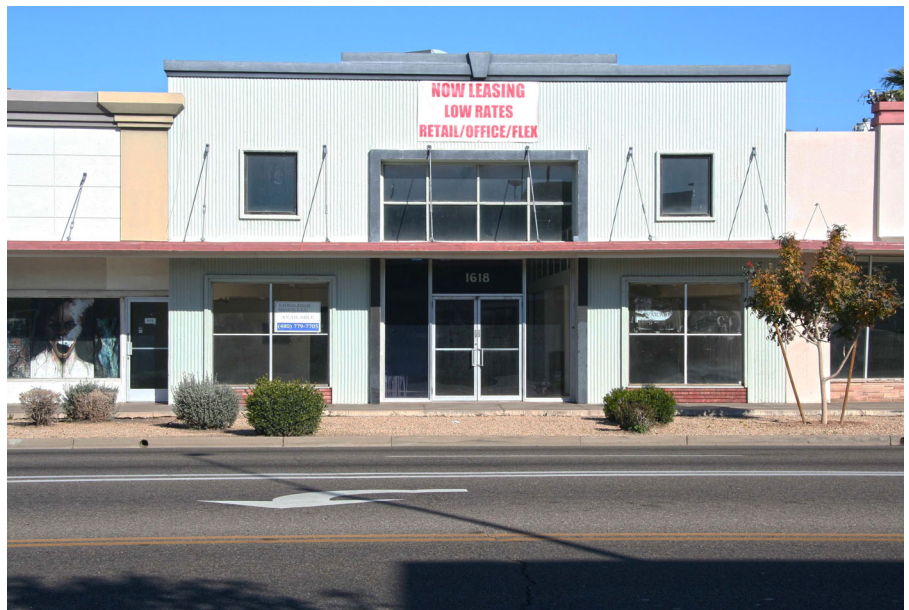
Site No. 13 Survey Area Miracle Mile

Storefront and interior alterations at 1612, valued at \$10,000 (Builder: Farmer + Godfrey, 1950), Storefront alteration at 1610 and storefront door replaced at 1618 (Builder: Hammock Const., 1954), stuccoed cornice/parapet coping added to front façade, façade stuccoed, windows infilled on west wall

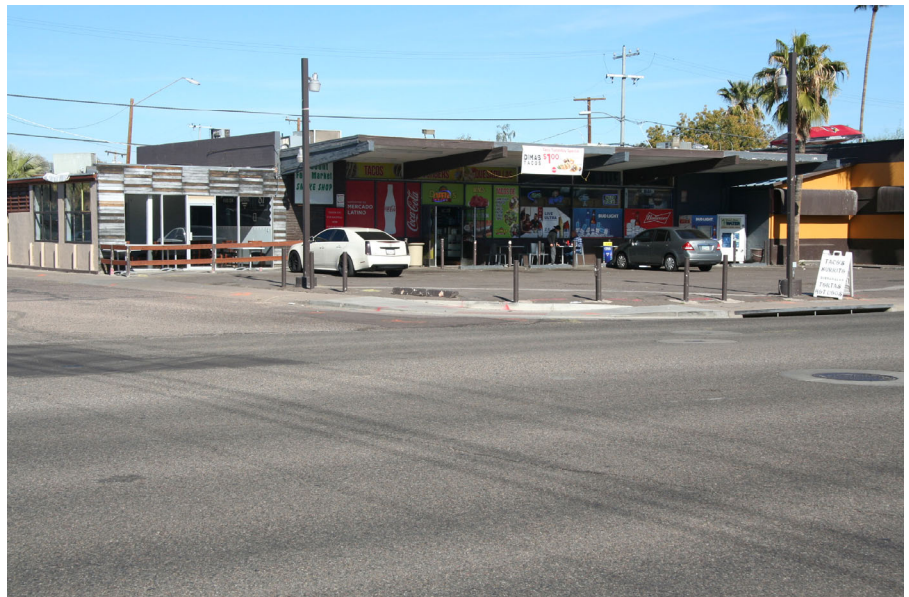
Site No. 23 Survey Area Miracle Mile

Addition to west façade, painted, storefront doors replaced, signage replaced

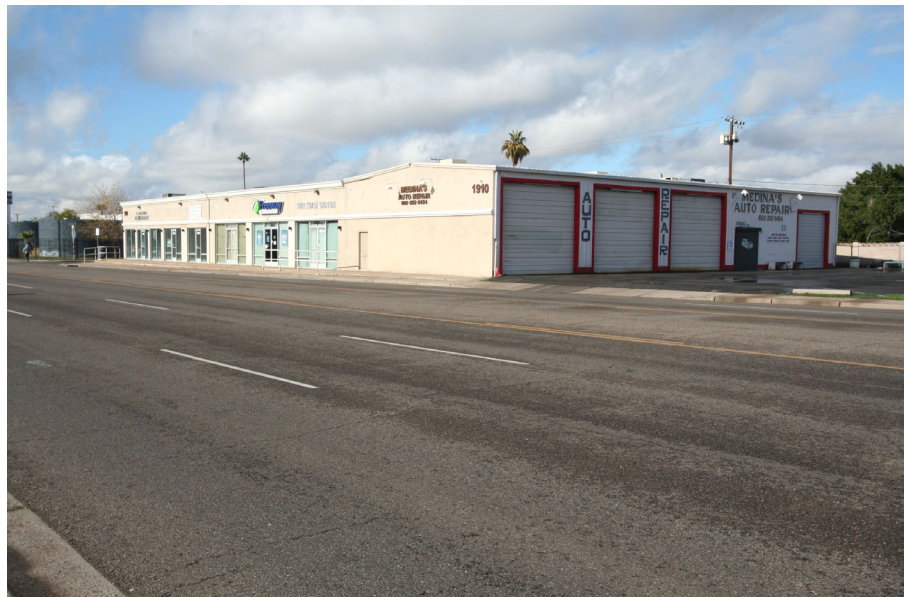
Site No. 29 Survey Area Miracle Mile

Stuccoed, parapet coping added, storefront replaced 2015-2016; garage addition to east side with service bay entries on east façade, date unknown

Windows/Doors: Aluminum storefront windows and doors, replaced within last 10 years

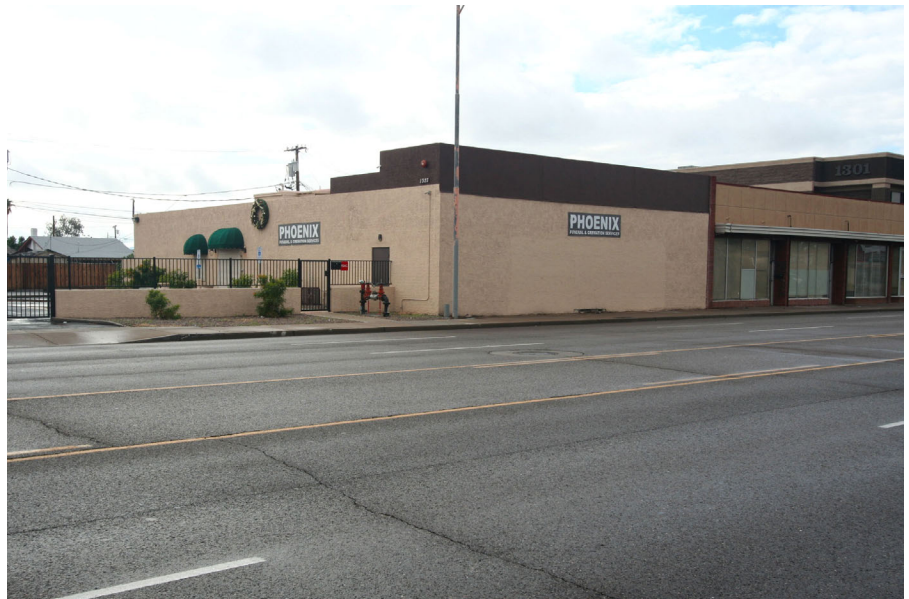
Site No. 33 Survey Area Miracle Mile

Original windows and doors removed, infilled or replaced with modern steel security doors, walls stuccoed.

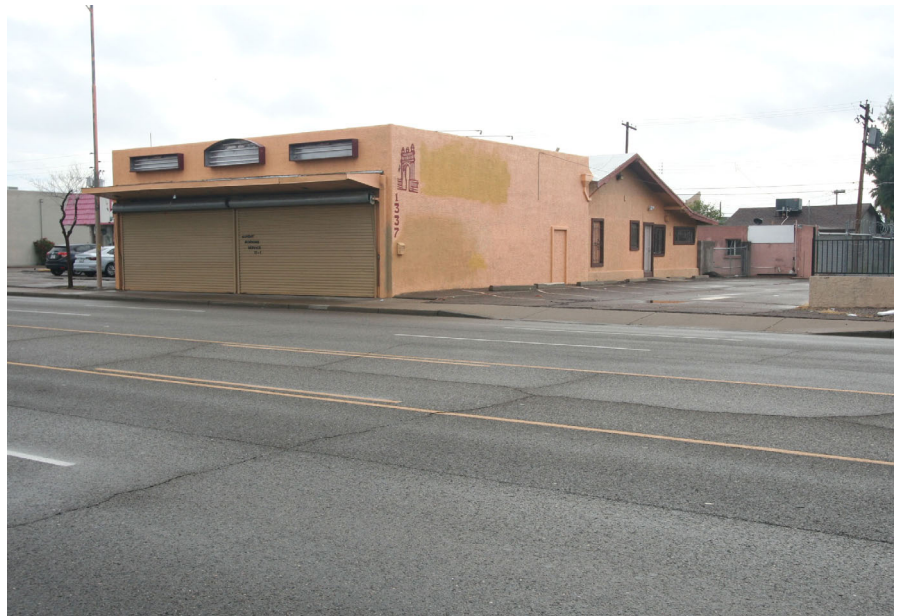
Site No. 34 Survey Area Miracle Mile

Original bungalow largely hidden by commercial addition, windows covered by security bars/plywood, no significant alterations to the addition noted

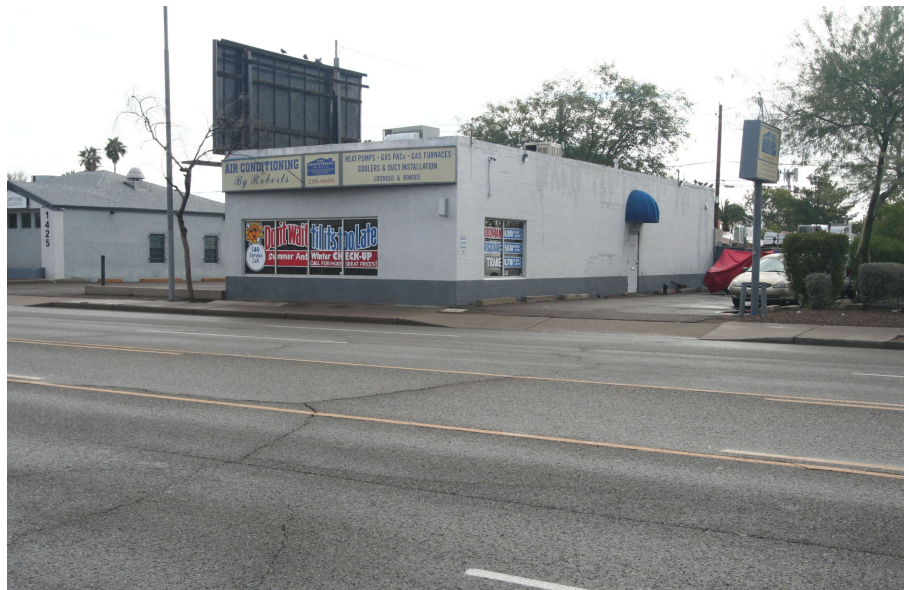
Site No. 37 Survey Area Miracle Mile

Signage altered, entry door replaced, original entry probably on façade facing McDowell Rd., front façade stuccoed, billboard adjacent to east

Windows/Doors: Fixed aluminum windows, steel replacement door

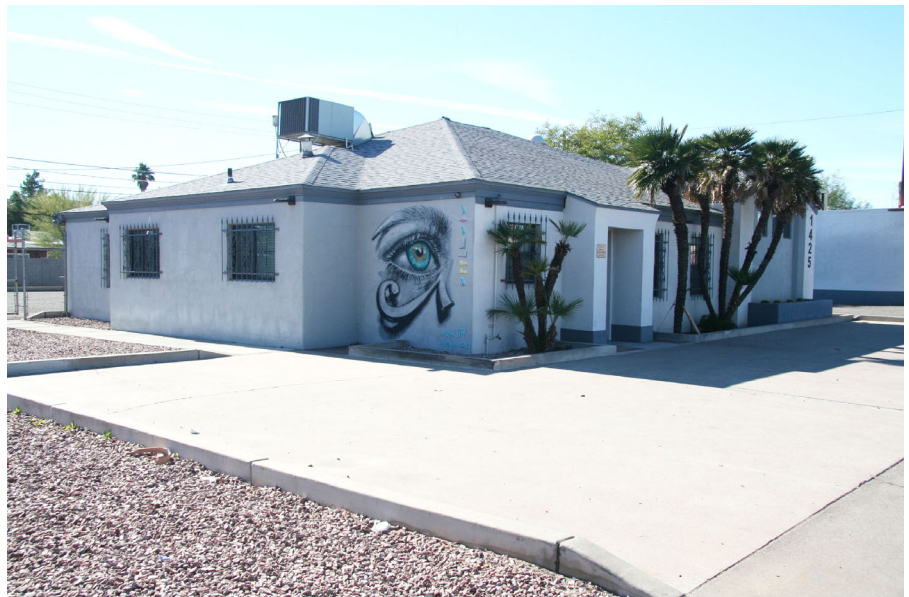
Site No. 38 Survey Area Miracle Mile

Large garage addition to west, window openings altered, sash replaced, entry altered

Windows/Doors: Aluminum replacements

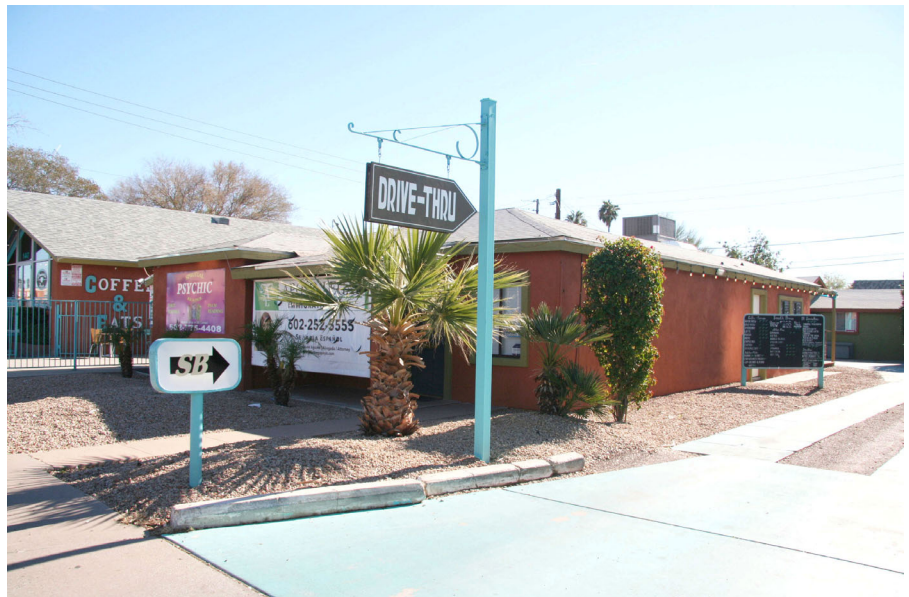
Site No. 40 Survey Area Miracle Mile

Additions, windows replaced with aluminum sliders, re-stuccoed

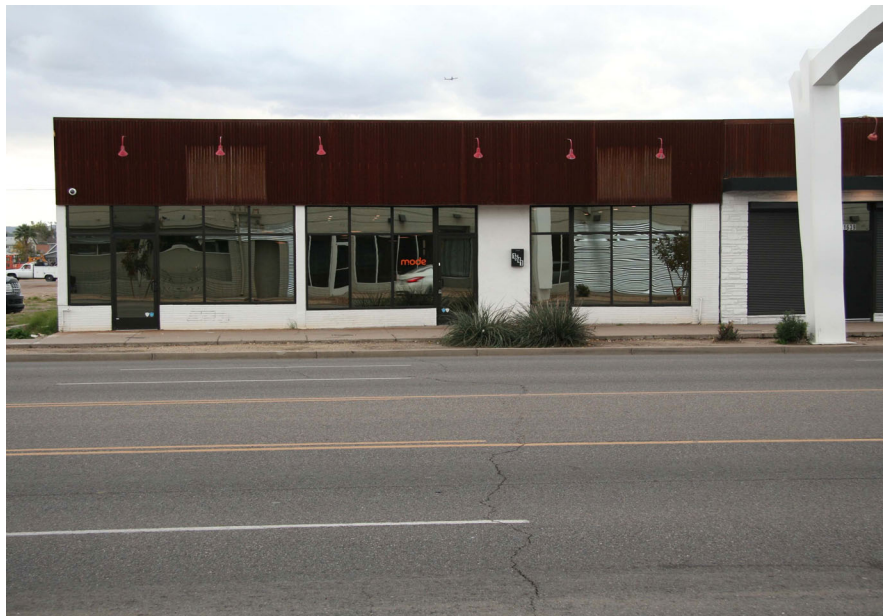
Site No. 54 Survey Area Miracle Mile

Brick has been painted, corrugated metal panel with lighting fixtures added above storefront header, storefront replaced with bronze anodized aluminum/solar reflective glazing

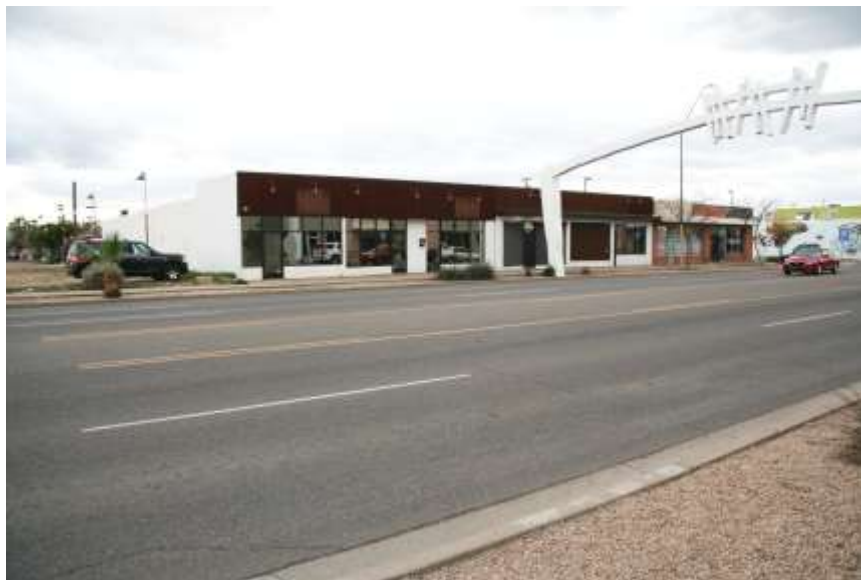
- GOOD (well maintained; no serious problems apparent)
- FAIR (some problems apparent) Vacant, signs of water damage on exterior
- POOR (major prob.; imminent threat):
- RUIN / Uninhabitable / DEMOLISHED

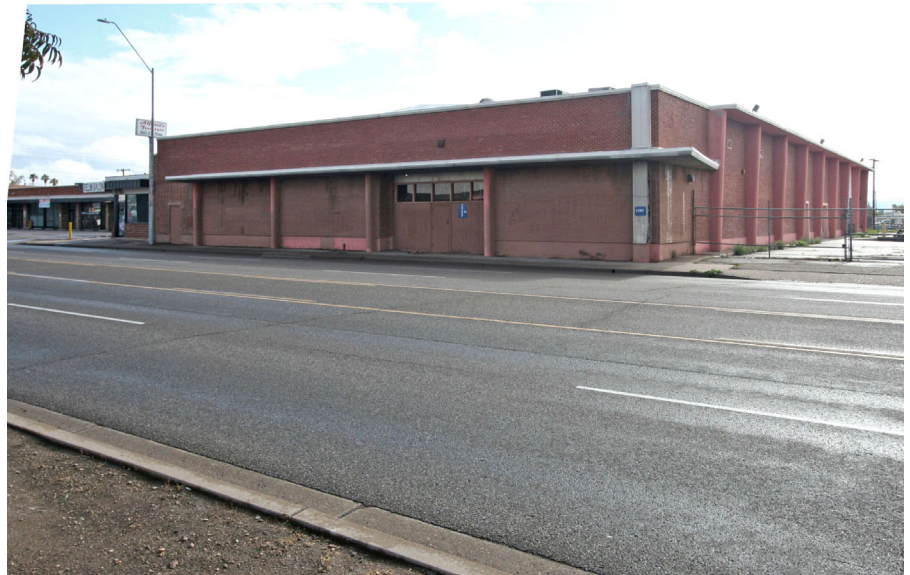
Site No. 55 Survey Area Miracle Mile

Original recessed storefront, facing McDowell road, has been removed and replaced with wood-faced panels, steel door, fixed wood windows. Original sign removed. West entry storefront removed/replaced w/ frame wall, steel door; all 1964/70

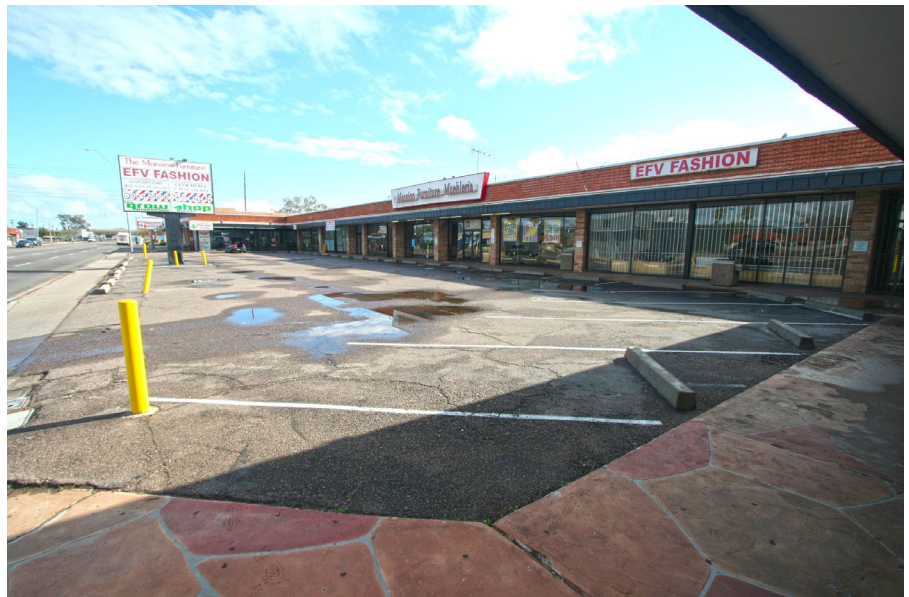
Site No. 56 Survey Area Miracle Mile

Storefronts replaced

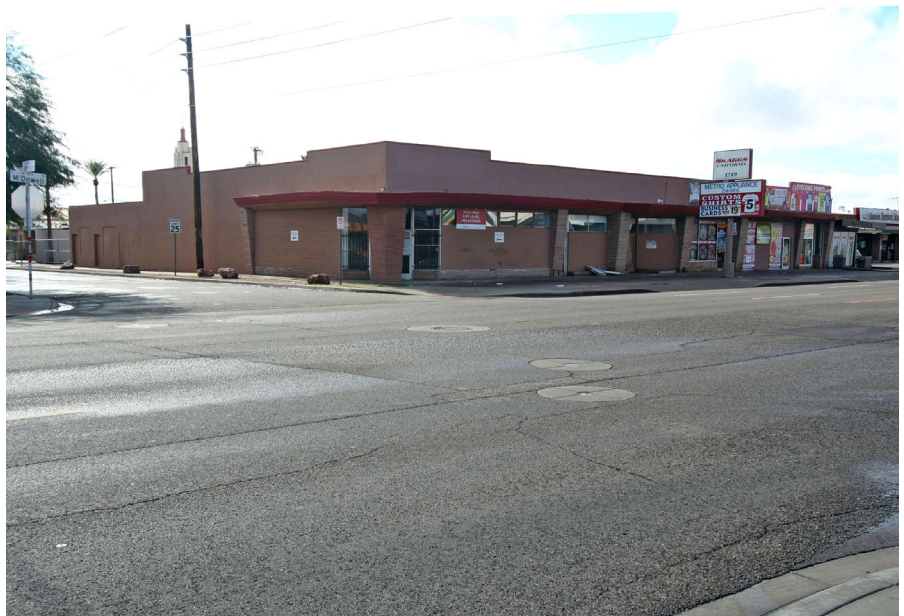
Site No. 57 Survey Area Miracle Mile

Most storefront replaced or infilled with painted panels or CMU; small early addition to rear.

Permits: Change glass front to masonry & add interior nonbearing partitions (1964) for 1741; build Masonry store building to side street (1950) for 1747; 35x38 addition to rear of store (1951); remove glass & replace w/ slump block (1975) for 1749.

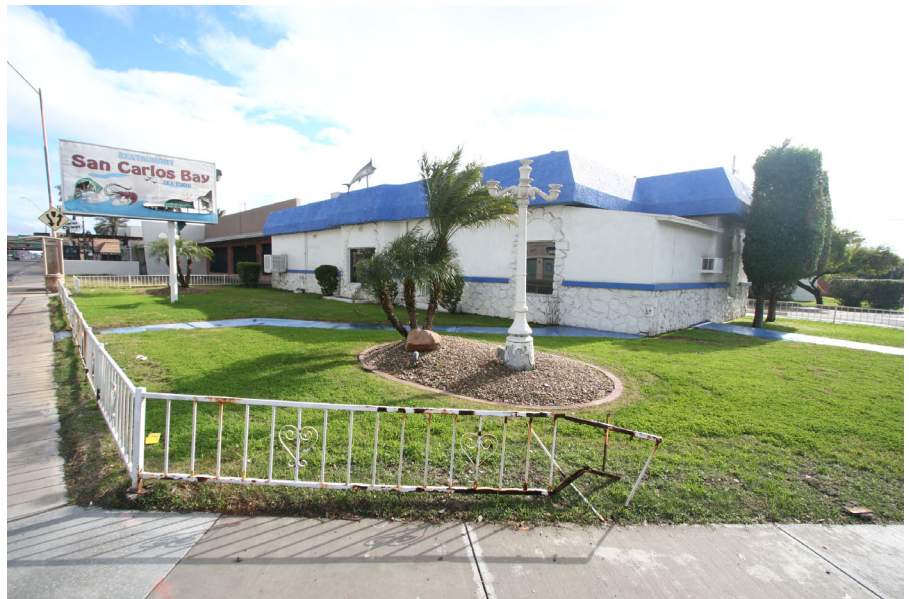
Site No. 63 Survey Area Miracle Mile

The configuration of the original residence is unknown. Has had extensive remodels/additions, dates unknown. No permits found for additions or alterations

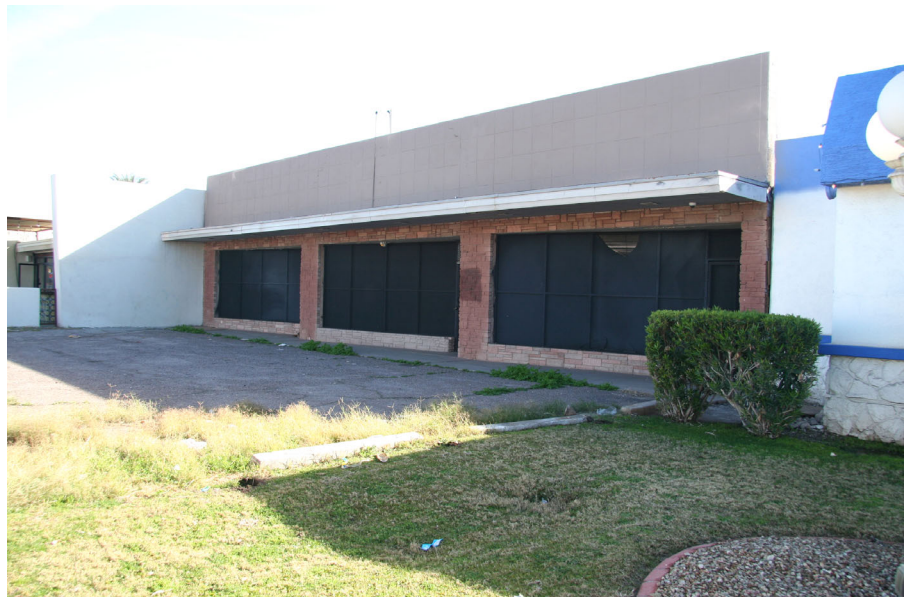
Site No. 64 Survey Area Miracle Mile

All the storefront windows and doors have been replaced. Patches of the ashlar stone have been painted to cover graffiti.

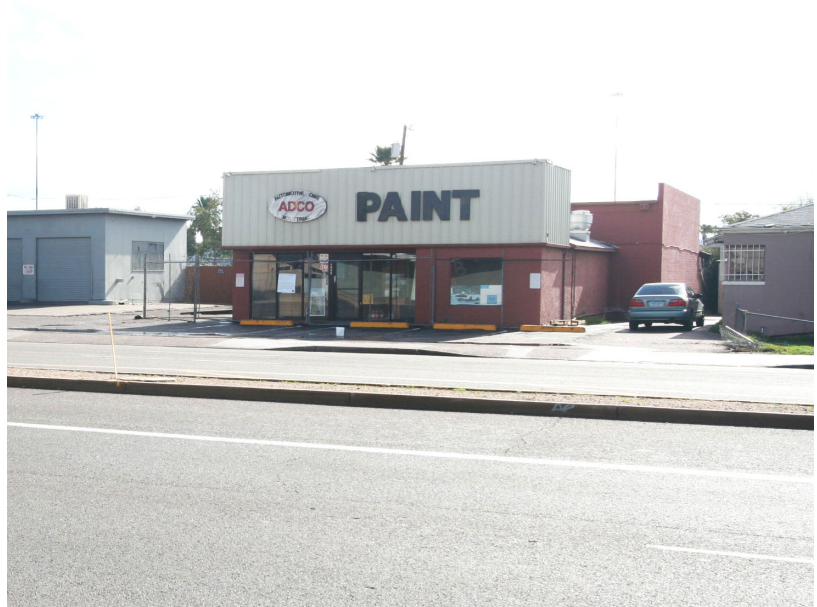
Site No. 69 Survey Area Miracle Mile

Storefront replaced, corrugated metal added to parapet, signage added, additions to building

Foundation Concrete

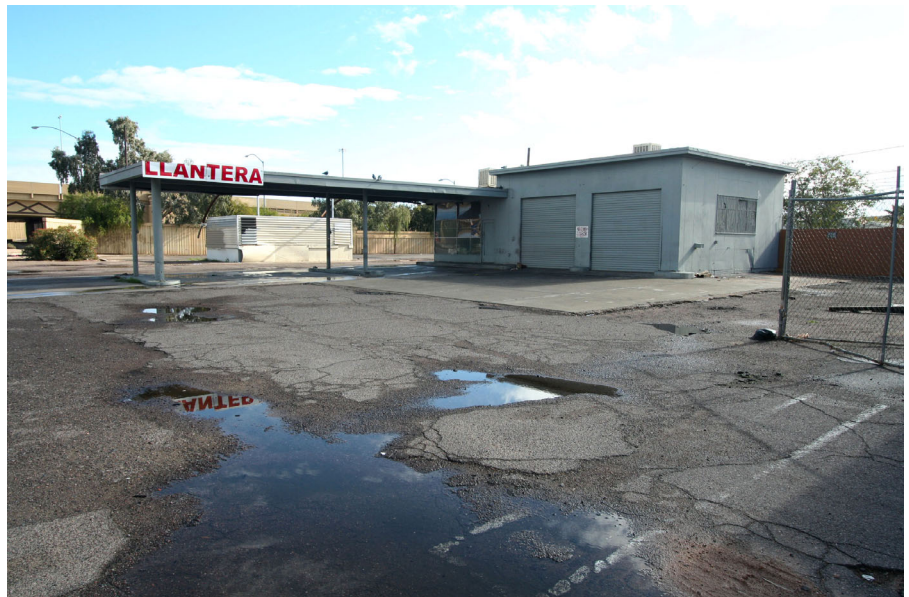
Site No. 70 Survey Area Miracle Mile

Some storefront infilled or replaced, stuccoed, gas pumps removed

Windows/Doors: One steel casement remains on west, replacement aluminum storefront windows and door elsewhere, garage d
