A Historical Building Inventory of North Mountain Park in the Phoenix Mountains Preserve, Phoenix, Maricopa County, Arizona

City of Phoenix Project Number: PA75200612-1

Logan Simpson Technical Report No. 2350186

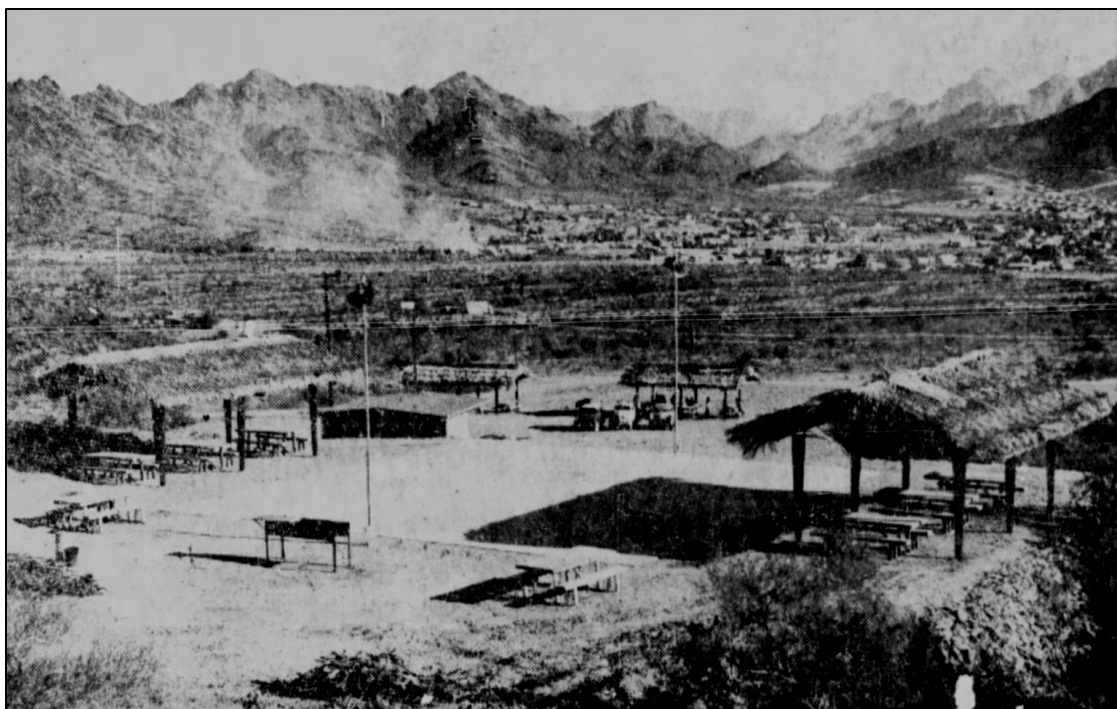
Figure 5. Overview of the new county regional North Mountain Park in 1957 (Arizona Republic 1957a).

This view depicts early structures of Building Group 2. The four ramadas, picnic tables, and barbeque shown in the photograph have since been replaced with modern structures, but the concrete slab is still present. So, too, is the ranger station (recorded as Building 2A).

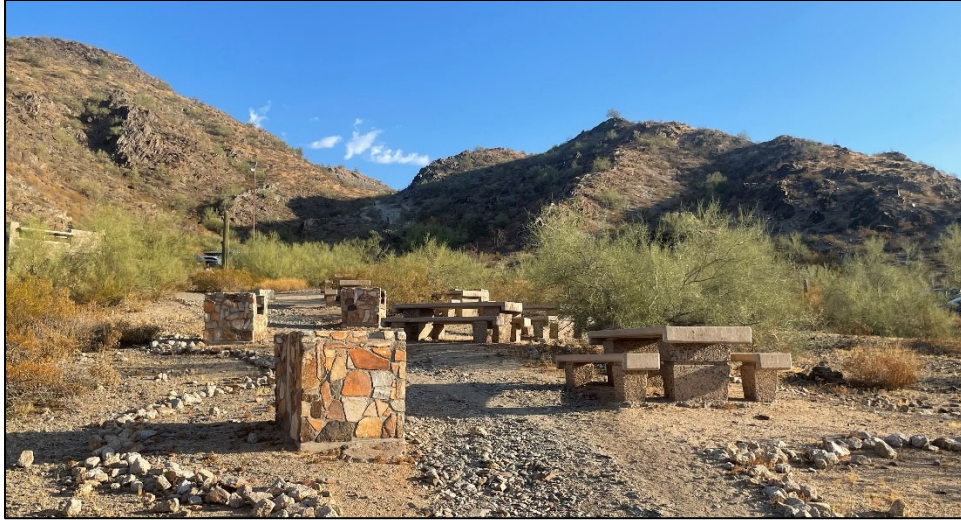
Figure 1. Overview of Picnic Area A, view facing north.

As shown, tables are made from concrete (exposed aggregate legs and slab tops), while barbecues are wet-lain stone.

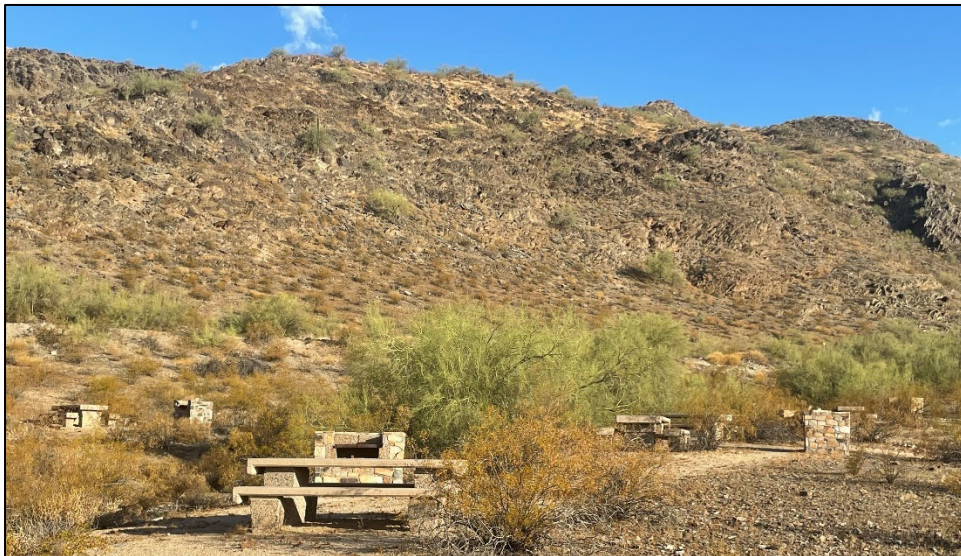
Figure 2. Overview of Picnic Area B, view facing northwest.

As shown, tables are made from concrete (exposed aggregate legs and slab tops), while barbecues are wet-lain stone.

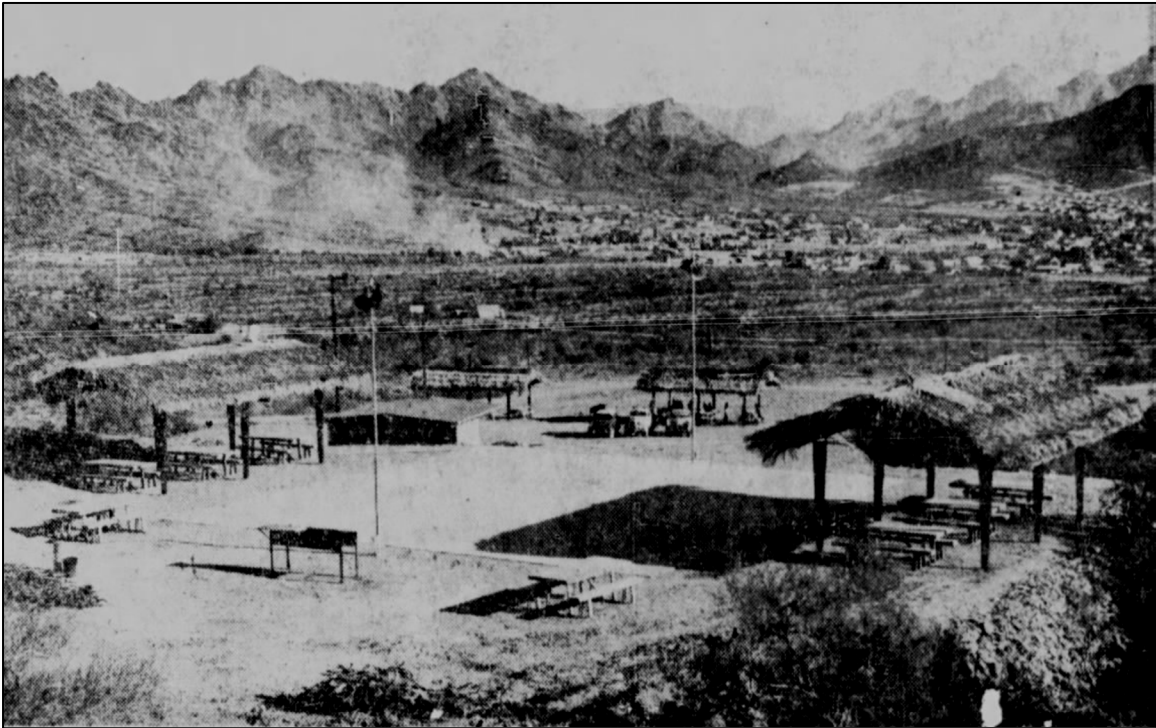
Figure 1. Overview of the new county regional North Mountain Park in 1957 (Arizona Republic 1957).

These were among the earliest structures constructed at North Mountain Park, including the ranger station (Building 2A) in the background. Constructed by Maricopa County, the original ramadas, picnic tables, and barbeque shown in the photograph have since been replaced with modern structures, but the concrete slab is still present. This area represents the upper level of the sloping Building Group 2.

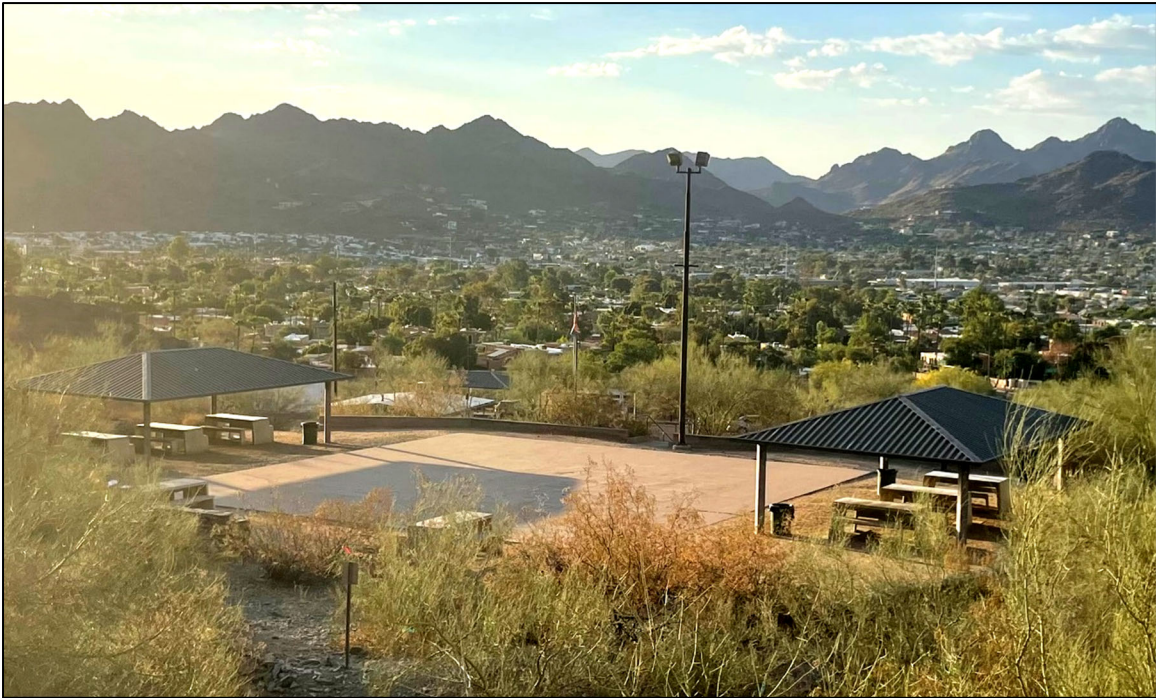
Figure 2. Contemporary view of upper concrete event slab with modern ramadas, view facing southeast (compare with Figure 1).

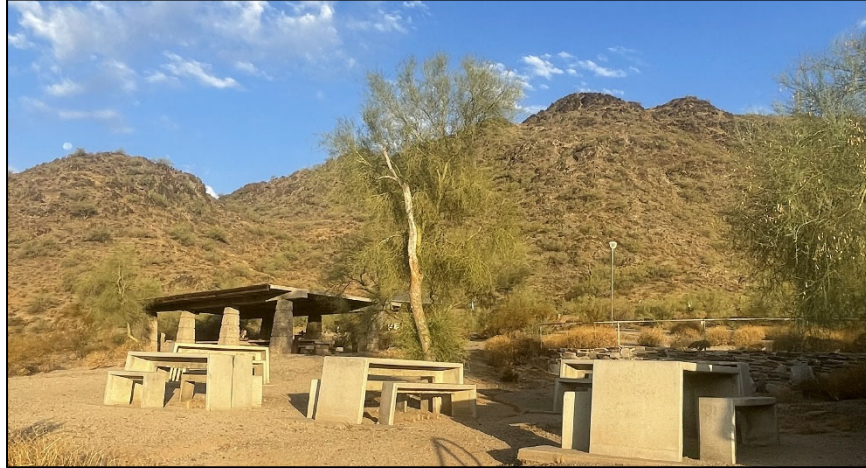
Figure 3. View of modern concrete tables with the unnamed ramada in background (Building 2B), view facing northwest.

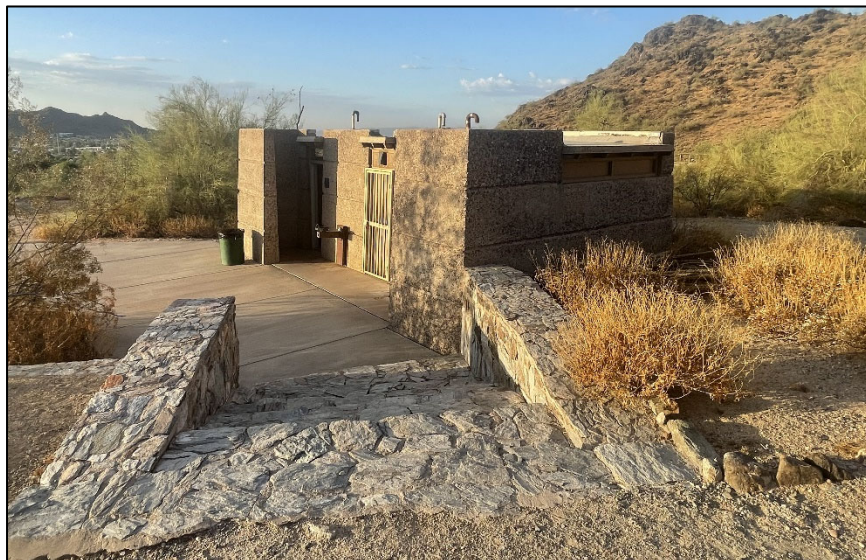
Figure 4. Overview of restroom facility (Building 2C) with modern stone retaining wall and steps, view facing south.

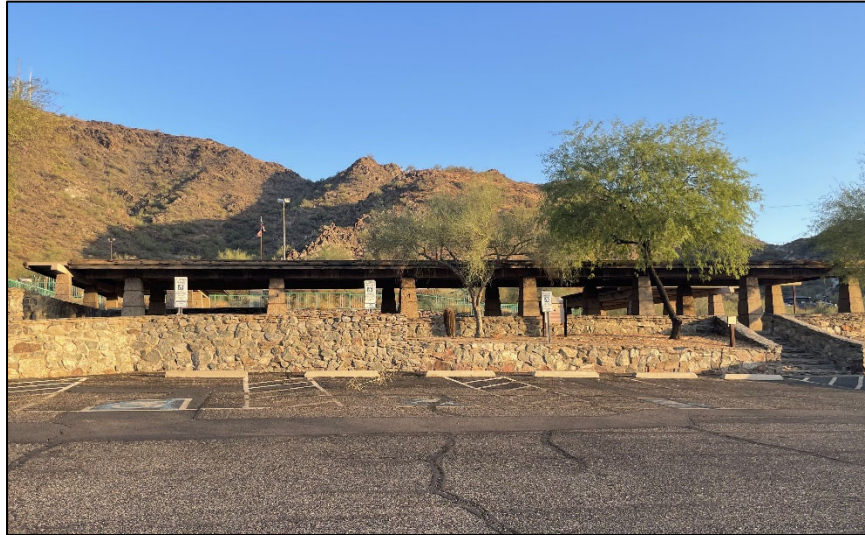
Figure 5. Overview of large Havasupai Ramada (Building 2D) and lower-level parking lot that forms the southeast boundary of Building Group 2, view facing northwest.

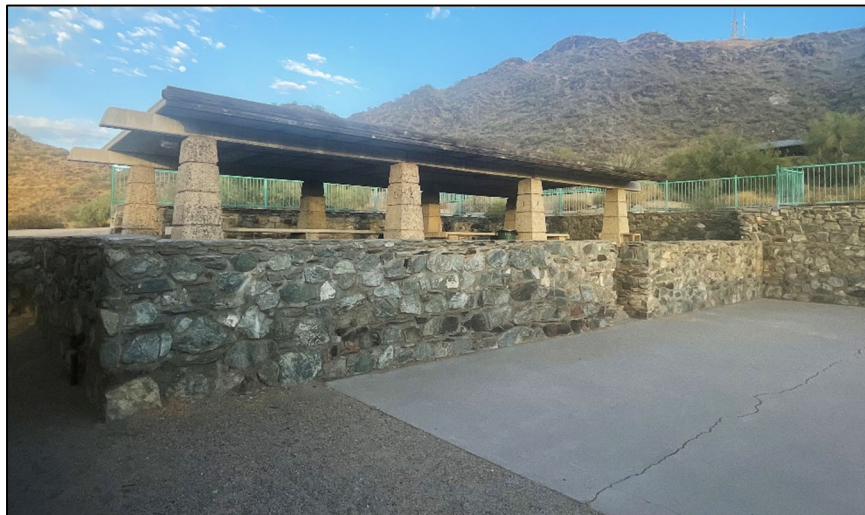
Figure 6. One of the ramadas that surround the concrete event slab in Building 2D. The placement of ramadas and perimeter retaining walls (wet-laid stone and/or concrete) effectively forms a recreation courtyard. View facing west.

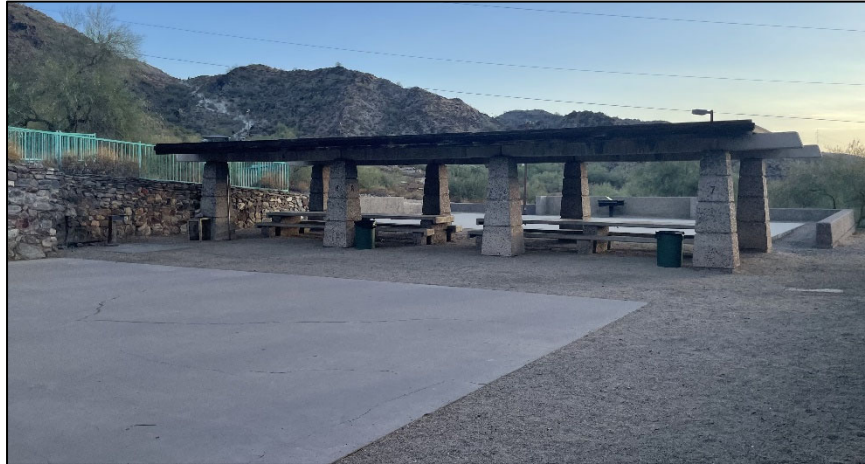
Figure 7. One of the ramadas of Building 2D that encompass the concrete event slab, surrounded by with wet-laid stone and concrete retaining walls. View facing northeast.

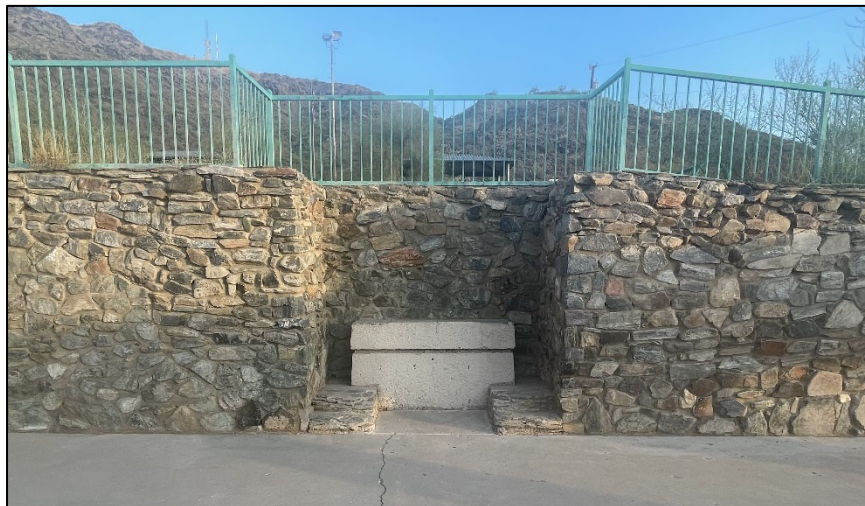
Figure 8. Overview of a stepped concrete pedestal that was once a drinking fountain. Located in the recreation courtyard of Building 2D (Havasupai Ramada), view facing northwest.

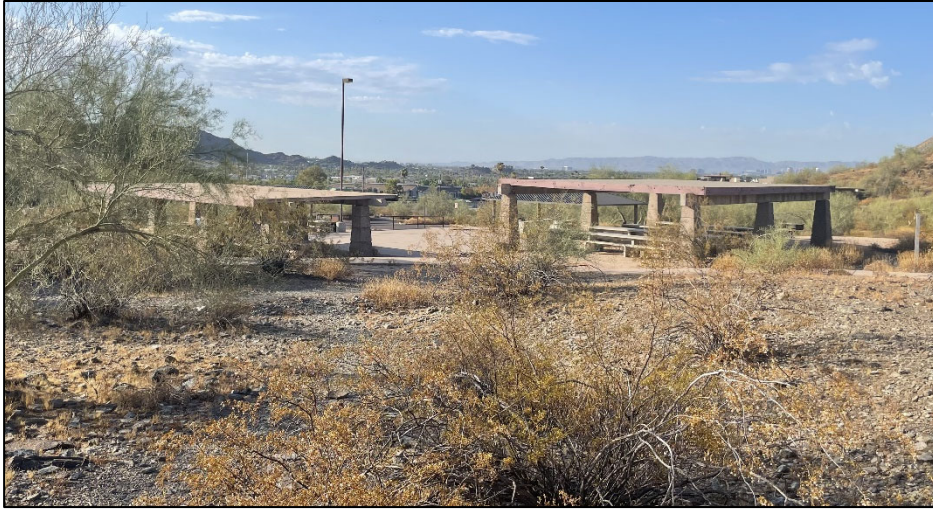
Figure 1. Overview of Yavapai Ramadas (Buildings 3A and 3B), surrounding a concrete event slab, view facing south.

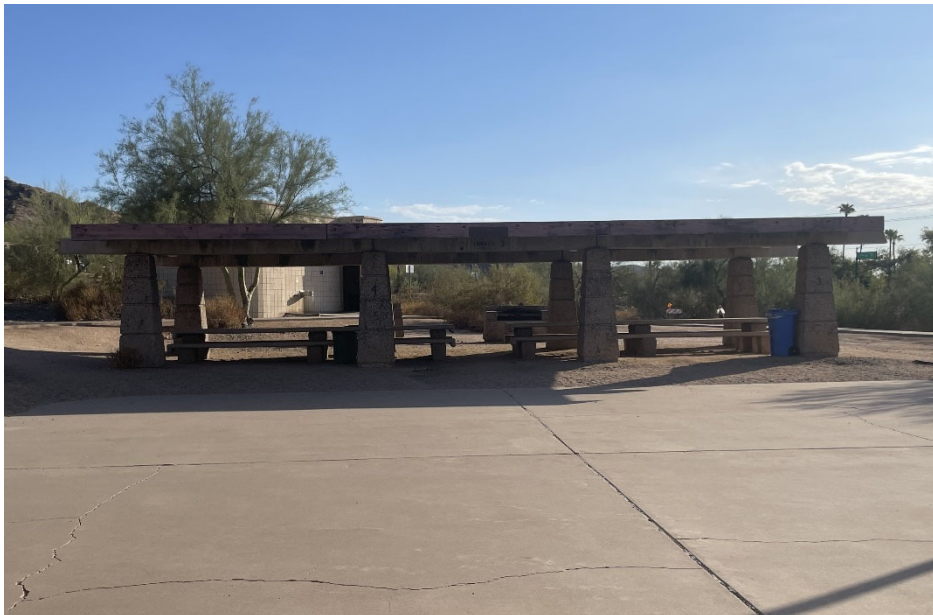
Figure 2. Overview of Building 3A and the concrete event slab. A modern restroom facility is to the rear. View facing north.

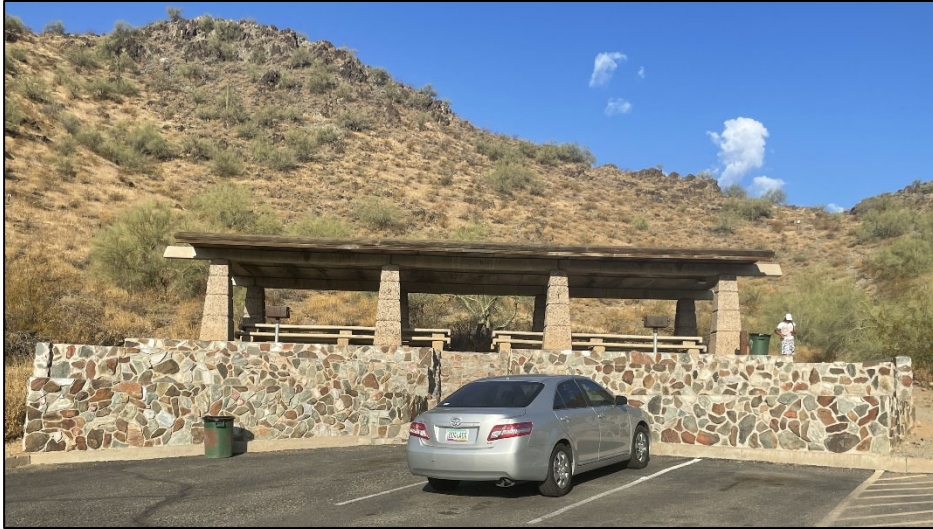
Figure 3. Overview of Quechan Ramada (Building 3C), view facing west.

The retaining wall appears to be modern (post 1974) and well maintained.

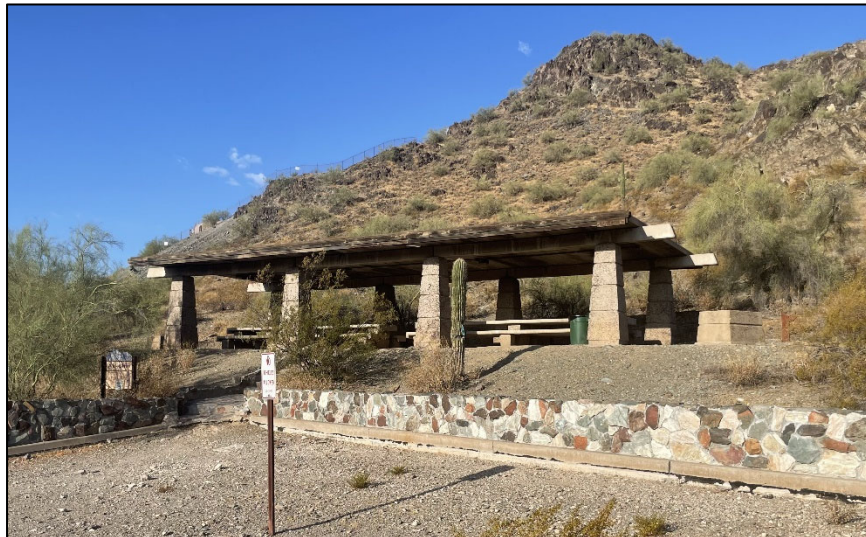
Figure 4. Overview of Ak-Chin Ramada (Building 3D), view facing southwest. The retaining walls appear to be modern (post 1974).

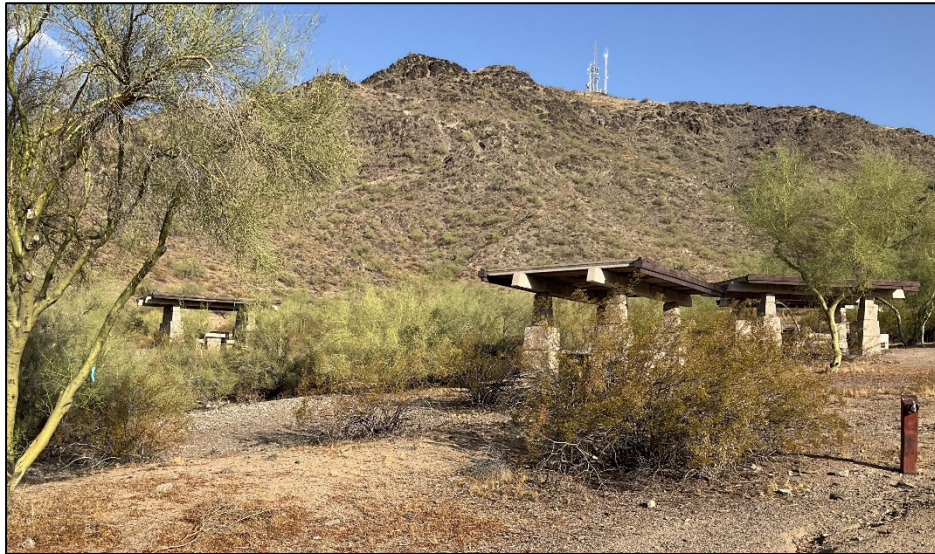
Figure 5. Overview of smaller ramadas, each with a single table and barbecue pit (Buildings 3E-3K). View facing northwest.

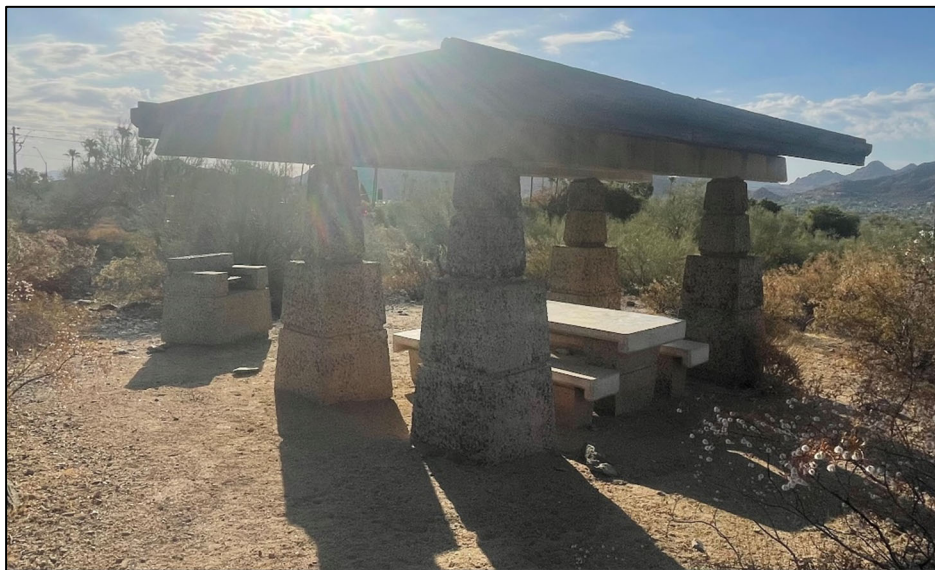
Figure 6. Overview of Building 3K, a small ramada table and barbecue. View facing southeast.

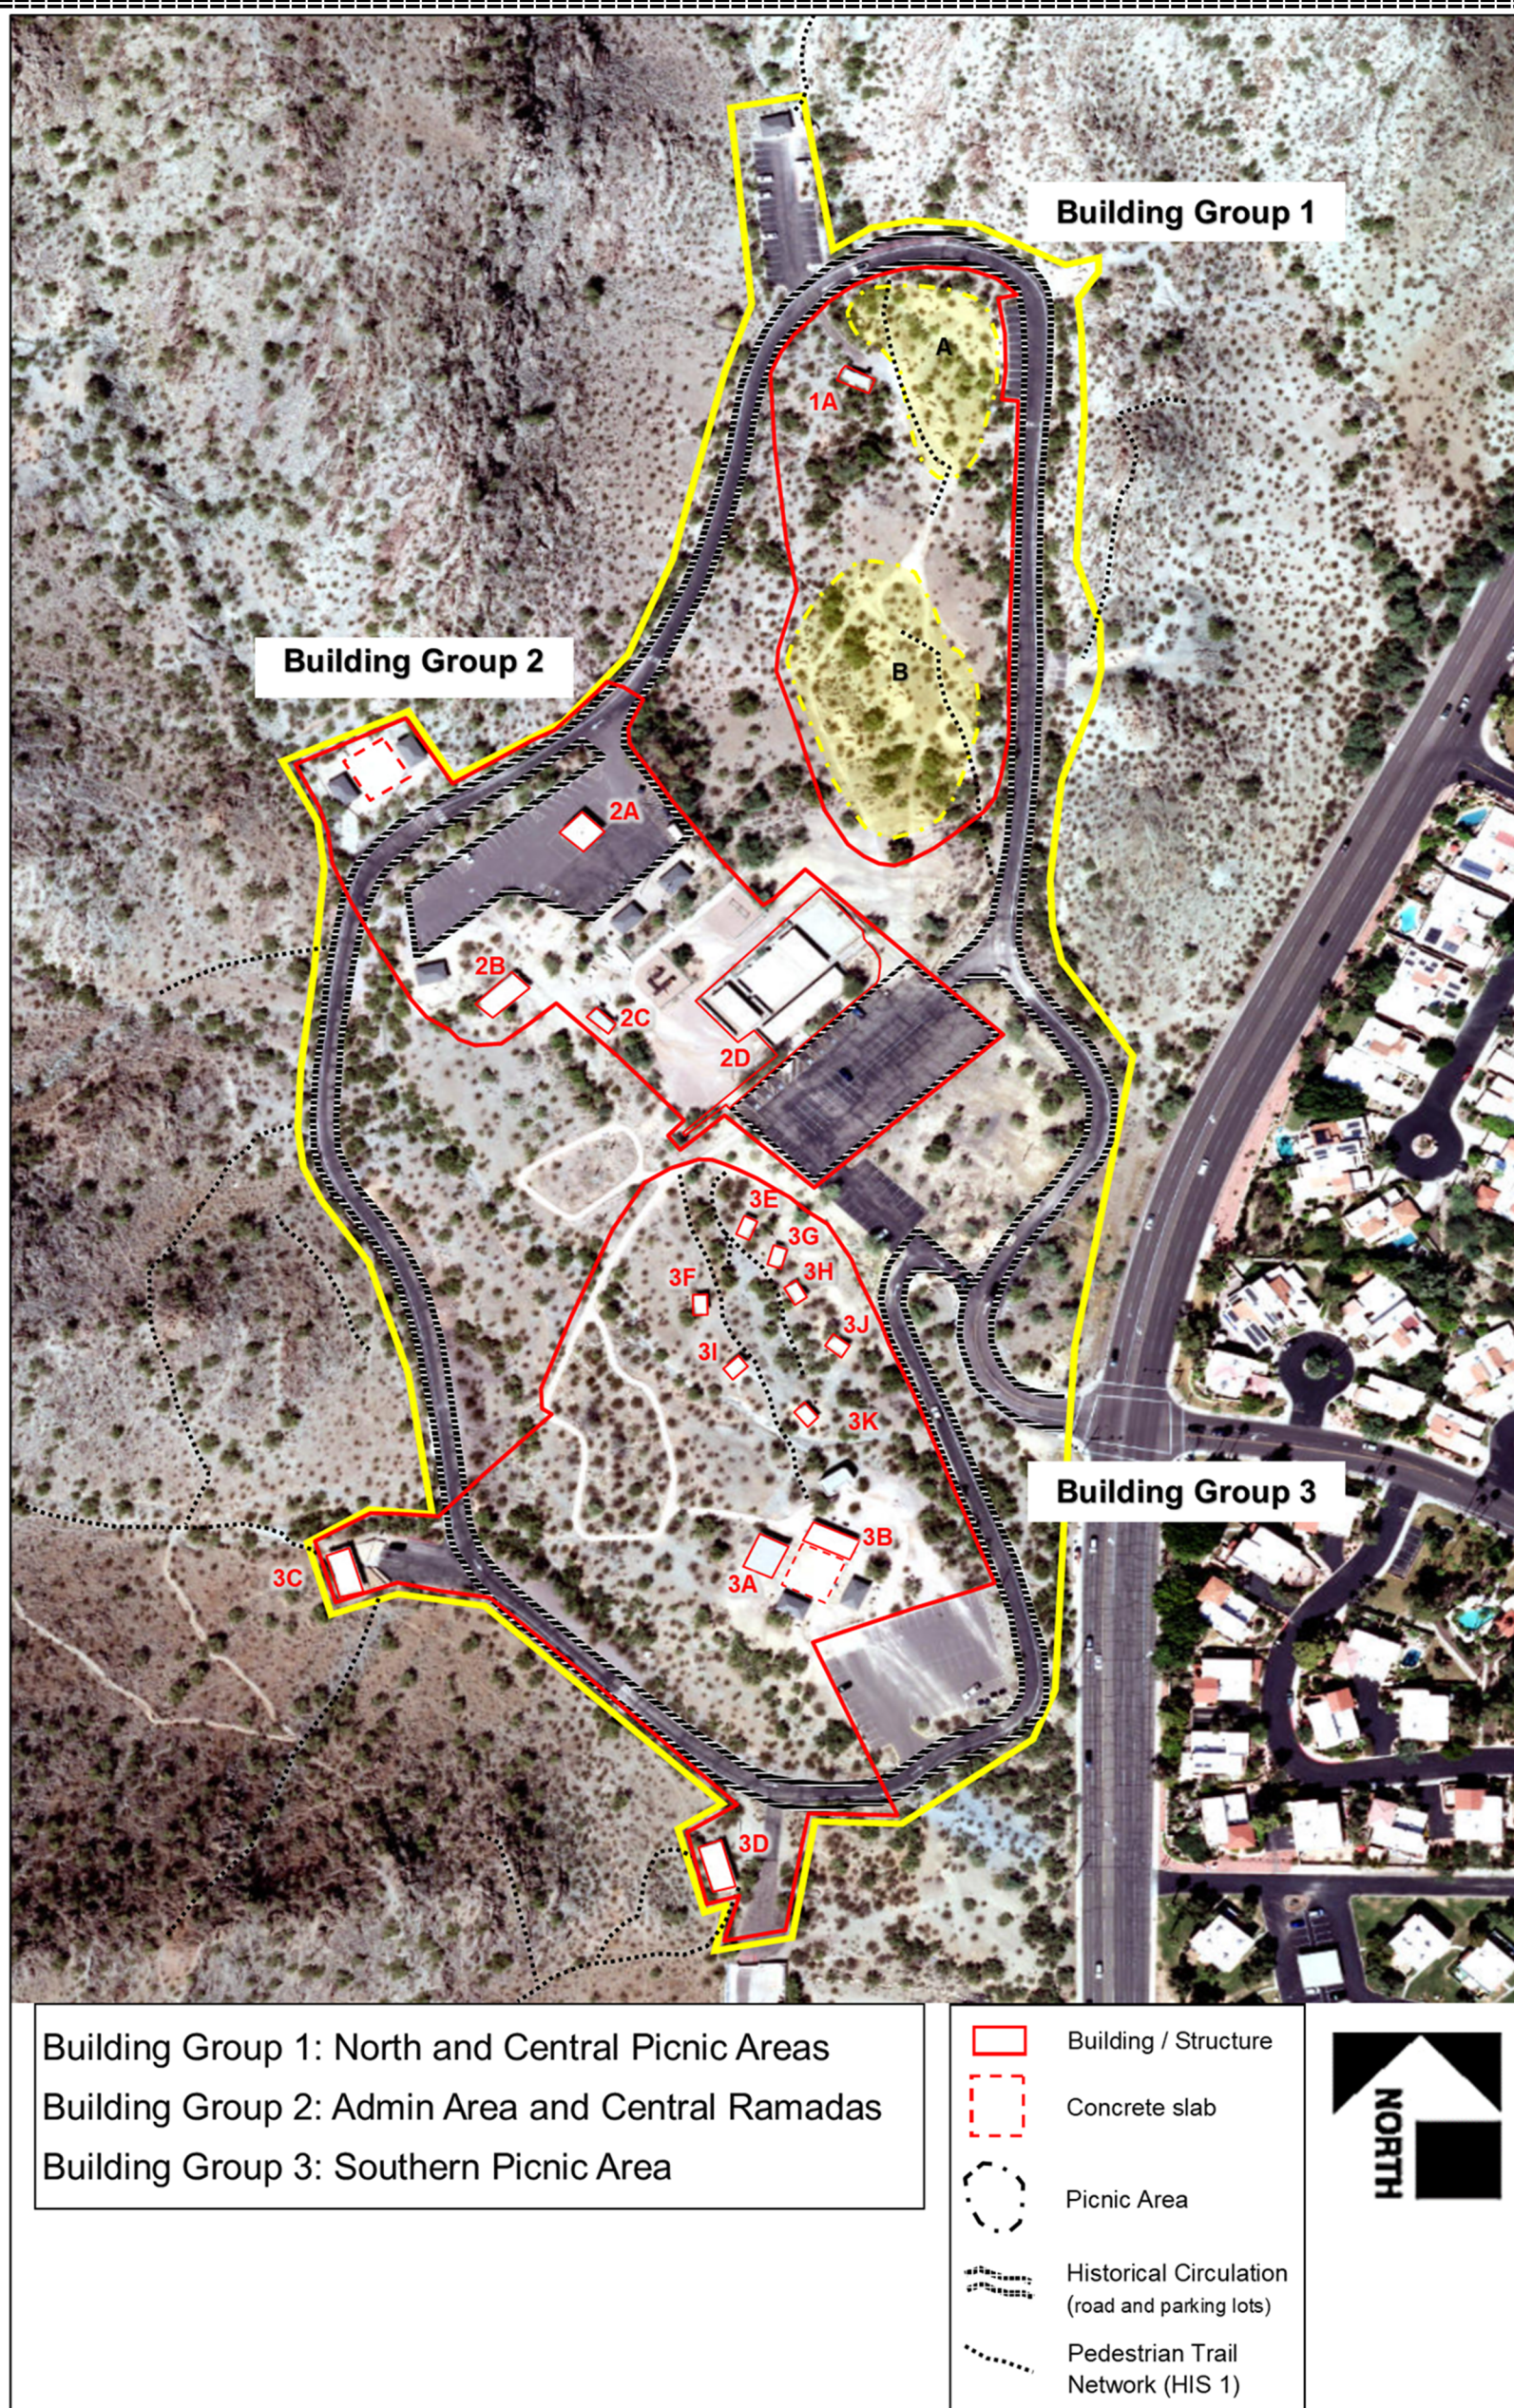
Figure 1. Contemporary aerial of the project area, showing building groups structures and building groups inventoried by Logan Simpson, as well as circulation of the recreation area and miscellaneous features.

Also shown are historical trail segments located within and immediately adjacent to the project area.

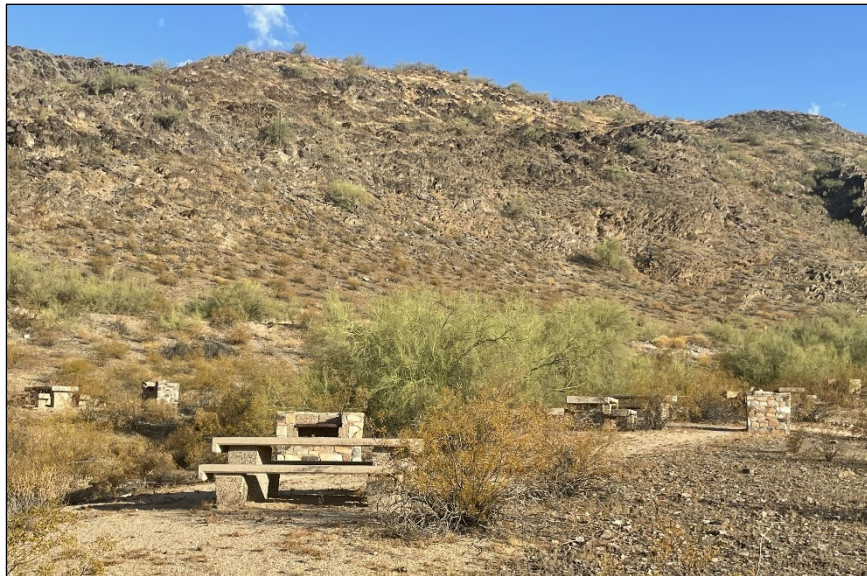
Figure 3. Overview of Picnic Area B in Building Group 1, view facing northwest.

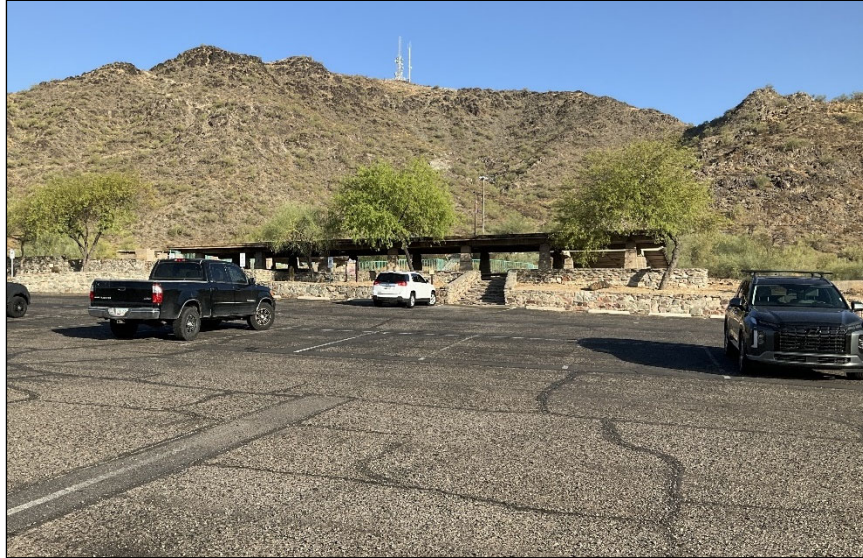
Figure 4. Overview of lower parking lot in Building Group 2, view facing northwest.

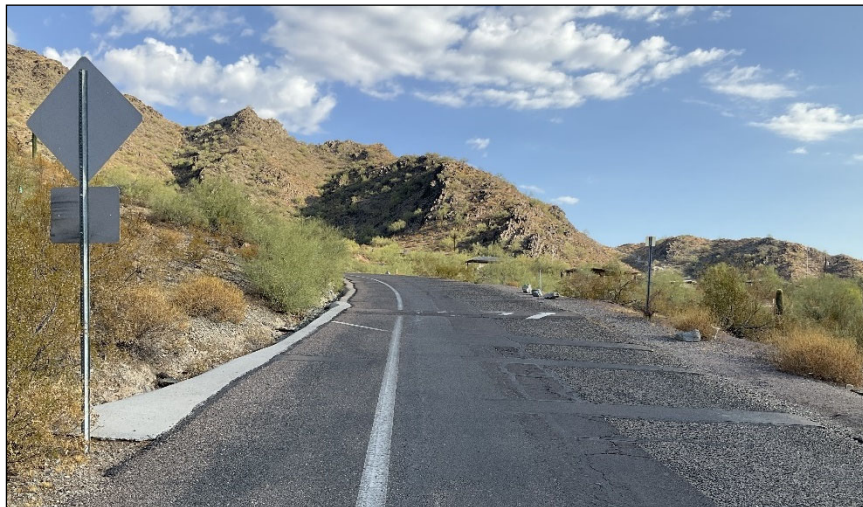
Figure 5. Overview of main access road from the west end of the park (near Building 3C), view facing north.

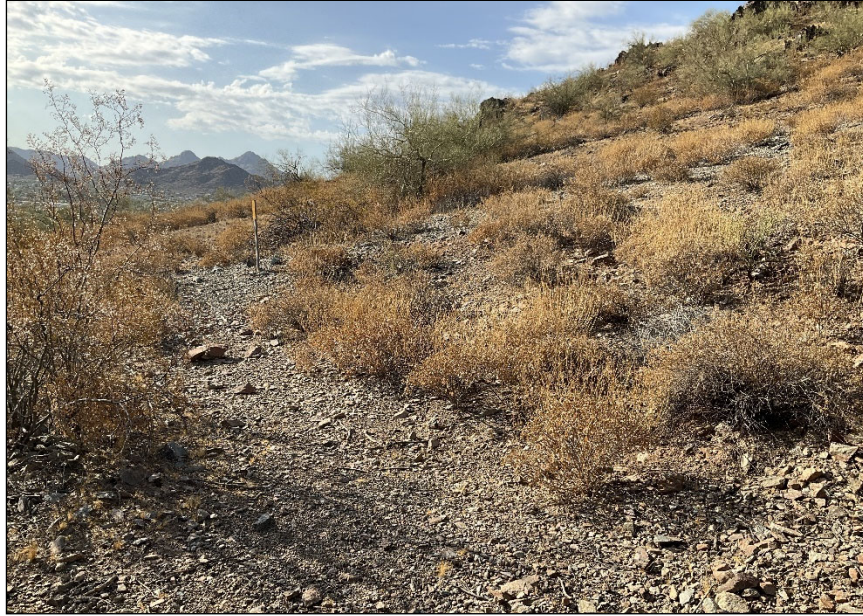
Figure 6. Overview of a possible historical trail at Building 3C, view facing southeast.

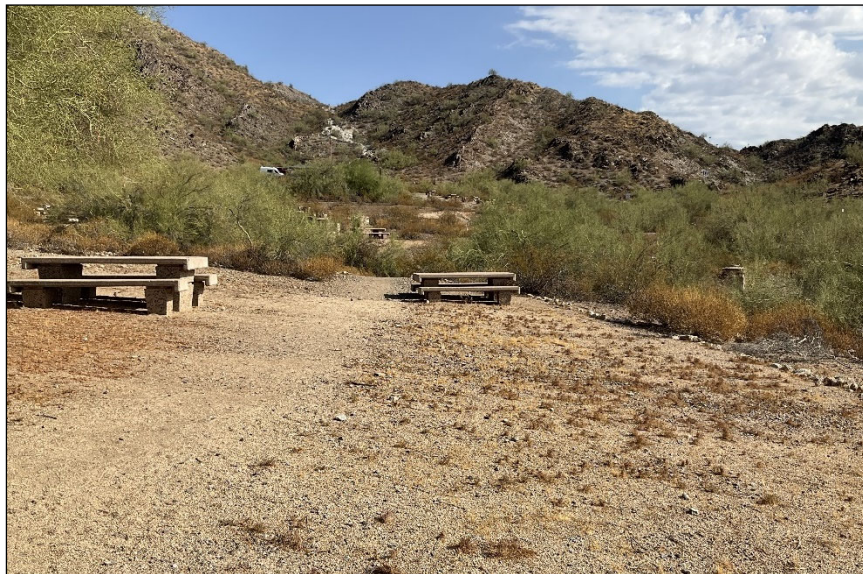
Figure 7. Possible historical pedestrian trail in Picnic Area B (Building Group 1), view facing.
