**CURRENT CONDITIONS REPORT
MOBILITY AREA 2
INDIAN SCHOOL-GRAND NEIGHBORHOODS**

City of Phoenix

**Olsson Associates
7250 North 16th Street
Phoenix, AZ 85020
602.748.1000**

July 2018

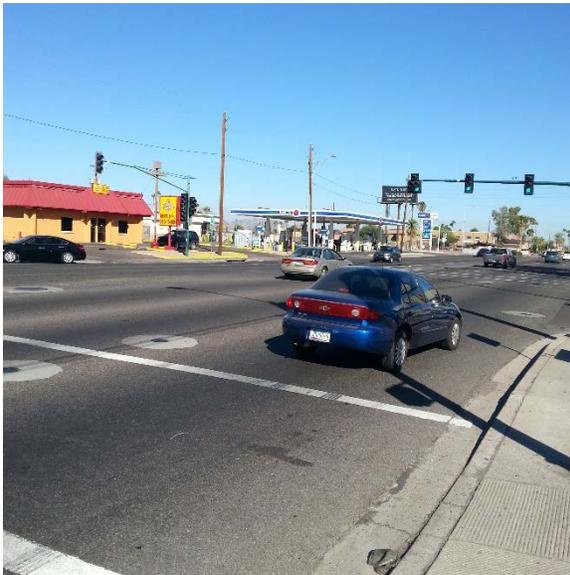
Photo 1 - Commercial

Map 1A - Study Area shows the location of Study Area 2 and identifies zoning near the study area. Study Area 2 consists of Commercial, and Residential zoned properties. The Commercial zoned properties are at the intersection of Indian School Road and 19th Avenue, see Photo 1 and Photo 2 (page 3). These properties are surrounded by single-family and multi-family Residential zoned properties, see Photo 3 and Photo 4 (page 4).

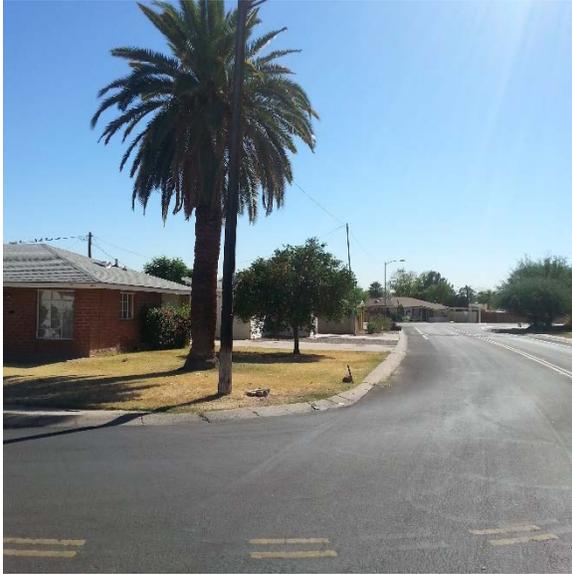
Photo 7 - 23rd Ave/Fairmount

- Arthur is a resident of the Westwood Estate neighborhood. He lives near the intersection of 23rd Avenue and Fairmount Avenue. See Photo 7 and Photo 8 (page 10).

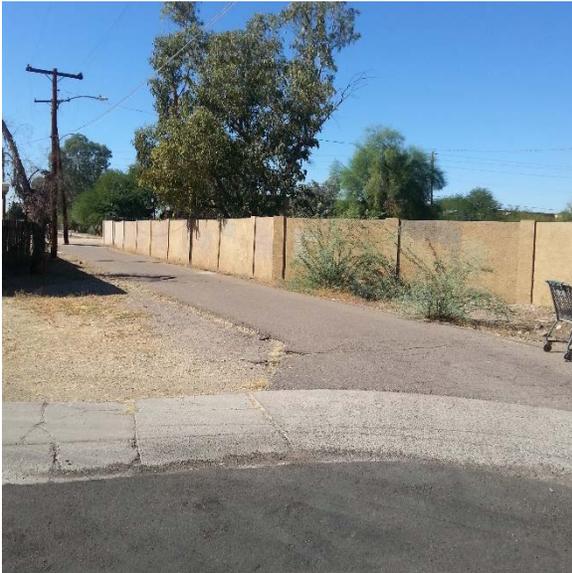
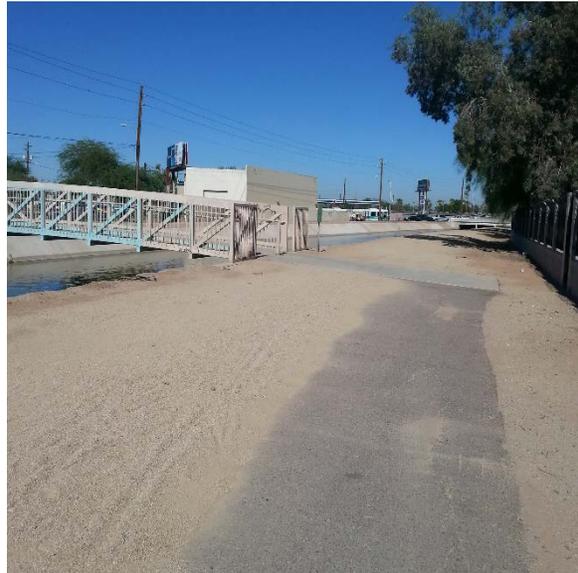
Photo 9 - 23rd Ave/Grand Canal

- Arthur feels that there is insufficient lighting along the canal and at the pedestrian bridge. Improved lighting here would reduce crime in the area. See Photo 9 and Photo 10 (page 10).

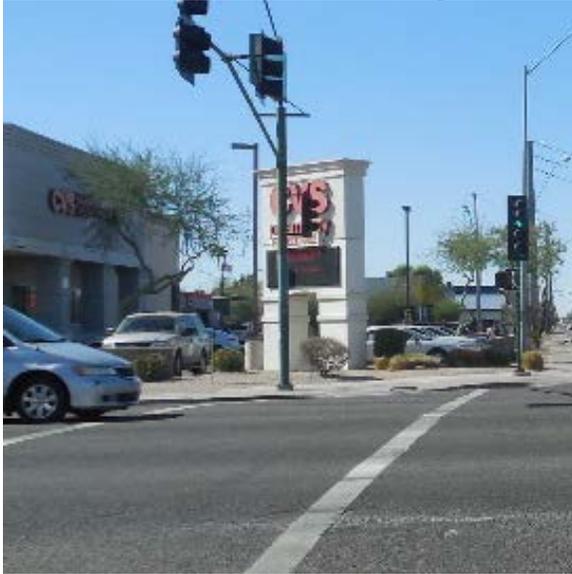
Photo 11 - CVS Pharmacy

- The Food City shopping center is located at the northwest corner of Indian School Road and 19th Avenue. The shopping center also has an Ace Hardware store, a Check Smart store, and various restaurants. See Photo 14 (page 15).
- CVS Pharmacy is located at the southwest corner of Indian School Road and 19th Avenue. See Photo 11 (page 15).
- Pan American Charter School is on the northwest corner of 20th Avenue and Indian School Road. Stakeholder interviews have indicated that the school is a traffic generator for the surrounding neighborhoods.
- There are various businesses including restaurants, barbershops, tattoo parlors, and other small businesses along 19th Avenue. See Photo 12 (page 15) and Photo 13 (page 15).
- There are also various medical providers along 19th Avenue, and along Indian School Road.

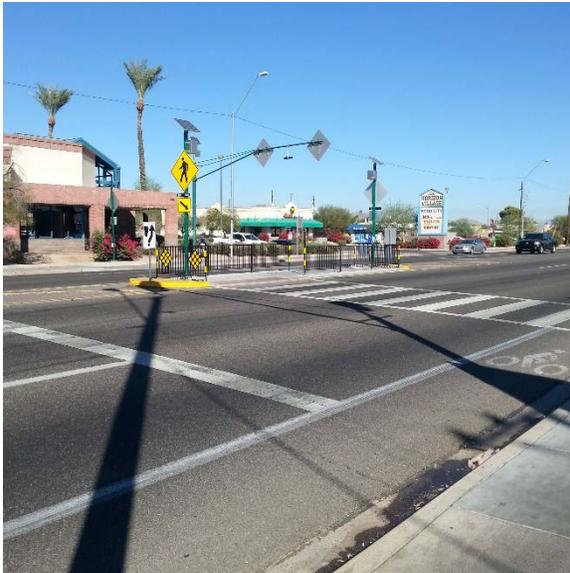
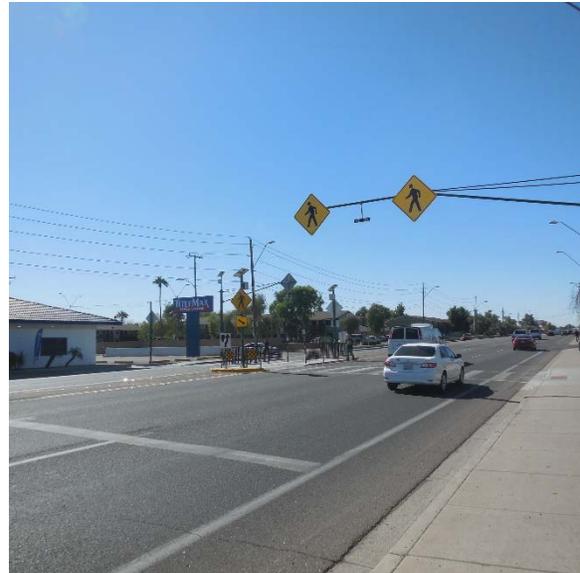
Photo 15 - 20th Ave RRFB

- There is currently only one existing or proposed RRFB in the study area. The RRFB is located at the crosswalk across Indian School on the east side of 20th Avenue. See Photo 15 and Photo 16 (page 21).

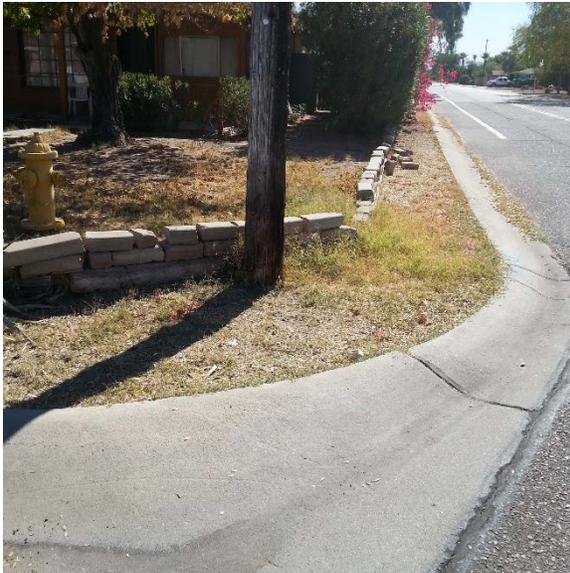
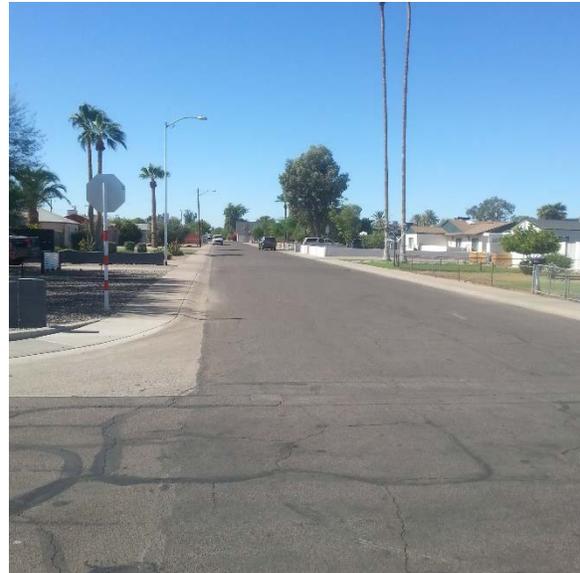
Photo 17 - Mountable Curb & Gutter

- Much of the neighborhood south of Indian School Road, and west of 19th Avenue consists of mountable curb & gutter with sidewalk behind. Most of the neighborhood has existing sidewalk. There are sidewalk gaps in various locations. See Photo 17 and Photo 18 (page 23).
- The neighborhoods east of 19th Avenue also consist of mountable curb & gutter with sidewalk behind. There are very few sidewalk gaps in these neighborhoods.
- The neighborhoods north of the Grand Canal have very few sidewalk gaps. Most of the existing sidewalk in this neighborhood is 4-ft wide. In many locations, there is no curb & gutter, only sidewalk. See Photo 19 (page 24). In other locations, mountable curb & gutter is used.
- The existing sidewalk along 23rd Avenue is barrier type curb & gutter. The existing sidewalk needs to be repaired in various locations. See Photo 20 (page 24).

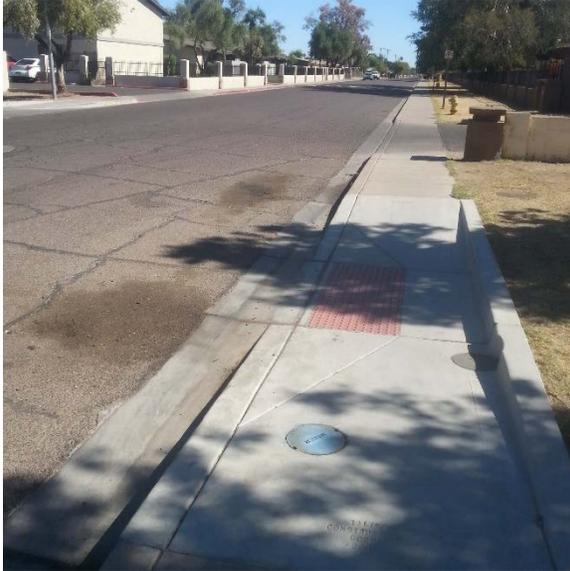
Photo 21 - ADA Compliant Ramp

Map 3B - Sidewalks identifies both ADA compliant and non-compliant curb ramps in the study area. The map also identifies locations where there should be a curb ramp, but the ramp is missing. These areas have been identified as non-accessible, see Photo 23 and Photo 24 (page 25). For this study, a curb ramp is considered non-compliant if it is missing detectable warning surface, if the landing behind the ramp is less than 4-ft x 4-ft in size, or if there are obstructions in the ramp or in the landing, see Photo 22 (page 25) In many locations, there is mountable curb & gutter. There is sidewalk in

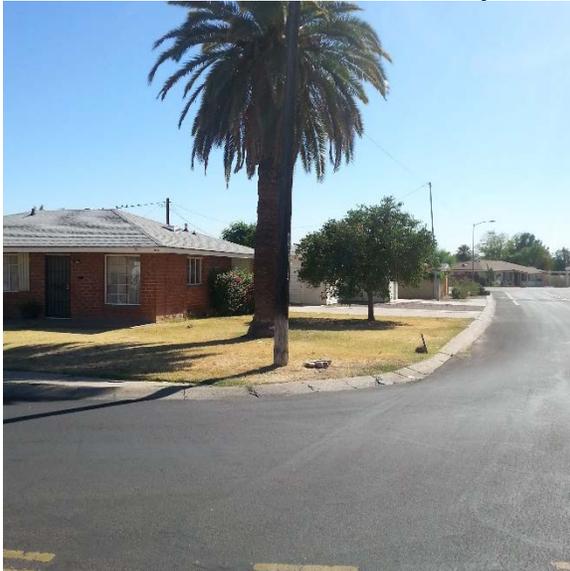
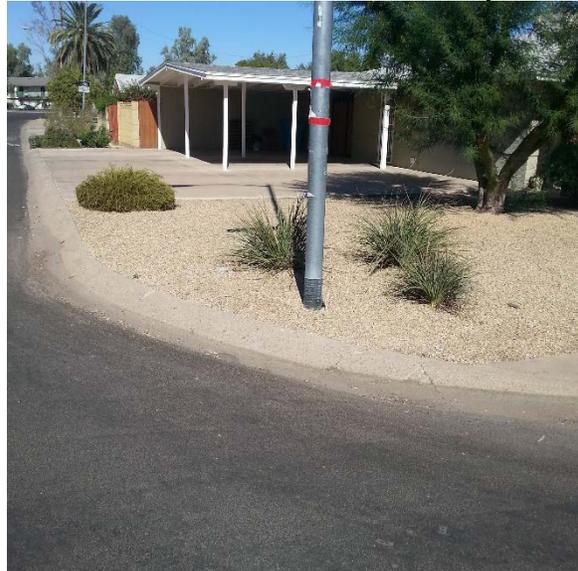
Photo 23 - Non-Accessible Ramp

these locations, but curb ramps have not been installed and so have been labeled as non-accessible.

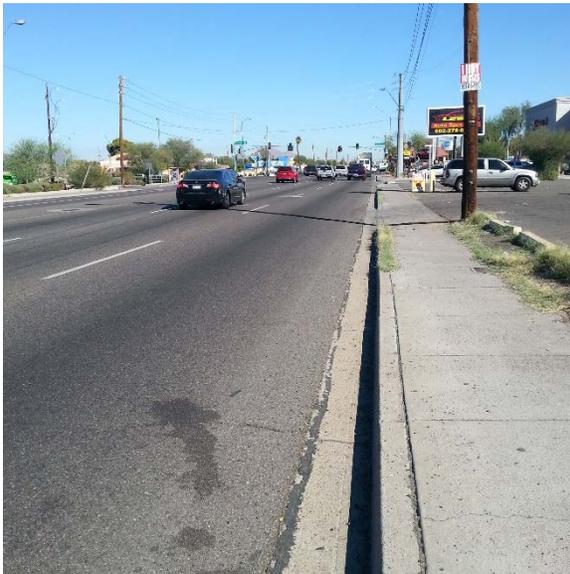
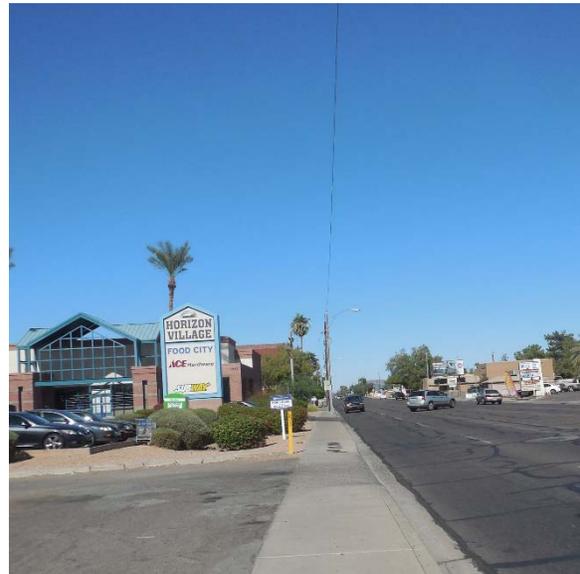
Photo 25 - Indian School Road

- Most of the neighborhoods northwest of the Grand Canal have sidewalk. The sidewalk is 4-ft wide which meets ADA guidelines. The sidewalk is blocked for pedestrian use when garbage cans are out. Furthermore, the existing driveways, are not ADA compliant and so the sidewalk is not considered compliant with ADA guidelines.
- The sidewalks along Indian School Road and along 19th Avenue are 6-ft wide. However, the existing driveways are not ADA compliant which means the sidewalk is not considered compliant with ADA guidelines.

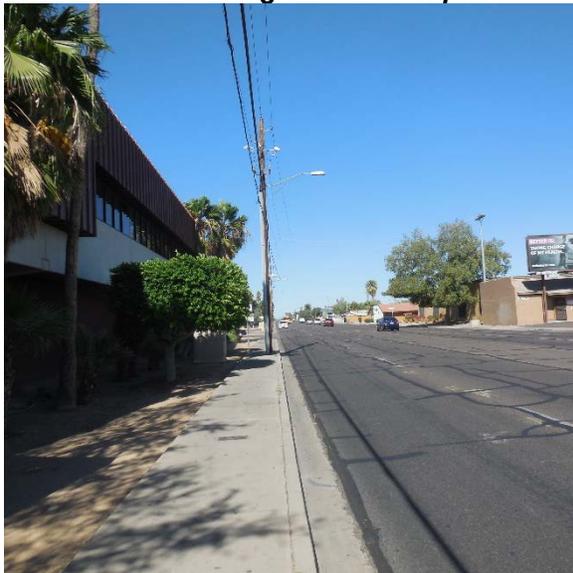
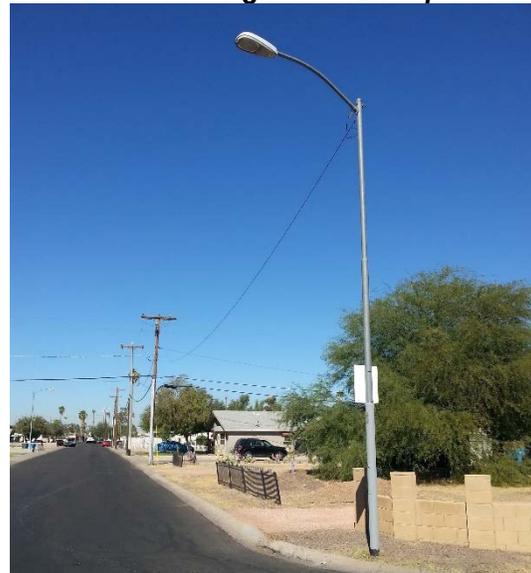
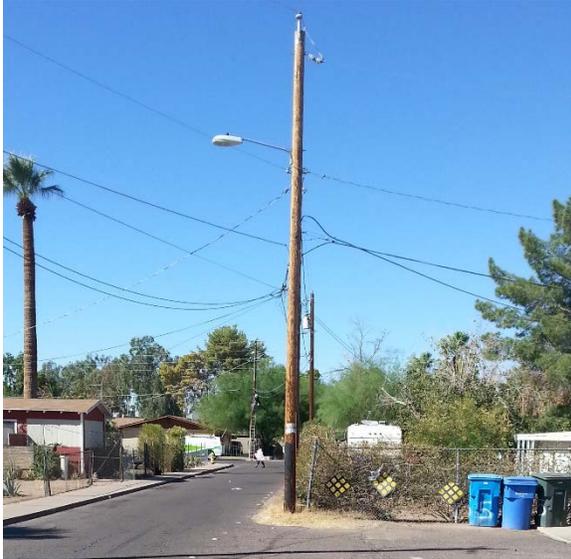
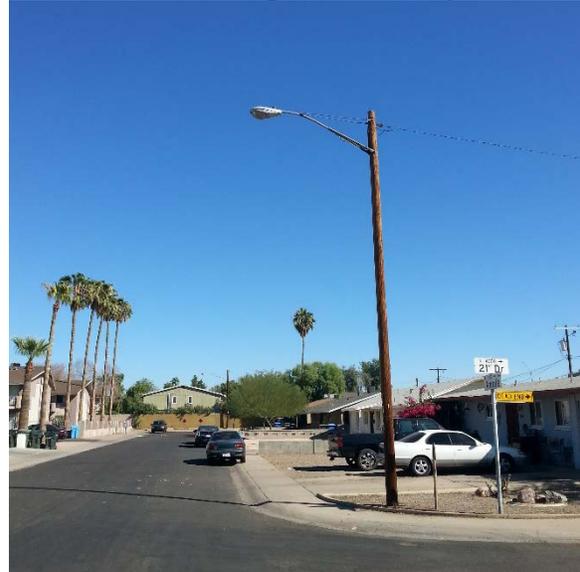
Photo 27 - Light Pole Example

Existing lighting, within the study area, was evaluated based on the City of Phoenix Streetlighting Layout Guidelines. Table 1: Spacing and Mounting Height Criteria provides the criteria used to evaluate spacing of the existing lighting. The study only evaluated spacing, it did not evaluate watts, lumens, or mounting height. Map 3C - Lighting identifies light pole locations, and the maximum light pole spacing based on the City guidelines. The study did not examine the existing light fixtures, but only noted that most of lights in the area are mounted on wood poles. The lighting will be evaluated more closely as potential projects are identified. See Photo 27, Photo 28, Photo 29, and Photo 30 (page 29 and 30).

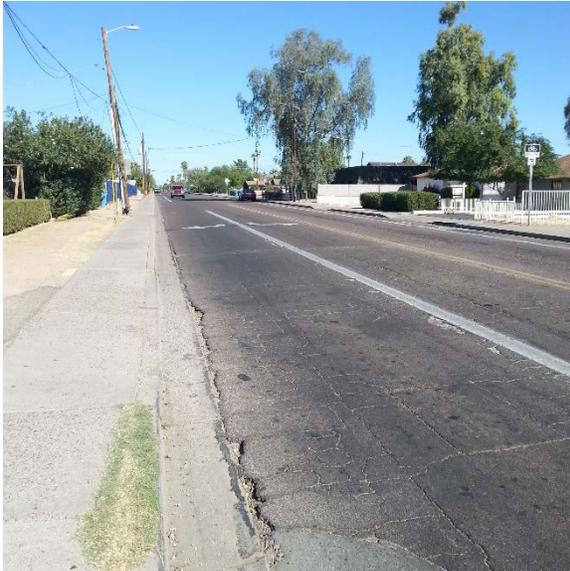
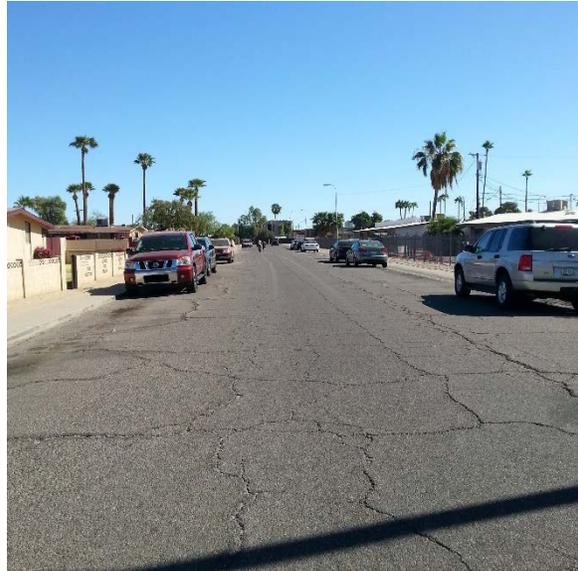
Photo 31 - 23rd Avenue Pavement

The City of Phoenix provided the pavement conditions index for roads within the study area. The existing pavement conditions have been evaluated based on the pavement condition index. The local roads have been classified as being in fair condition. Indian School Road west of 19th Avenue, and 19th Avenue south of Indian School Road, are classified as being in good condition. Pavement preservation projects have recently been completed in the neighborhoods south of Indian School Road. Future pavement preservation projects are planned on Indian School Road and in the neighborhoods north of Indian School Road.

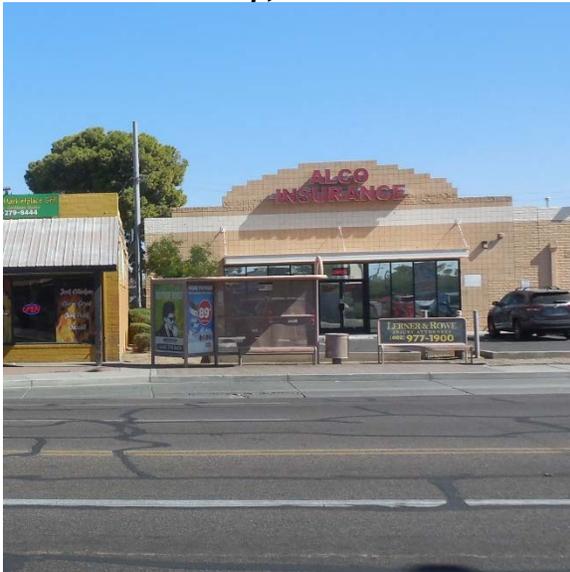
Photo 33 – Bus Stop, All Amenities Provided

Bus stops in the area were evaluated for ADA accessibility and for amenities provided. A bus stop is considered accessible if users can access the stop by sidewalk. Users should not be required to walk in the street or on the shoulder to access the bus stop. None of the bus stops within the study area are considered ADA non-accessible. Bus stop amenities were evaluated to determine if a bus stop is missing a bench, a shelter or both. Several bus stops within the area are missing these amenities.

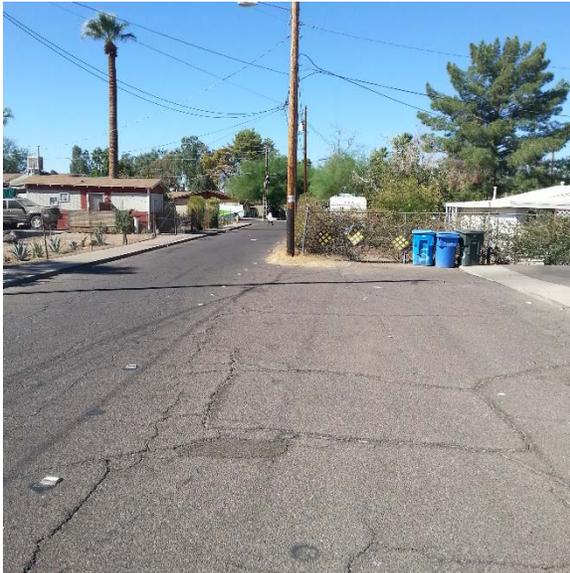
Photo 35 - Heatherbrae Ave/23rd Ave

- There is a right-of-way constraint at the northeast intersection of 23rd Avenue and Heatherbrae Avenue. The full width of right-of-way on Heatherbrae Avenue was not acquired when the road was originally constructed. Heatherbrae Avenue is only constructed to its half width at this location.
- There is a similar right-of-way constraint at the southeast intersection of 23rd Avenue and Turney Avenue. Turney Avenue is only constructed to its half width at this location.

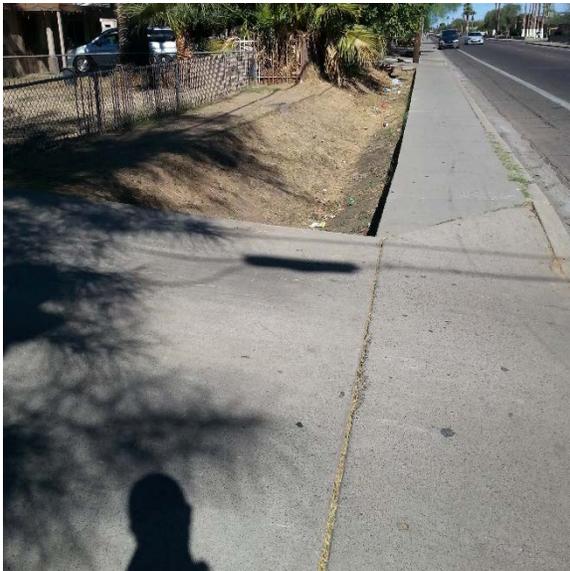
Photo 37 - 23rd Avenue Ditch

- The City has completed various work orders associated with flooding and clogged storm drains around the intersection of 23rd Avenue and Indian School Road. See Photo 41 (page 44).
- The City has also completed work around the intersection of 19th Avenue and Indian School Road. See Photo 42 (page 44).
- The City has completed many work orders at the intersection of of 22nd Drive and Devonshire Road. See Photo 38 (page 43)
- The City has received complaints of flooding and clogged catch basins at the intersection of 18th Avenue and Turney Avenue. See Photo 39 and Photo 40 (page 44).
- There is an open drainage channel on the west side of 23rd Avenue between Heatherbrae Avenue and Glenrosa Avenue. The City frequently receives requests from the public to clean and mow the ditch. See Photo 37 (page 43).

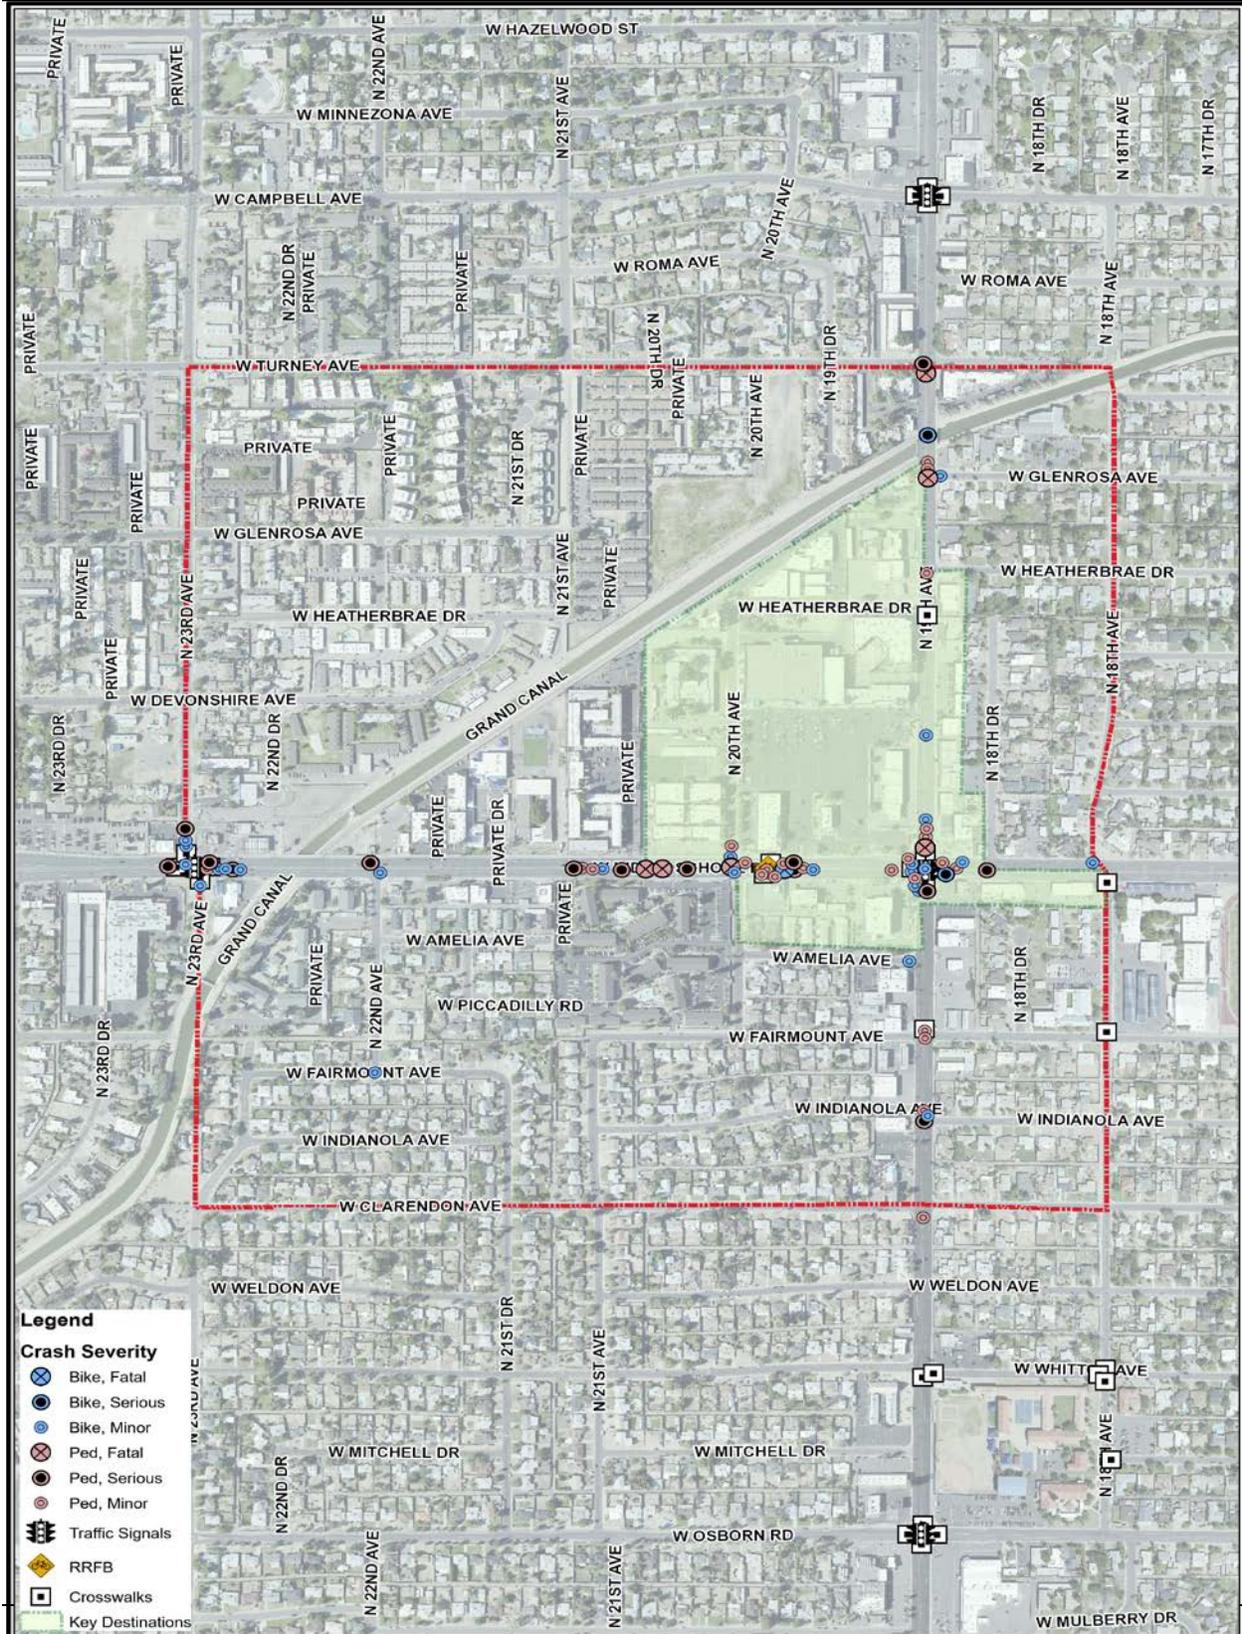
- In one of the fatal crashes, pedestrian was crossing in the crosswalk and was hit by a vehicle that failed to yield.
- In the other fatal crash, the pedestrian was drinking at the time of the crash. In this crash, the pedestrian did not use the crosswalk.
