**CURRENT CONDITIONS REPORT
MOBILITY AREA 1
SOUTH DOWNTOWN NEIGHBORHOODS**

City of Phoenix

**Olsson Associates
7250 North 16th Street
Phoenix, AZ 85020
602.748.1000**

July 2018

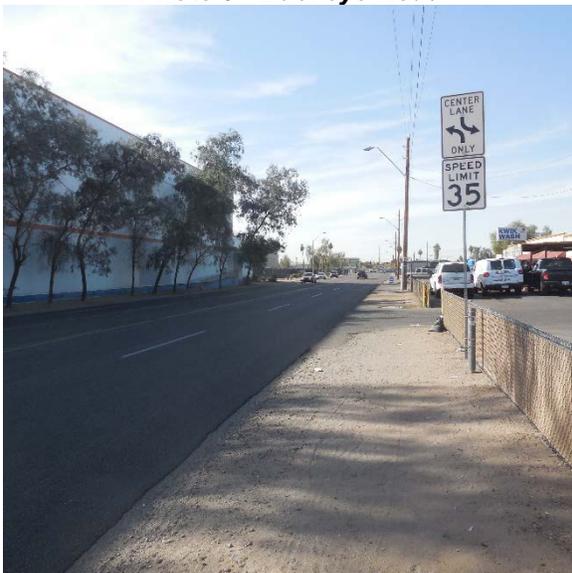
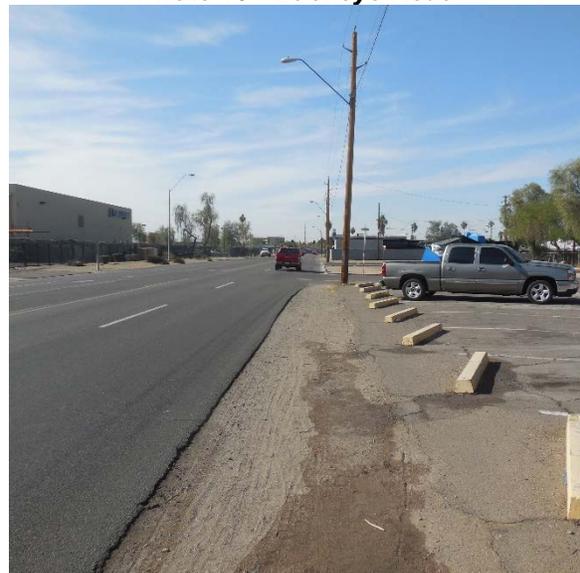
Photo 9 - Buckeye Road

- Curb & gutter and sidewalk is missing on Buckeye Road. Lyle observed that the street floods during rain storms, and that he does not feel safe walking on Buckeye Road without any sidewalk. See Photo 9 and Photo 10 (page 9).

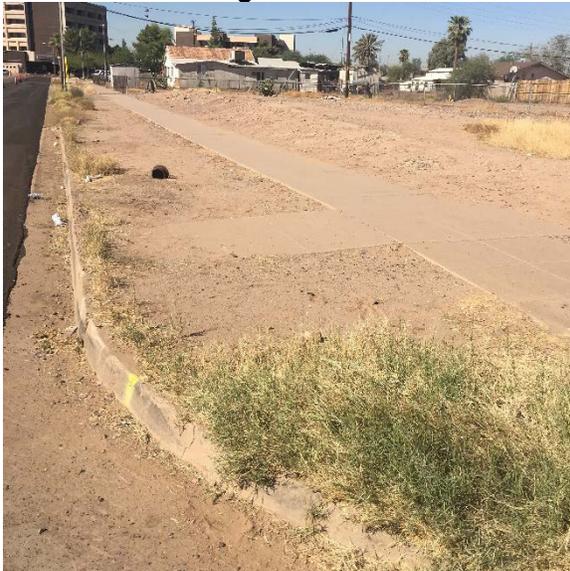
Photo 11 - Neighborhood Aesthetics

- There is frequently trash and debris in the area, the lighting needs to be improved, there are abandoned houses in the area, and there are stray dogs. See Photo 11 and Photo 12 (page 13).

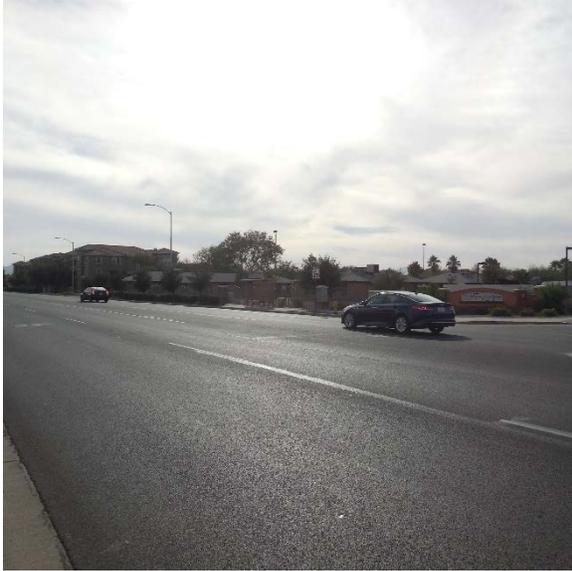
Photo 13 - 7th Ave/Hadley St.

- The school would like to see HAWK beacons installed on 7th Avenue somewhere between Sherman Street and Grant Street. See Photo 13 (page 14).
- The school would also like to see a HAWK beacon installed on Buckeye Road at approximately 5th Avenue. See Photo 14 (page 14).

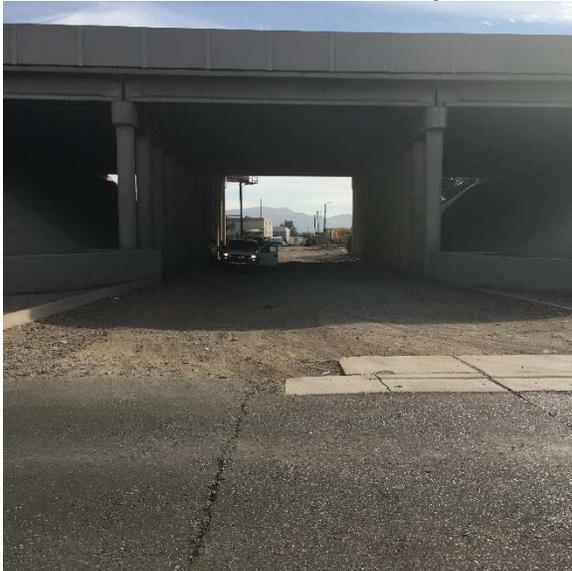
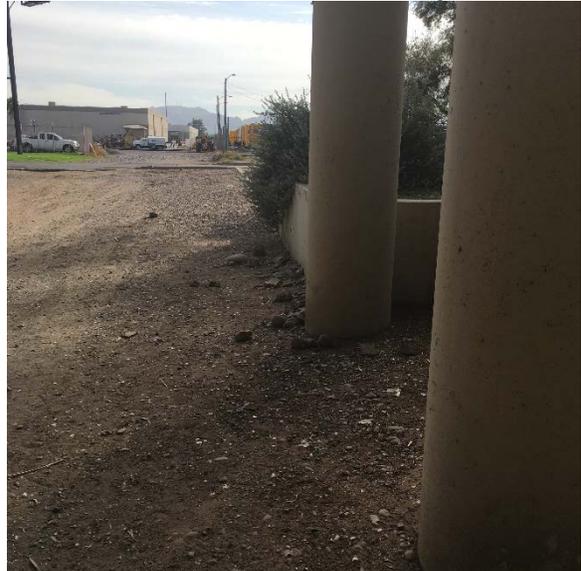
Photo 15 - 3rd St/I-17 Underpass

- Joe is the bicycle mobility specialist at the City of Phoenix.
- Joe would like the study to look at alternatives to connect to the Salt River Trail system, he recommends utilizing the abandoned railroad right-of-way beneath I-17 at 3rd Street. See Photo 15 and Photo 16 (page 14).
- It is currently very difficult for bicycles and pedestrians to cross Buckeye Road between 7th Avenue and 7th Street, other than at Central Avenue.
- Joe would like the study to examine opportunities to incorporate bicycle safety into the Sunburst Plan which specifies how vehicles are circulated through downtown during special events.

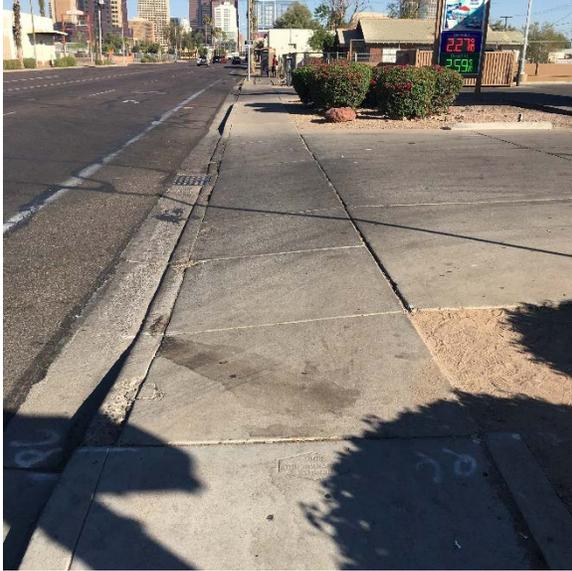
Photo 37 - Central Avenue Bike Lanes

- 1st Avenue/Central Avenue is an existing bikeway from Lincoln Street south to Southern Avenue.
- Central Avenue has also been identified as a Tier I corridor to add missing bike lanes, and improve intersections for bicycles.
- Currently, 1st Avenue/Central Avenue, through the study area, has striped bike lanes in each direction with bike route wayfinding signs in various locations along the corridor. See Photo 37 and Photo 38 (page 27).

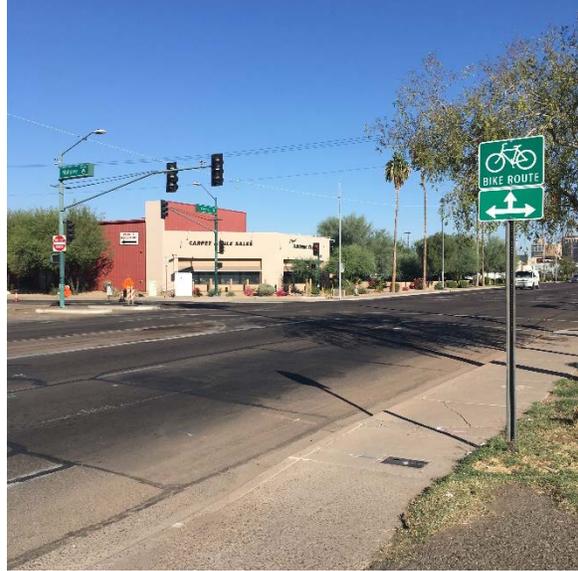
Photo 38 - Central Avenue Bike Signing

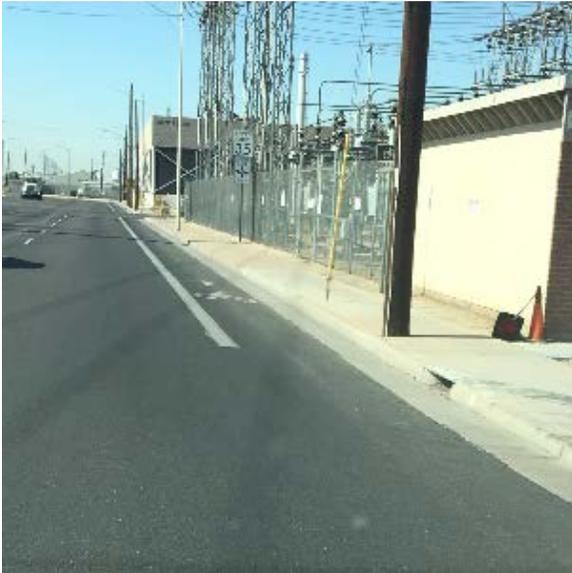
Photo 39 - Lincoln Street Bike Lanes

- The City Master Plan does not identify Lincoln Street as an existing bikeway or a Tier I, II, or III corridor, but it does have painted bike lanes from 7th Avenue to 2nd Avenue. From 2nd Avenue to 2nd Street, the outside lanes of Lincoln Street are designated as share-use lanes. See Photo 39 and Photo 40 (page 27).

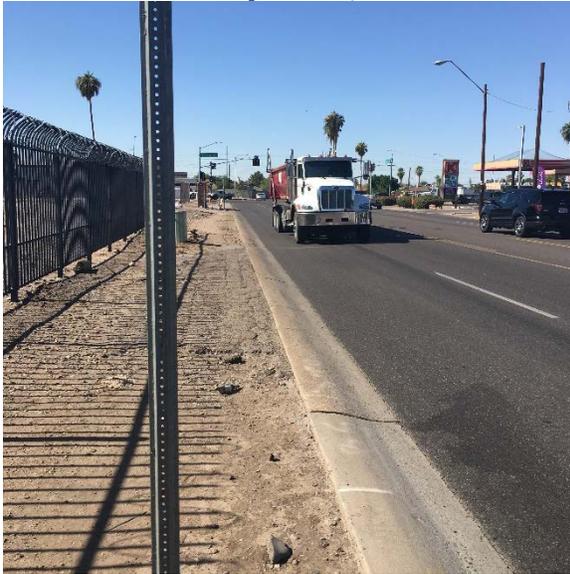
Photo 41 – Buckeye Road, East of Central

- Neither 7th Avenue nor Buckeye Road have striped bike lanes, but currently neither road is classified as an existing bikeway or a Tier I, II, or III corridor in the City Master Plan. See Photo 41 and Photo 42 (page 28).

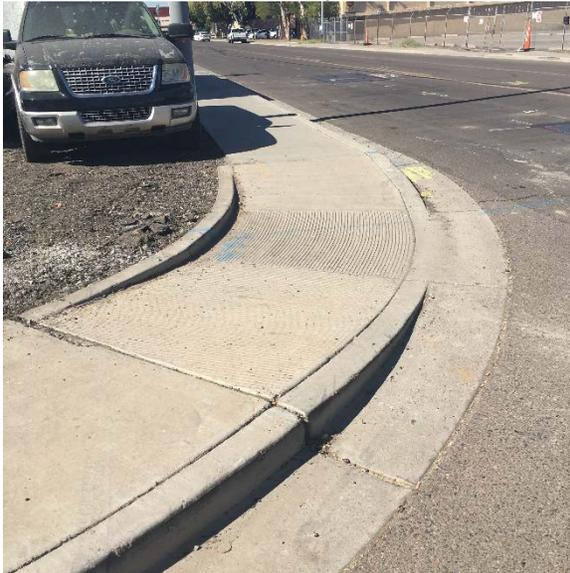
Photo 43 – Mohave St, East of Central

- The City Master Plan classifies Pima Street as a bikeway from 19th Avenue to 3rd Avenue. The bikeway then shifts south at 3rd Avenue to Mohave Street from 3rd Avenue to 16th Street.
- The bikeway currently does not have striped bike lanes but has wayfinding signage and speed humps. See Photo 43, Photo 44, Photo 45, Photo 46 (page 28).

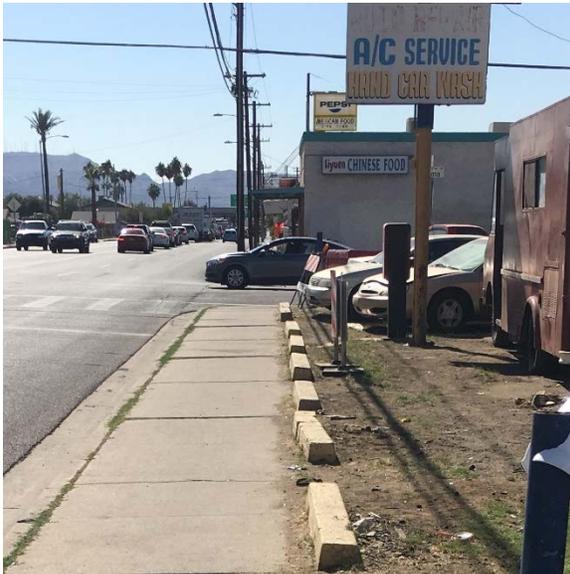
Photo 47 - 7th Avenue/Pima Street

- A HAWK beacon is planned at the intersection of 7th Avenue and Pima Street. Pima Street has been designated as a bikeway in the City of Phoenix Master Bike Plan, a HAWK beacon at this location will allow bicycles to safely cross 7th Avenue. See Photo 47 (page 34).
- A HAWK beacon is planned at the intersection of 3rd Avenue and Buckeye Road in front of Lowell Elementary school, this HAWK will replace the existing school zone in this location. See Photo 48 (page 34).

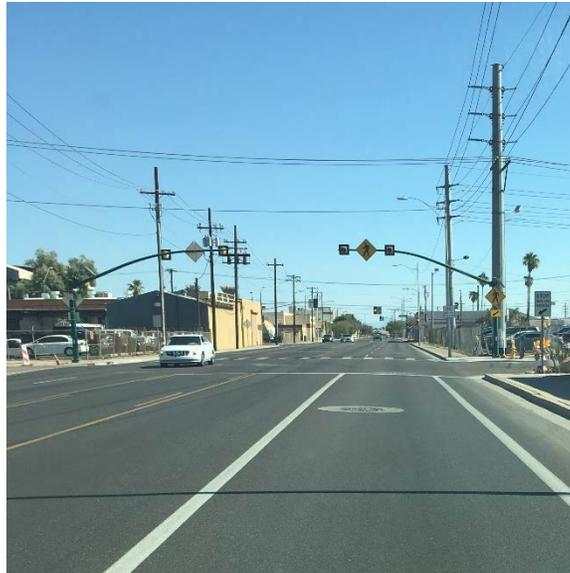
Photo 49 - 2nd Avenue/Lincoln Street

- There is currently only one existing or proposed RRFB in the study area, at the intersection of 3rd Avenue and Buckeye Road. See Photo 49 (page 35).

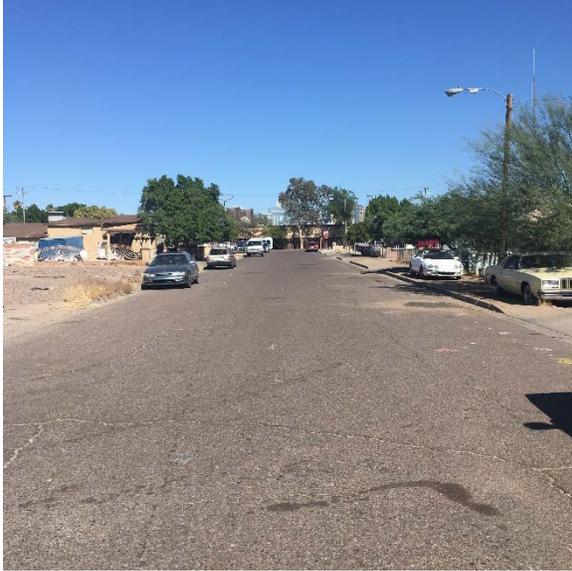
Photo 50 - 1st Street, North of Durango

- Much of the neighborhood between Mohave Street and Durango Street, east of Central Avenue, does not have existing sidewalk. Furthermore, in many locations, there isn't any curb and gutter either. This neighborhood has had a high rate of flooding complaints. Vehicles in the neighborhood are parking in the shoulder, or behind the existing curb & gutter, as a result, pedestrians are forced to walk in the street. See Photo 50, Photo 51, Photo 52, and Photo 53 (page 39).

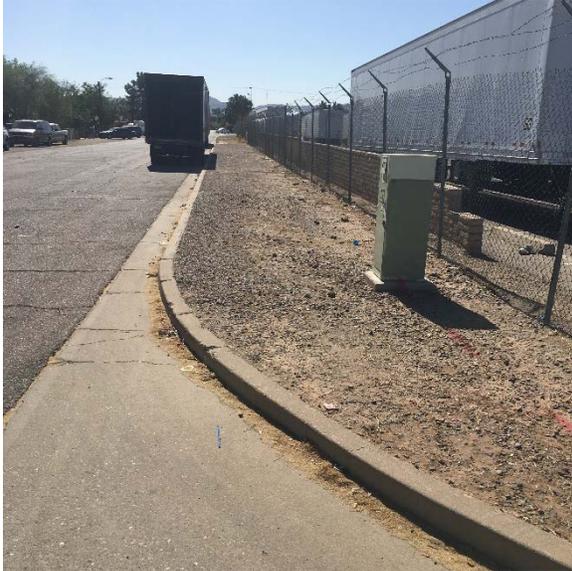
Photo 54 - 3rd Street, South of Pima St.

- There are some areas with missing sidewalk in the industrial neighborhood along Pima Street, east of Central Avenue. In many locations, the area behind the curb is paved with asphalt and used for parking. See Photo 54 (page 40).

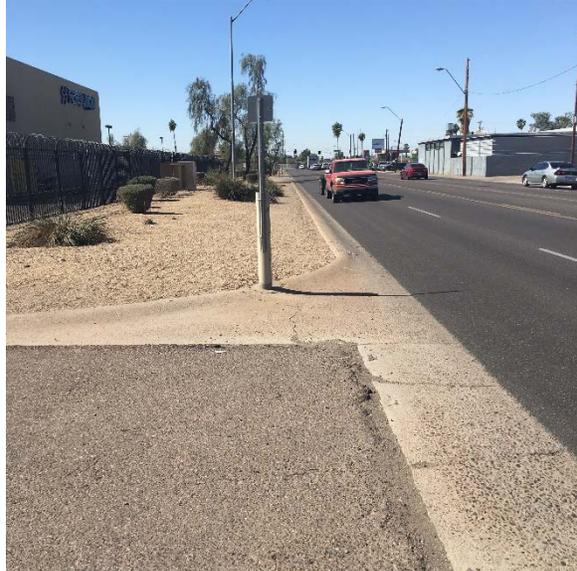
Photo 55 - Buckeye Rd, East of Central

- Both sides of Buckeye Road, east of Central Avenue, are missing sidewalk. The north side of the road is also missing curb & gutter. Reports from residents in the area indicate that the road floods during heavy rains due to the lack of infrastructure. The City is working on a project to improve Buckeye Road, from Central Avenue to 16th Street. In the study area, from Central Avenue to 3rd Street, sidewalk will be added to the south side of Buckeye Road. There will be no improvements to the north side of the road. See Photo 55 (page 40).

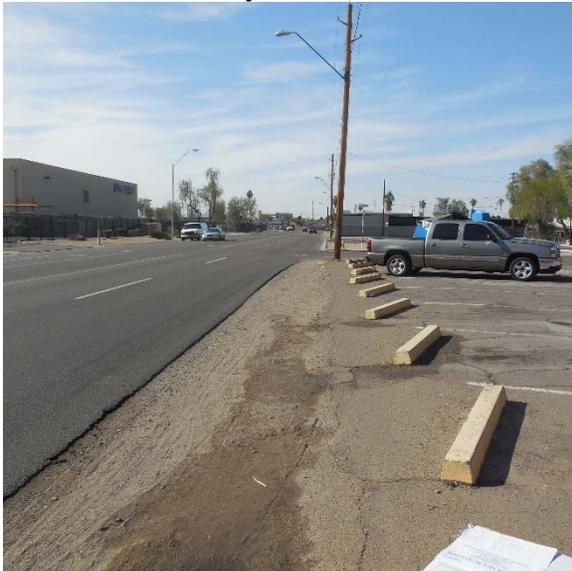
Photo 57 - 1st Avenue, North of Cocopah

- The sidewalk and curb & gutter is missing in various locations along 1st Avenue between I-17 and Papago Street, and along Apache Street from 7th Avenue to Central Avenue. Like other neighborhoods, vehicles along Apache Street are parking in the shoulder or behind the existing curb & gutter which forces pedestrians to walk in the street. See Photo 57 and Photo 58 (page 40).

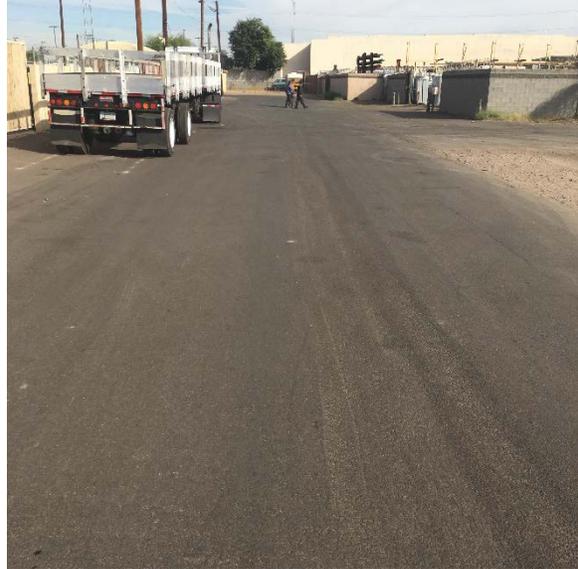
Photo 59 - Gibson Ln, East of 6th Ave.

- Most of the streets within the study area, south of I-17 are missing sidewalks, and many are missing curb & gutter as well. This area is zoned as industrial, and the land use is mostly industrial. See Photo 59 (page 41).

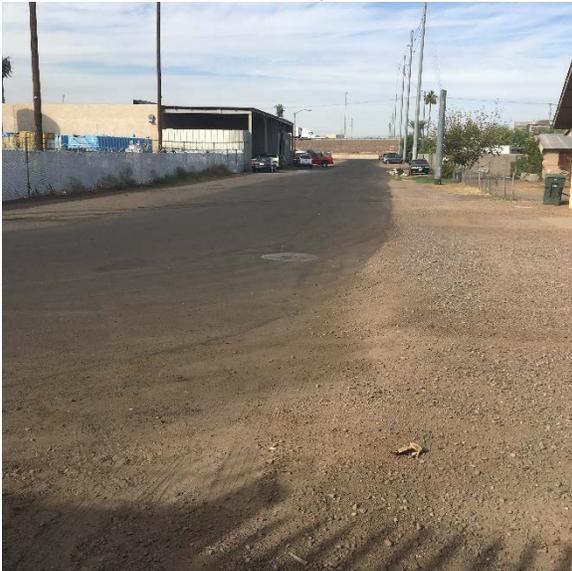
Photo 61 - Watkins Road

- Most of the sidewalk locations not following the ADA guidelines can be found on 7th Avenue and Central Avenue.
- In locations where Watkins Street has sidewalk, ADA guidelines are not followed.

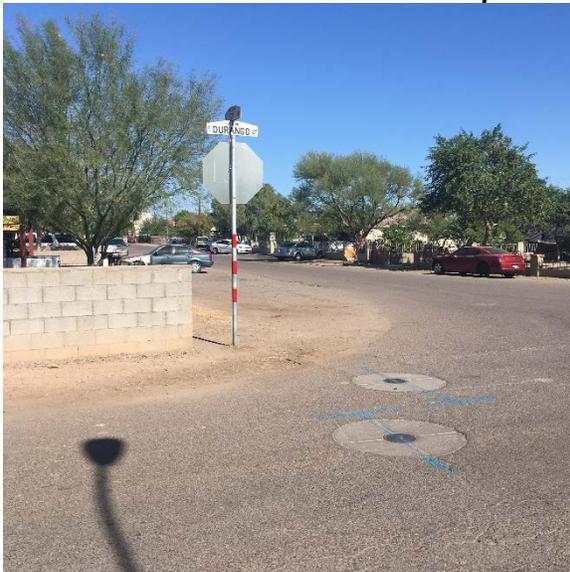
Map 3B - Sidewalks shows areas that are constructed within ADA guidelines and some that are not. The map also identifies locations where there should be a curb ramp, but the ramp is missing. These areas have been identified as non-accessible. For this study, a curb ramp is considered non-accessible if it is missing detectable warning surface, if the landing behind the ramp is less than 4-ft x 4-ft in size, or if there are obstructions in the ramp or in the landing. Many of the curb ramps in the area have been modified or replaced to meet ADA guidelines, but there are still many that need improvements.

Photo 62 - Non-Accessible Ramp

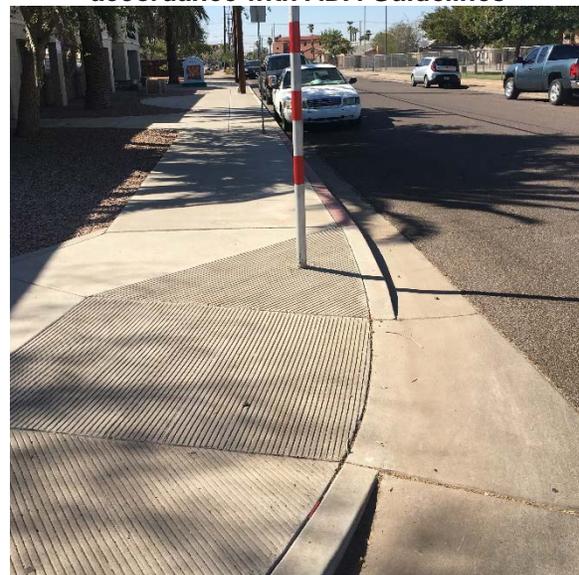
Photo 63 - ADA Ramp that is not in accordance with ADA Guidelines

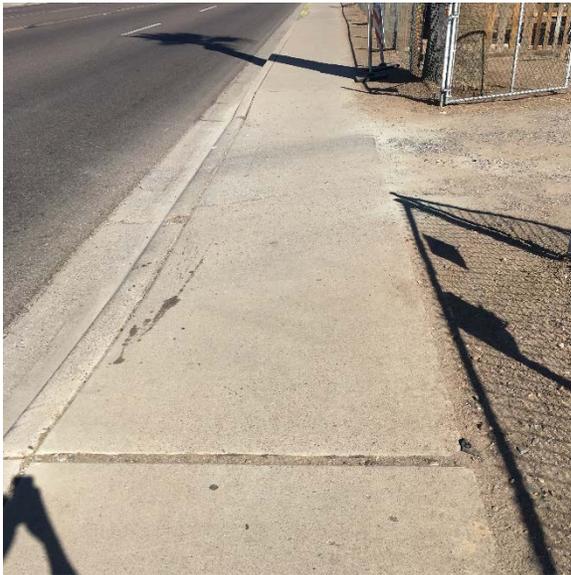
Map 3B - Sidewalks also identifies sidewalk locations that do not meet ADA guidelines. These sidewalks have been labeled with orange. These sidewalks do not follow ADA guidelines because existing driveway slopes do not follow ADA guidelines. Driveways that follow the ADA guidelines provide a 3-ft minimum width landing/walk way behind the ramp so that users with mobility disabilities do not have to navigate the warped portion of the driveway.

Photo 64 – Sidewalk not constructed in accordance with ADA Guidelines

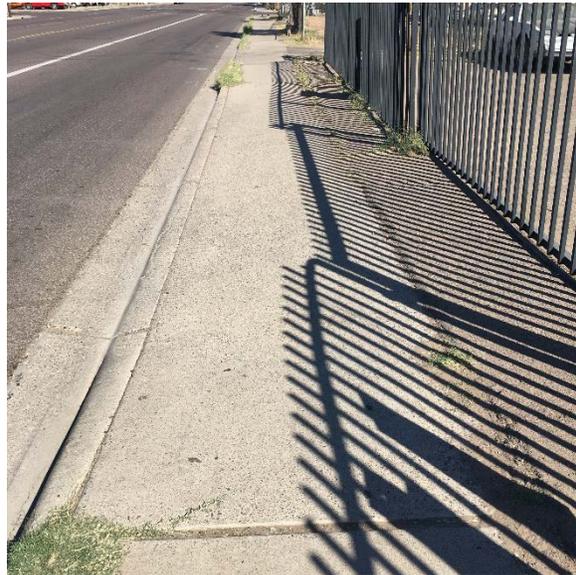
Photo 65 – Sidewalk not constructed in accordance with ADA Guidelines

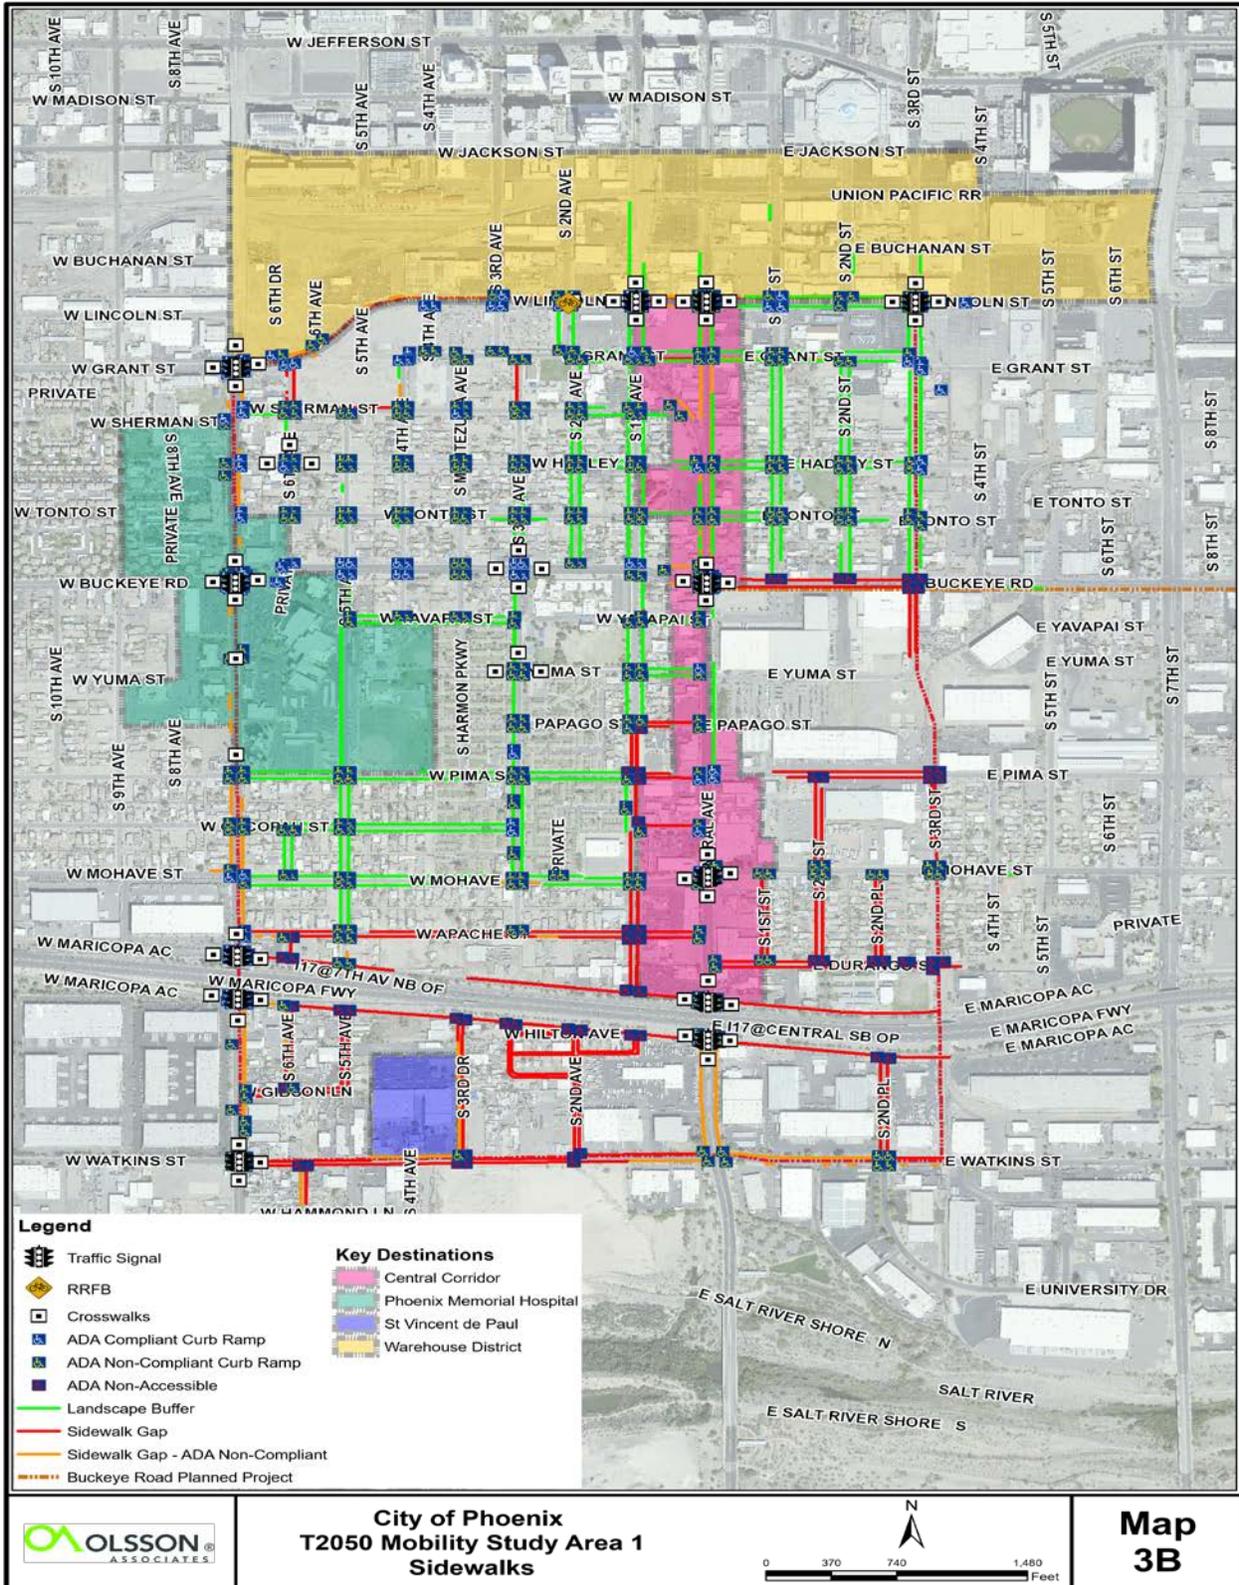
Map 3B - Sidewalks identifies locations where there are gaps in the existing sidewalk system, and locations where the existing sidewalk does not meet ADA guidelines. The map also identifies locations where the existing curb ramps do not meet ADA guidelines, or locations where there are no existing curb ramps.

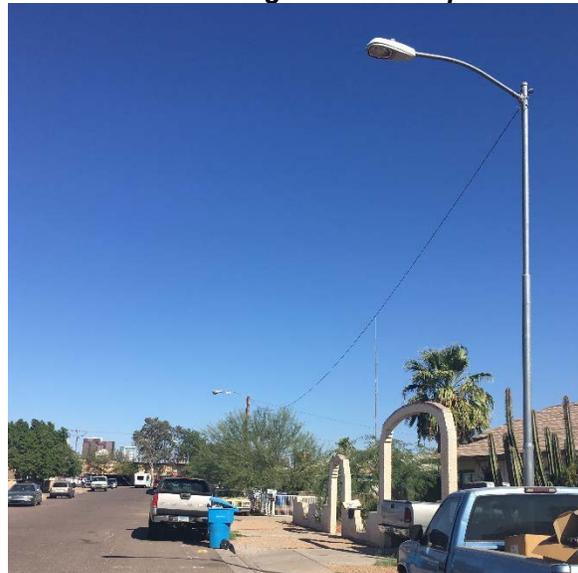
Photo 67 - Light Pole Example

Existing lighting, within the study area, was evaluated based on the City of Phoenix Streetlighting Layout Guidelines. Table 1: Spacing and Mounting Height Criteria provides the criteria used to evaluate spacing of the existing lighting. The study only evaluated spacing, it did not evaluate watts, lumens, or mounting height. Map 3C - Lighting identifies light pole locations, and the maximum light pole spacing based on the City guidelines. The study did not examine the existing light fixtures, but only noted that most of lights in the area are mounted on wood poles. The lighting will be evaluated more closely as potential projects are identified. See Photo 66 and Photo 67 (page 46). In general, the spacing of the existing lighting in the study area meets City guidelines.

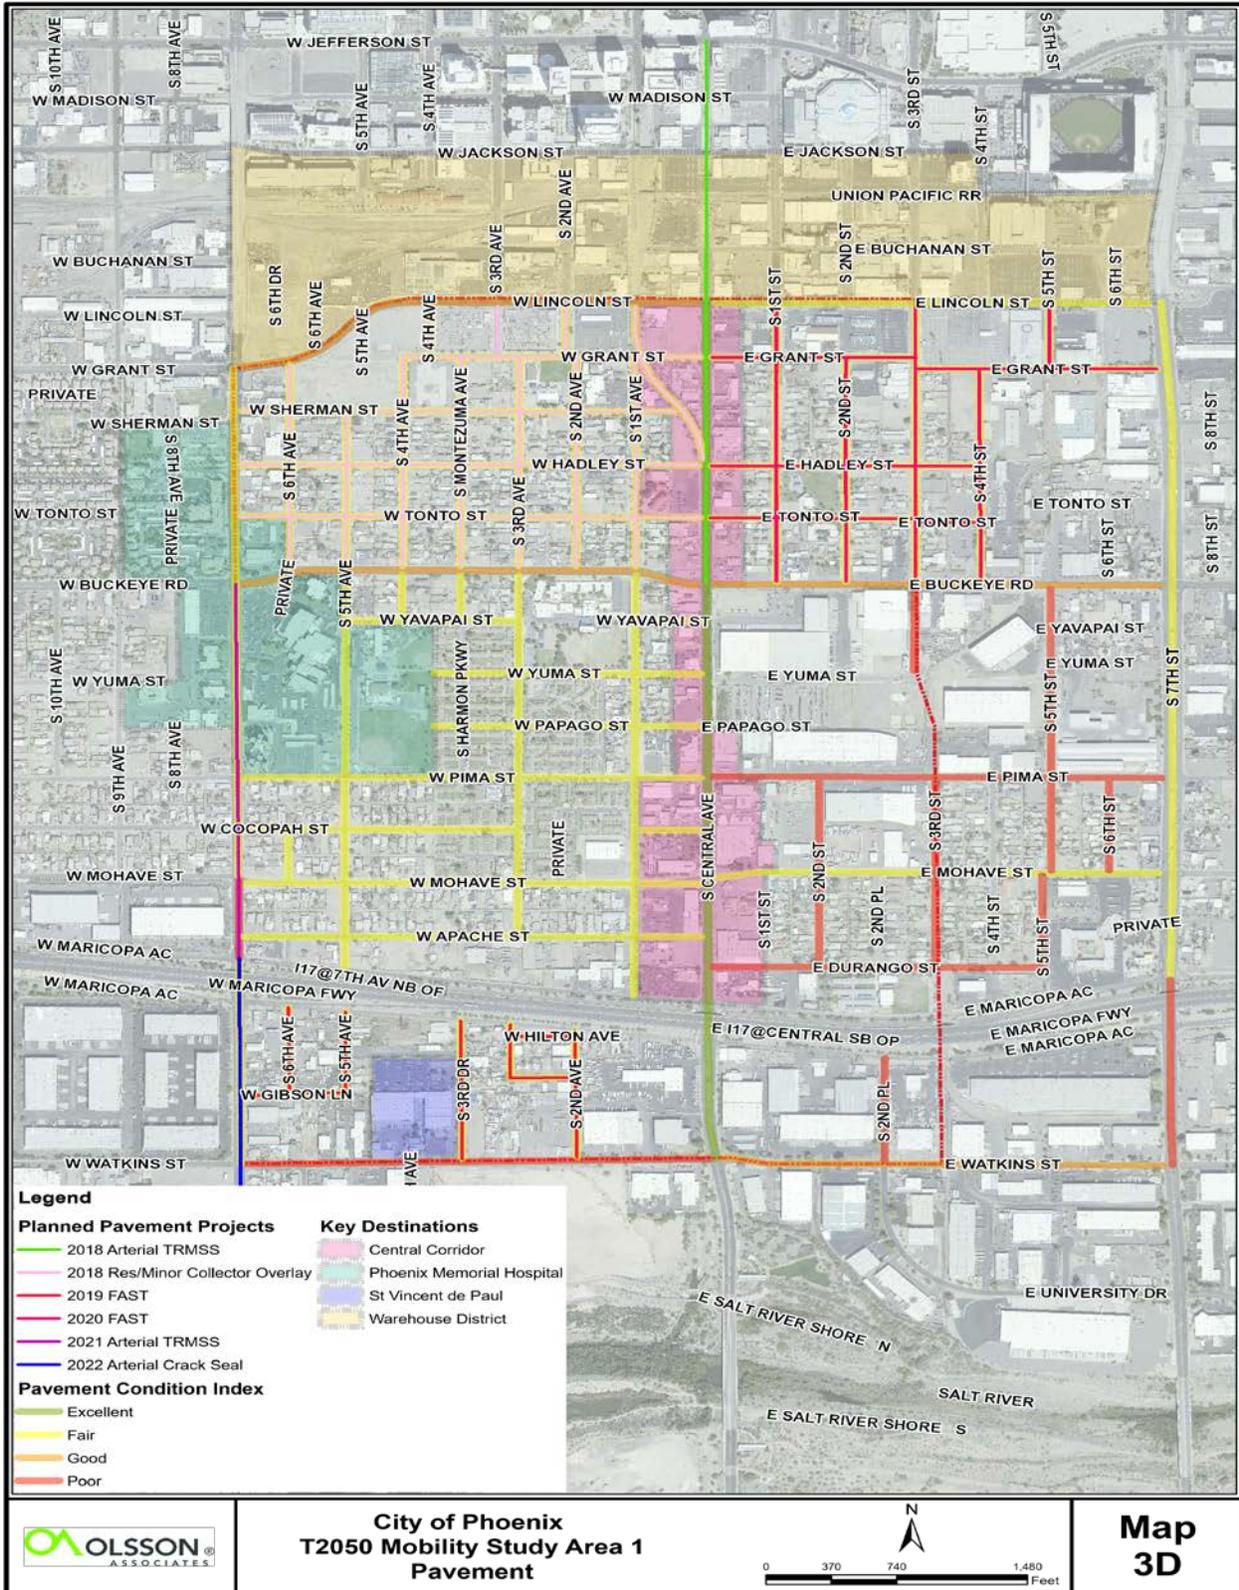
- The local roads west of Central Avenue have been classified as being in fair condition.
- The local roads east of Central Avenue have been classified as being in poor condition.
- 7th Avenue is classified as fair condition.
- Watkins Street is classified as poor condition.
- Central Avenue is classified as excellent condition.
- Lincoln Street is classified as good condition.
- Pavement preservation projects are identified on Map 3D - Pavement Condition.

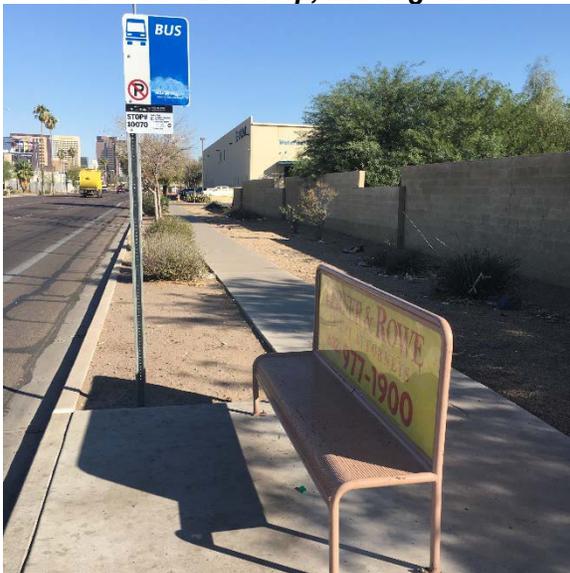
Bus stops in the area were evaluated for ADA accessibility and for amenities provided. A bus stop is considered accessible if users can access the stop by sidewalk. Users should not be required to walk in the street or on the shoulder to access the bus stop. None of the bus stops within the study area are considered ADA non-accessible. Bus stop amenities were evaluated to determine if a bus stop is missing a bench, a shelter or both. Several bus stops within the area are missing these amenities.

Photo 68 - Bus Stop, Missing Shelter

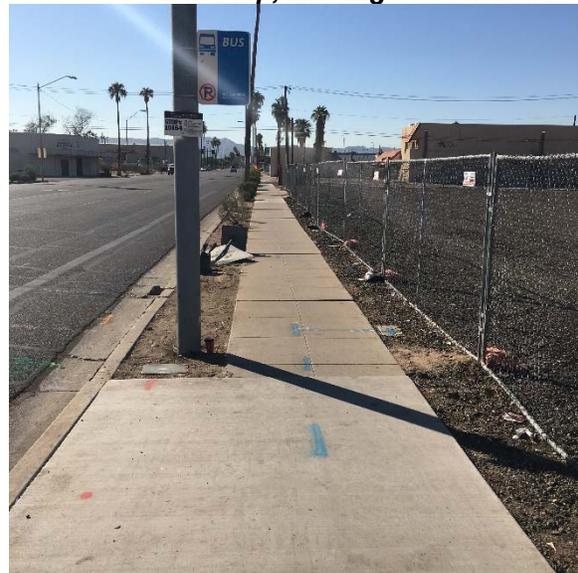
Photo 69 - Bus Stop, Missing Shelter/Bench

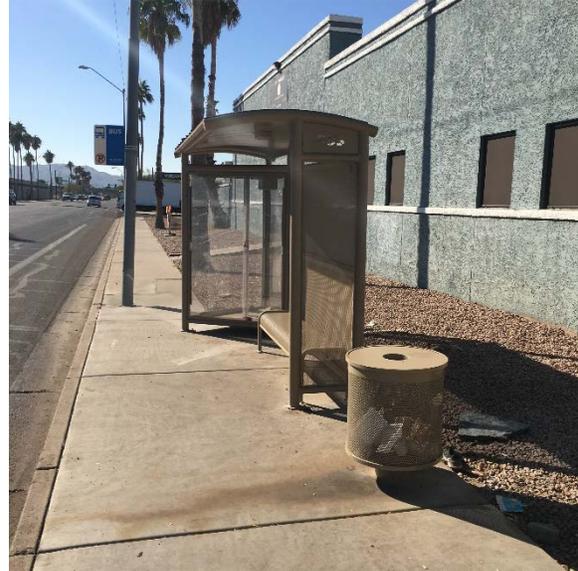
Photo 71 - Bus Stop, All Amenities Provided

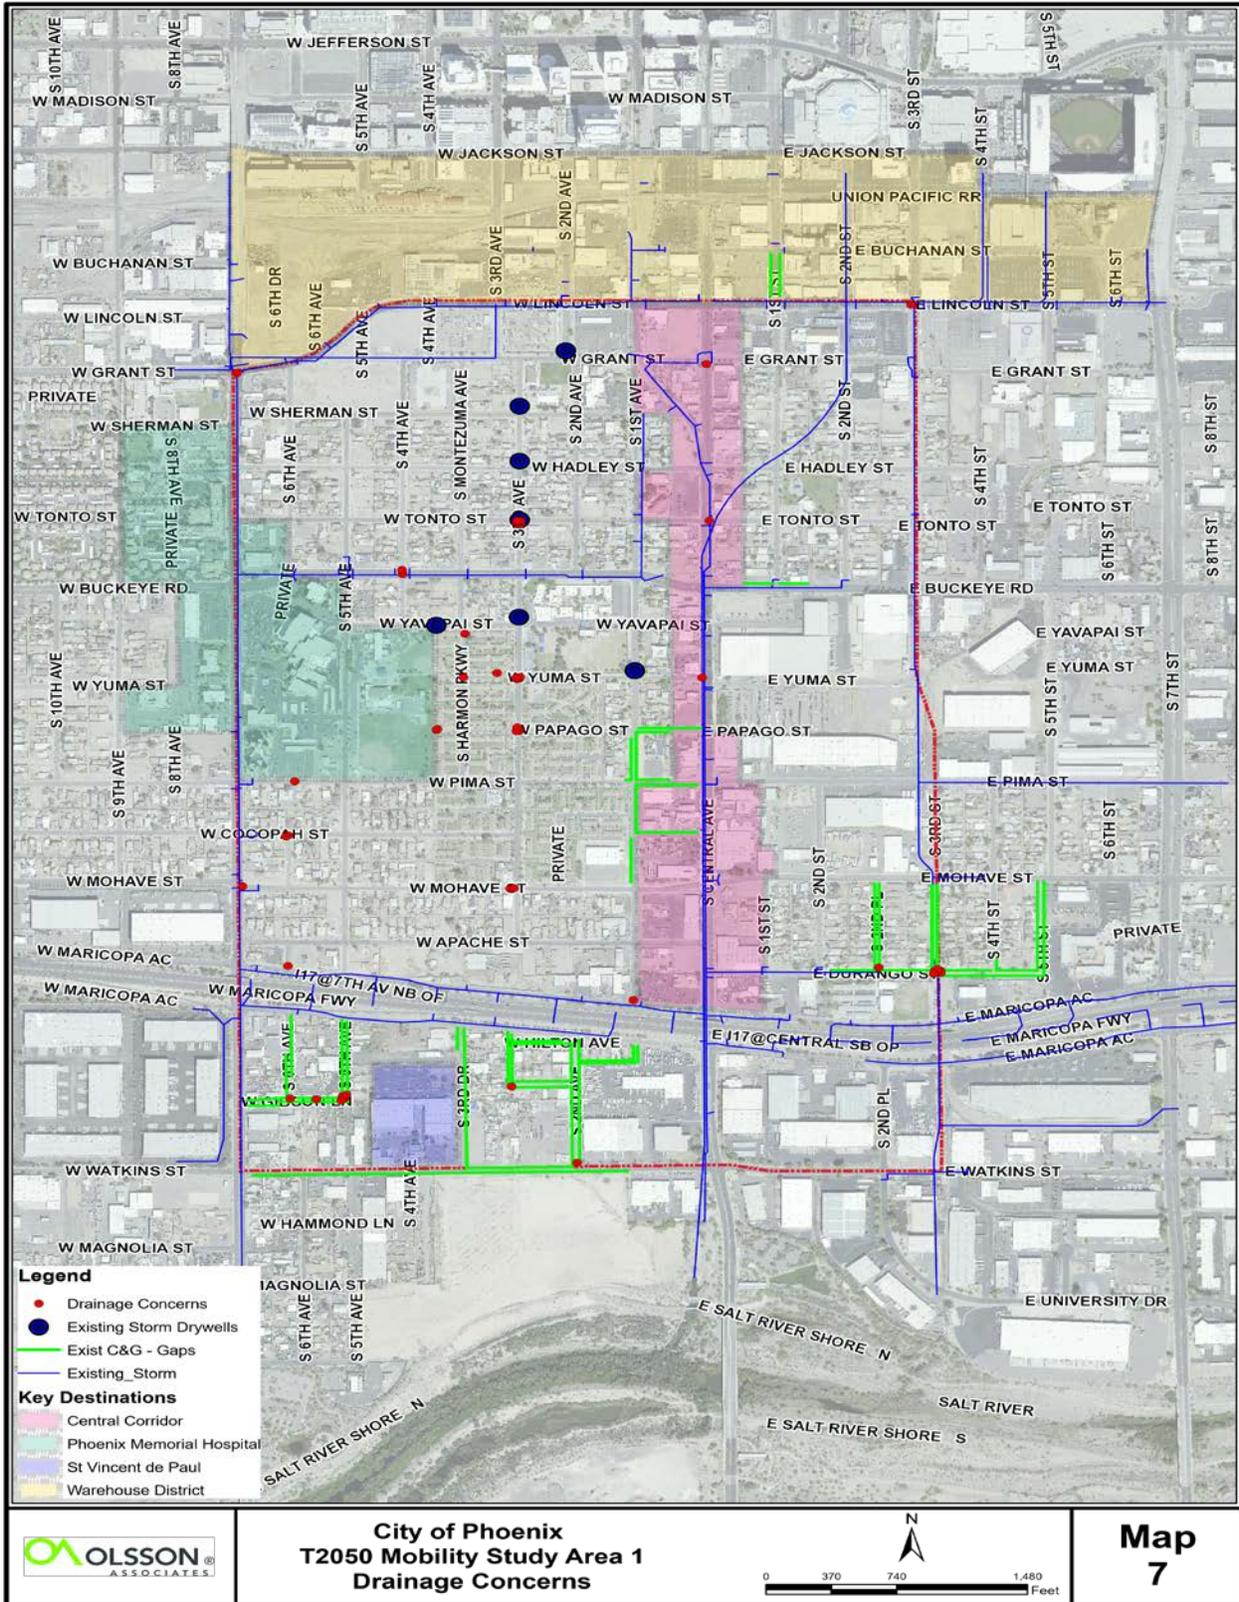
The City provided a list of public concerns and work orders initiated within the study area. Map 7 - Drainage Concerns shows locations where the City completed work orders associated with flooding or other drainage concerns. The map also shows the existing drainage infrastructure as well as locations where curb & gutter is missing. Missing curb & gutter is a drainage concern because storm water cannot be conveyed properly. Areas with potential flooding concerns include:

- Most of the streets south of I-17 are missing curb & gutter. The City has received several complaints of flooding or standing water on Gibson Lane at 5th Avenue.
- Most of the street in the neighborhood east of Central Avenue between Durango Street and Pima Street is missing curb & gutter. The City has received several complaints of flooding or standing water at the intersection of 3rd Street and Durango Street.
- The streets between Mohave Street and Papago Street and between 1st Avenue and Central Avenue are missing curb & gutter.
- The City has received several complaints of flooding and standing water in locations where street drainage is managed by drywells.
