City of Phoenix

ANNUAL REPORT

Municipal Separate Storm Sewer System

September 27, 2019

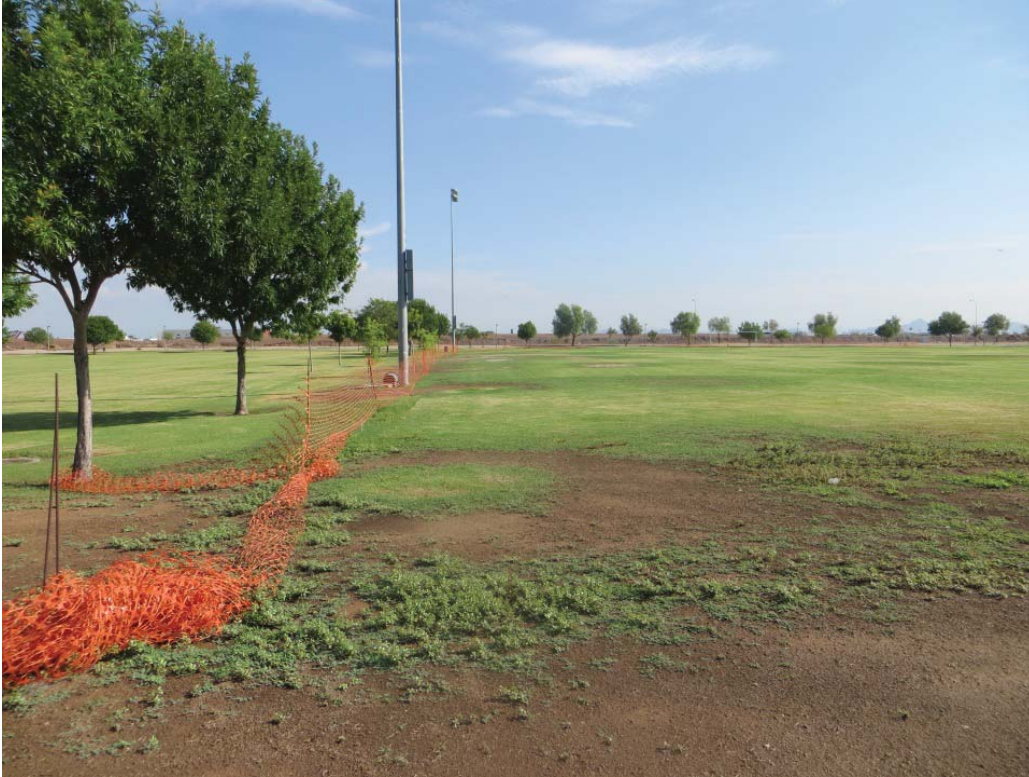
- No understory or groundcover vegetation in/around swale that conveys water from street to the turf bioretention area. Benefits of slowing, filtering or cleaning stormwater may be reduced.
- Over 50% of trees in as-builts no longer exist.
- Bare spots in turf (assumption is from cars/heavy pedestrian-use) may decrease water infiltration rates.
- Flood irrigation and sprinkler systems may not promote efficient water use.

Manzanita Park Turf Bioretention

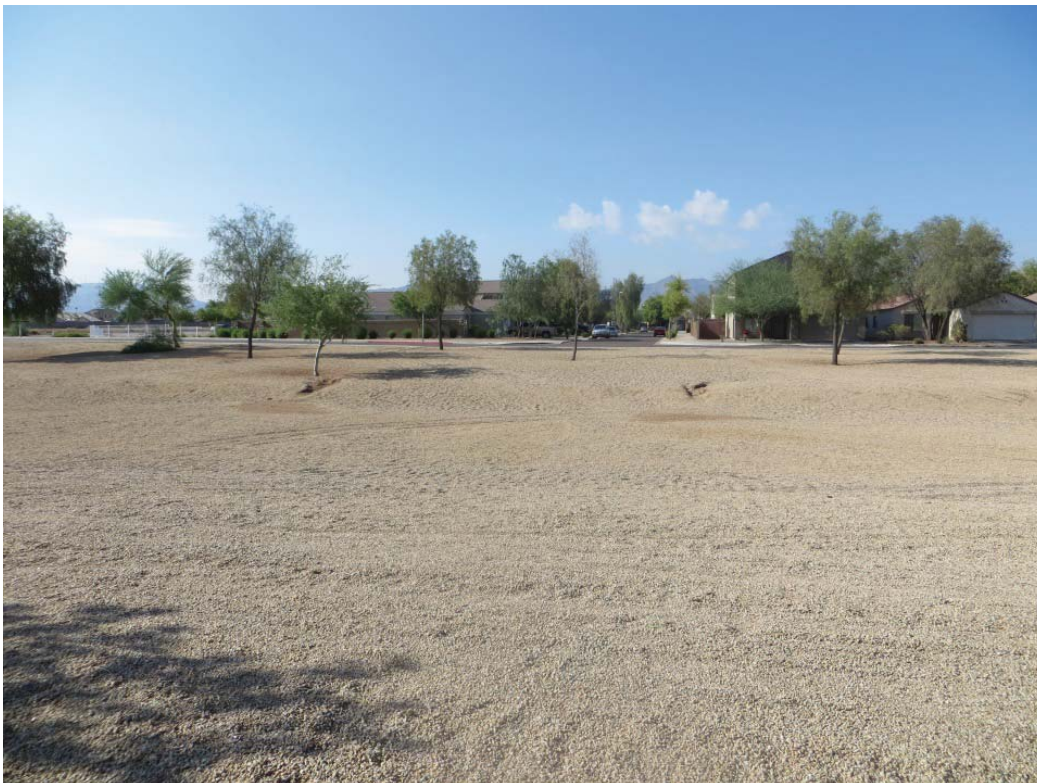
Manzanita Park Decomposed Granite Bioretention

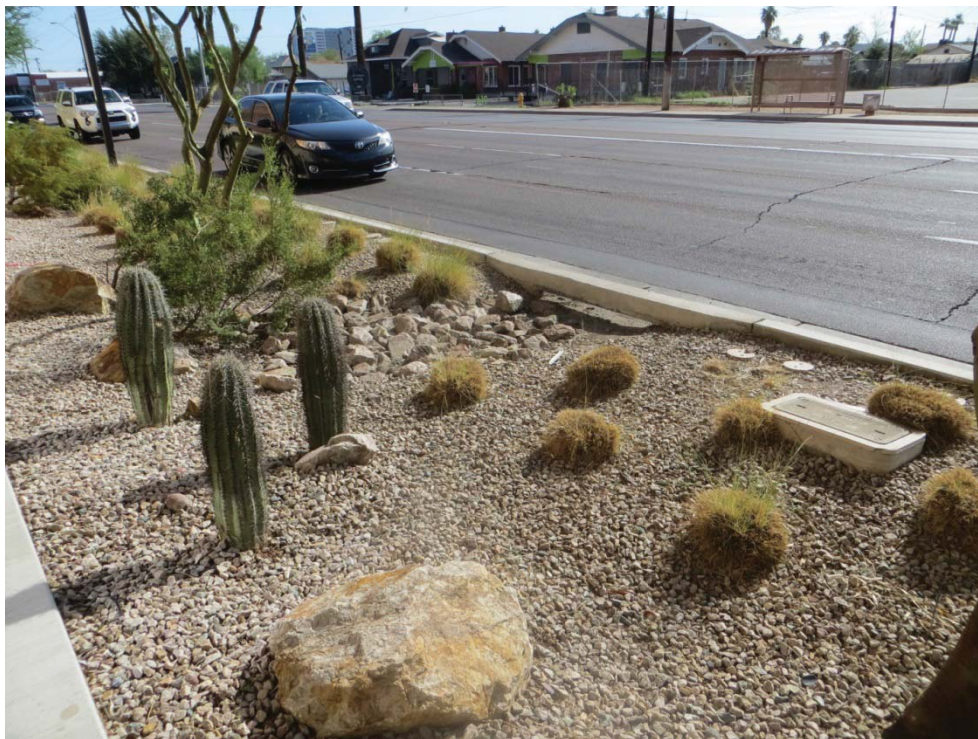
- Some holes in bioswale appear to have been left from a tree that was damaged or died.

Cancer Center Bioswale

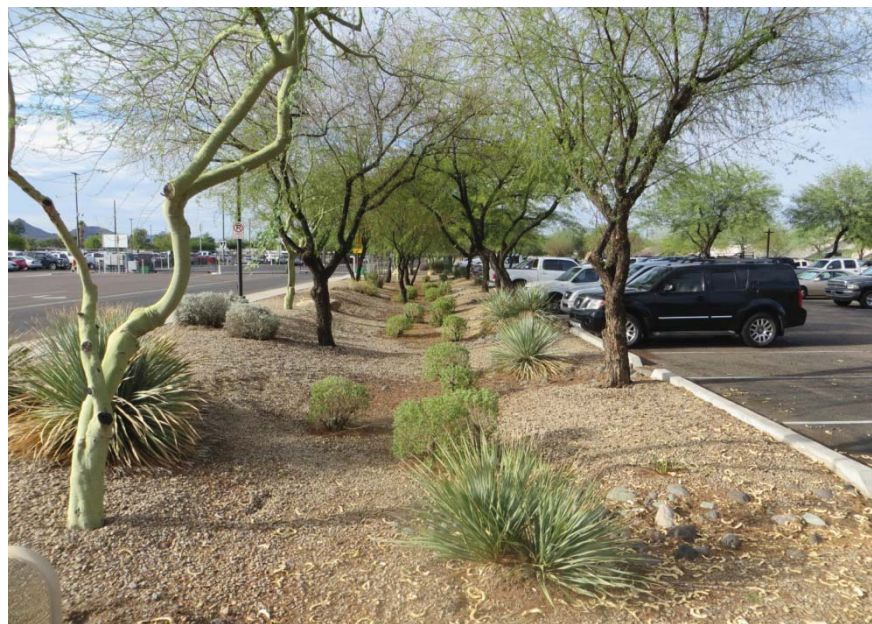
- Bioswale stores 5,063-ft³ of stormwater runoff.
- Bioswale infiltrates stormwater runoff at an average rate of 4 in/hr.
- Bioswale reduced stormwater runoff by 68% from 0.28-cfs to 0.09-cfs.
- Vegetation has 25% coverage. Soil conditions match as-builts.
- Irrigation valve boxes need repairs.
- Maintenance may not support the function of the bioswale due to extreme uplimbing of trees and shearing of shrubs.

Union Hills is one of the oldest designs from the group of bioswale/bioretention test sites. This may have something to do with the condition of its irrigation and plant survival rate. Site visit occurred within 24 hours of a rain event.

Union Hills Service Bioswale

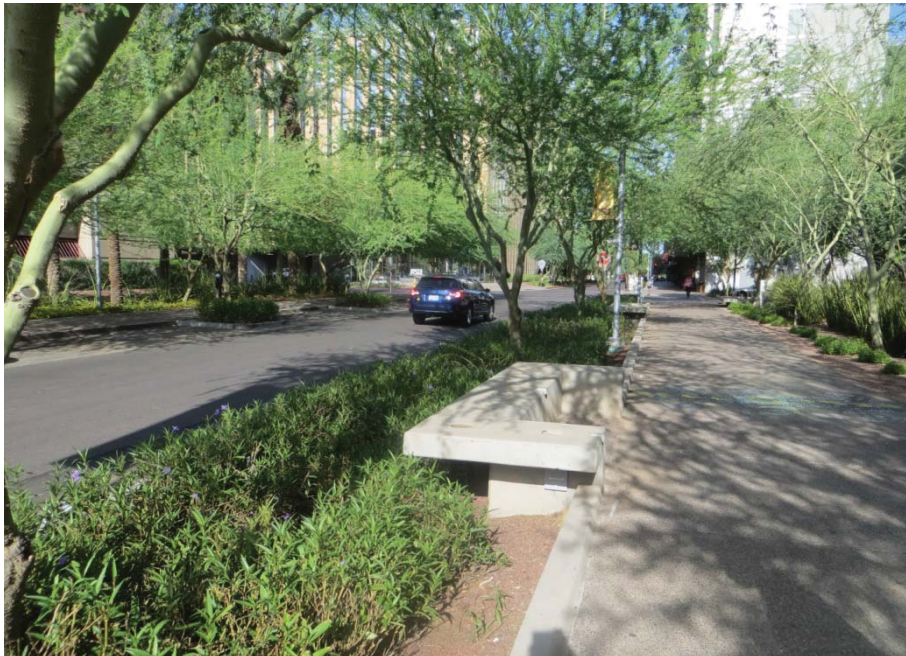
- Erosion at some inlets was amended with large rock not specified in as-built.
- Missing vegetation in basin between 2nd Ave. and 3rd Ave. allows pedestrians to cross through, thus aggravating bare areas and compacting soil, possibly leading to reduced infiltration rates.

Taylor Mall Bioswale

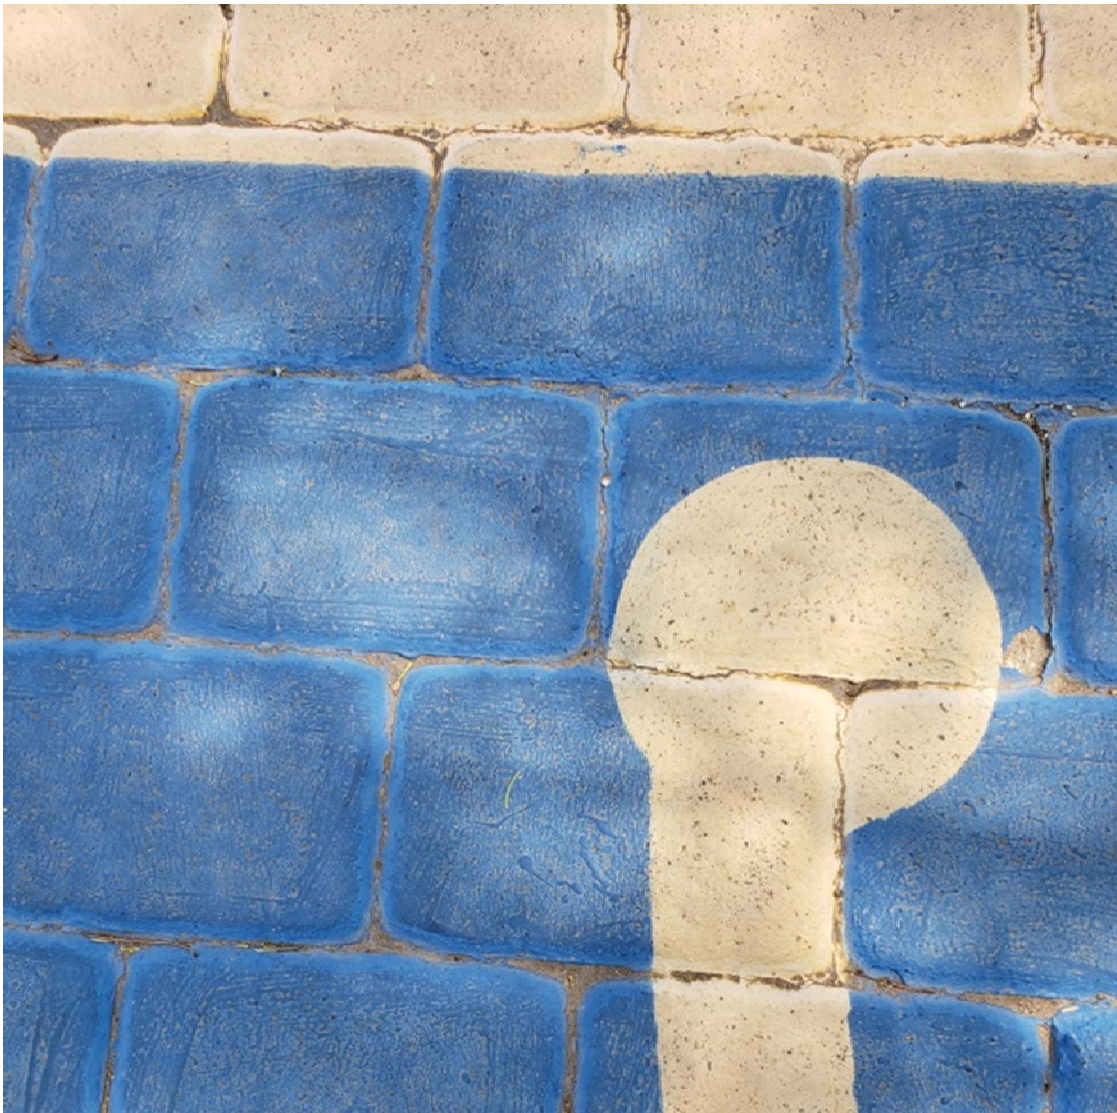
- Pavers do not allow water to infiltrate
- Handicap parking symbols were painted onto pavers and may be detrimental to infiltration function in these areas (see picture below)

Painted Permeable Pavers

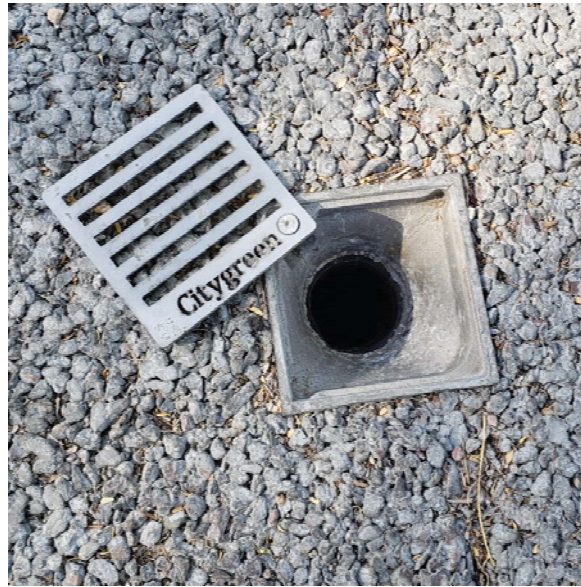
There appears to be an under-drain system which was not found in the as-built plans. Pervious concrete sidewalk sections were intermixed with traditional concrete sidewalk sections with under-drain throughout.

Unclogged drain inlet

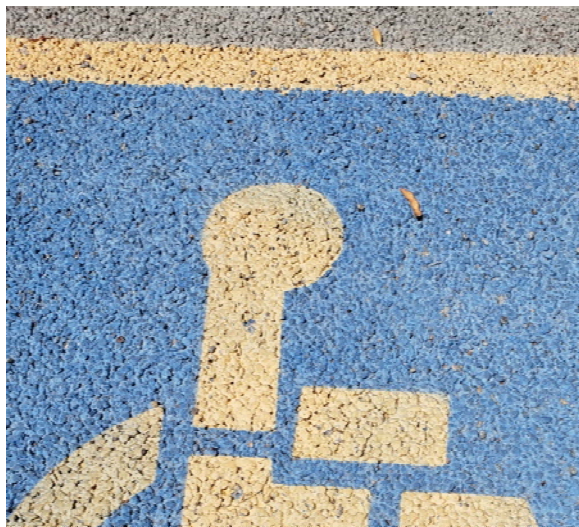
Painted handicap symbol
